Docket No. 272 – Development and Management Plan Inspection

Segment 3 Underground Line

Date: January 23, 2007

Location: East Devon Substation to the Housatonic River Crossing

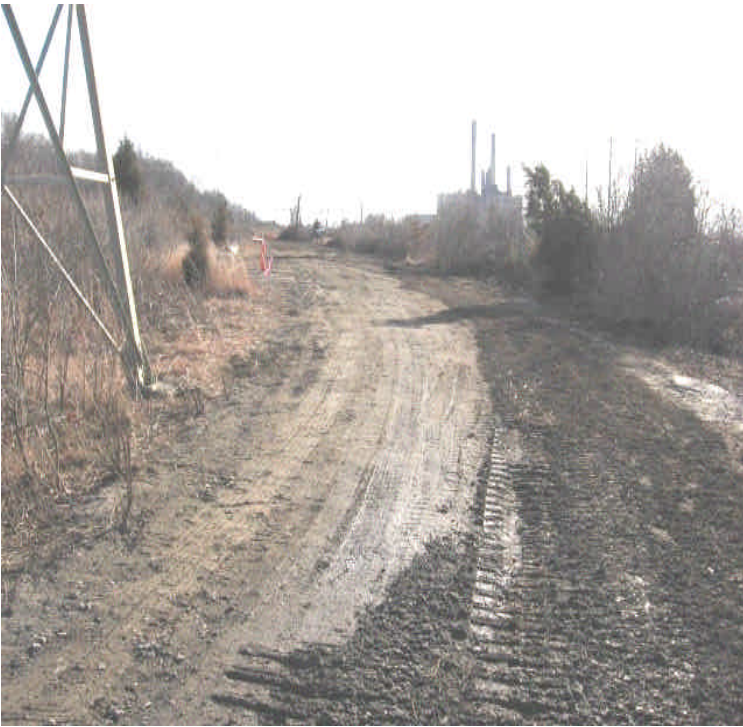
Photo taken near station #1058. A mixed aggregate base was applied as cover on the trench to stabilize the existing access road

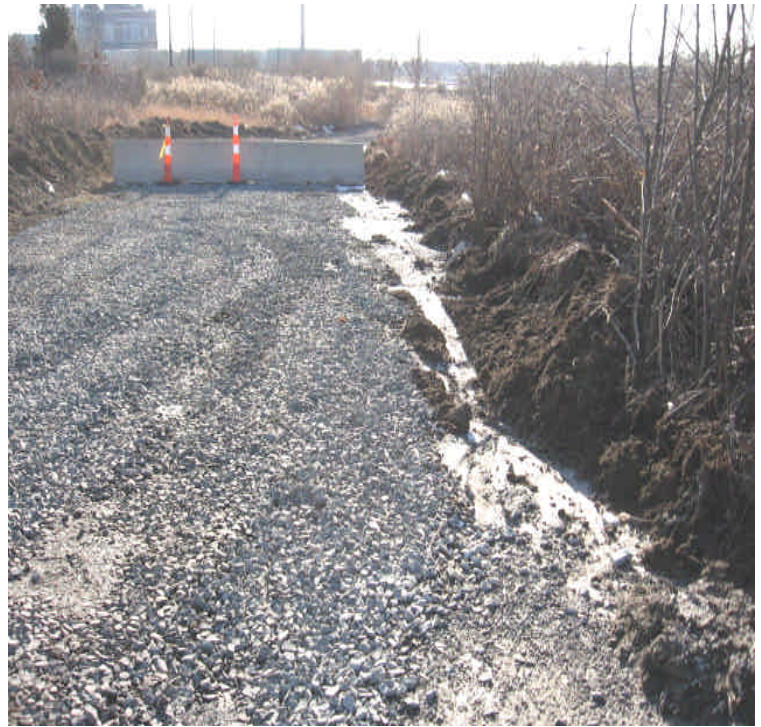
Photo of an uncontained concrete washout released along the access road near station #1055. The concrete should be removed and properly disposed of. Remind drivers to use appropriate locations.

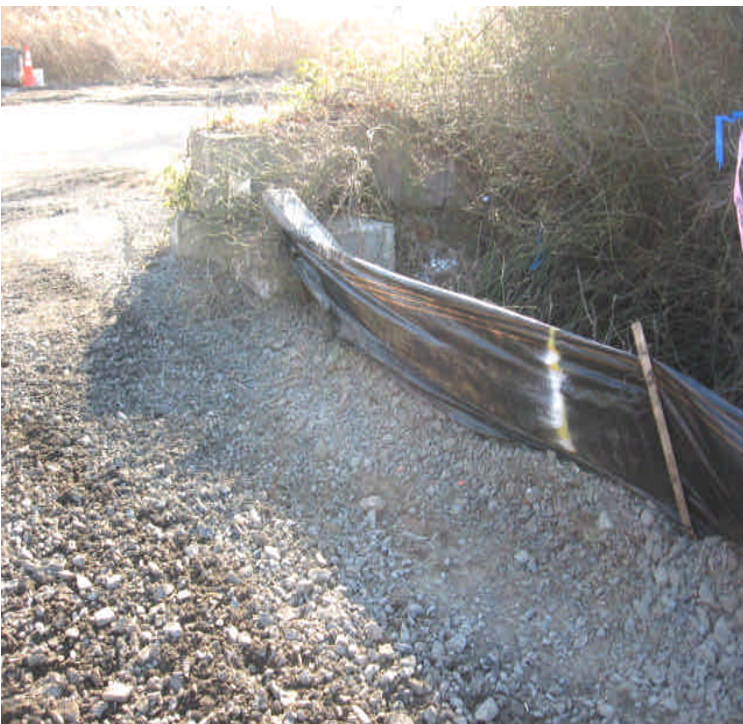
The silt fence west of station #1052, immediately adjacent to construction entrance and resource area. Ensure that the fence is toed-in and provide maintenance as necessary.

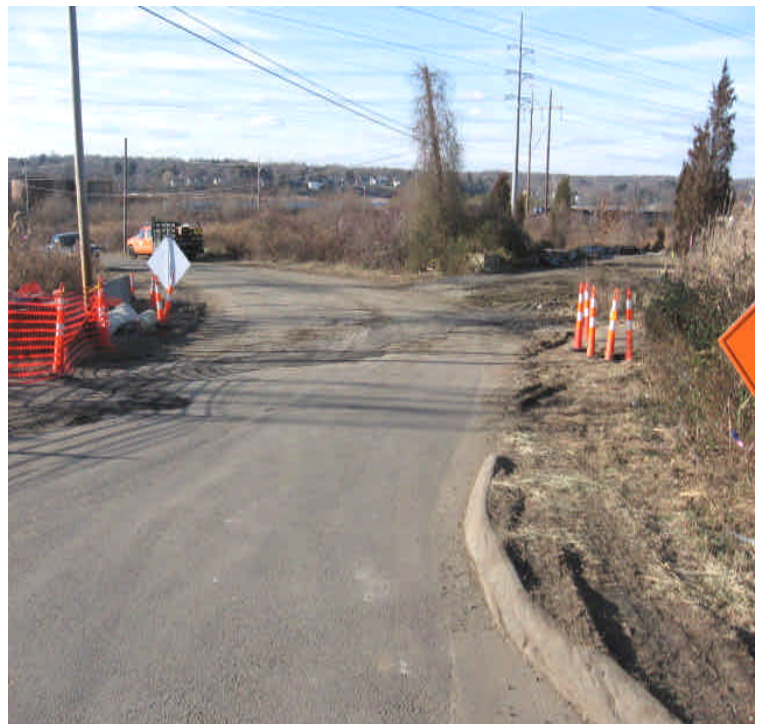
Photo of Naugatuck Ave. which was swept and currently free of sediment.

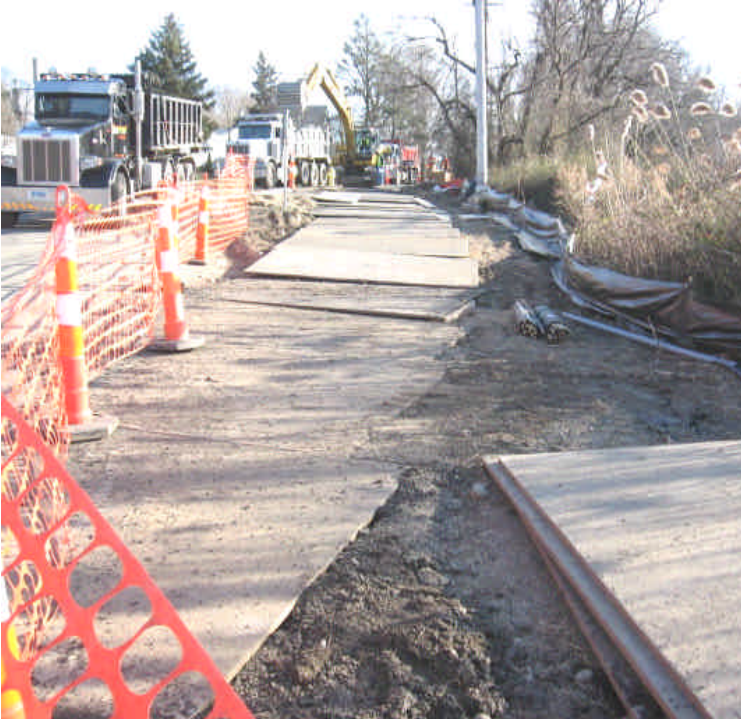
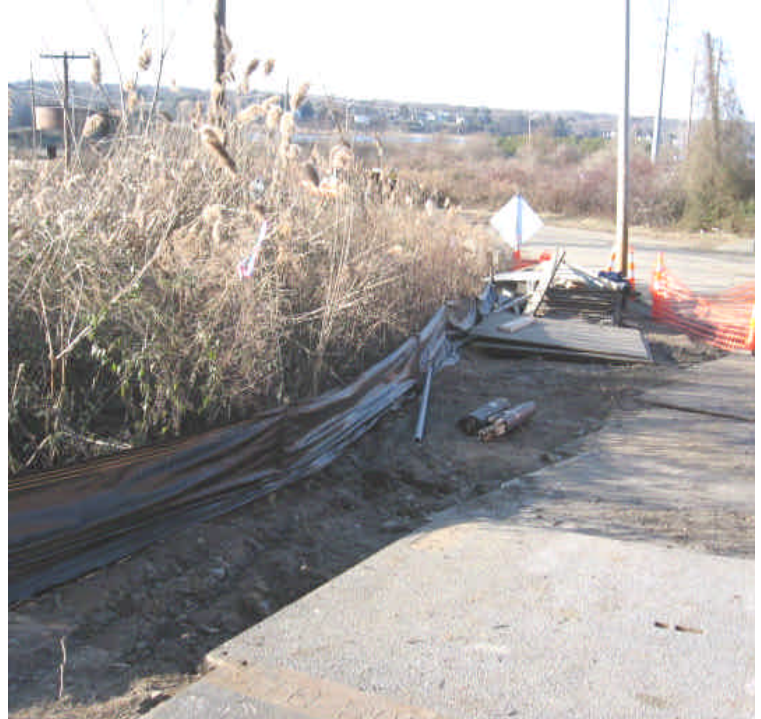
Both photos are of trenching activities from station #1049 to 1051. Resource areas are located immediately adjacent to the trench (indicated by the wetland flagging). Silt fence is installed but was not toed-in and some materials are stored on the opposite side of the controls. Issues in the adjacent areas were not noted but repairs are needed.

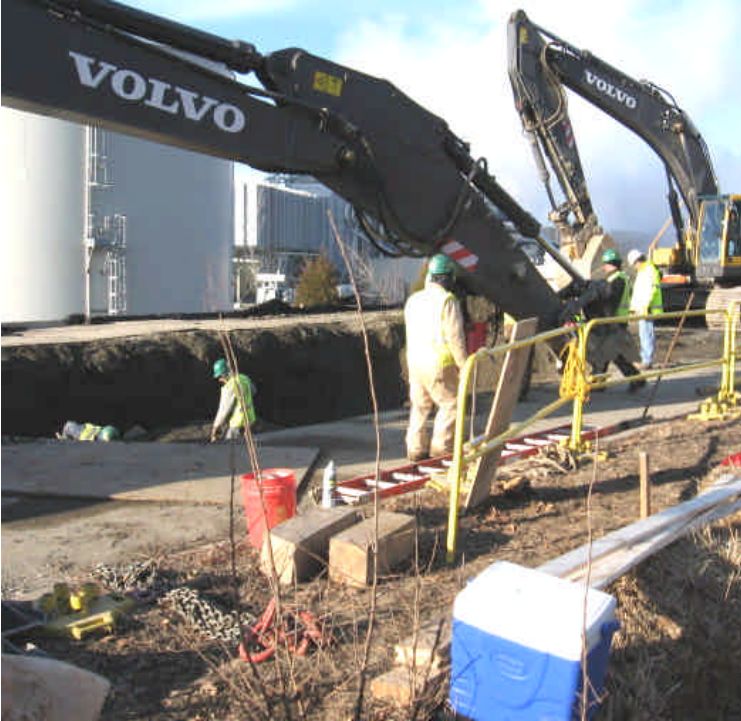
Photograph of Vault #6 installation activities.

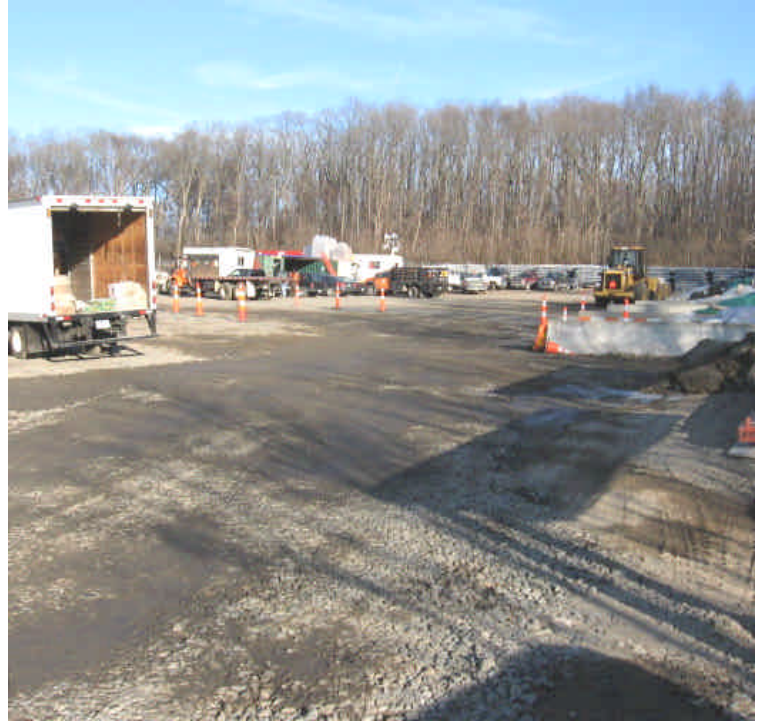
The Milford lay-down yard is being used to divert traffic around Vault #6 installation activities.
