**Docket No. 272 – Development and Management Plan Inspection**

**Segment 4a Underground Line**

**Date:** January 3, 2007

**Location:** Singer Substation to Fairfield/Westport Town Line

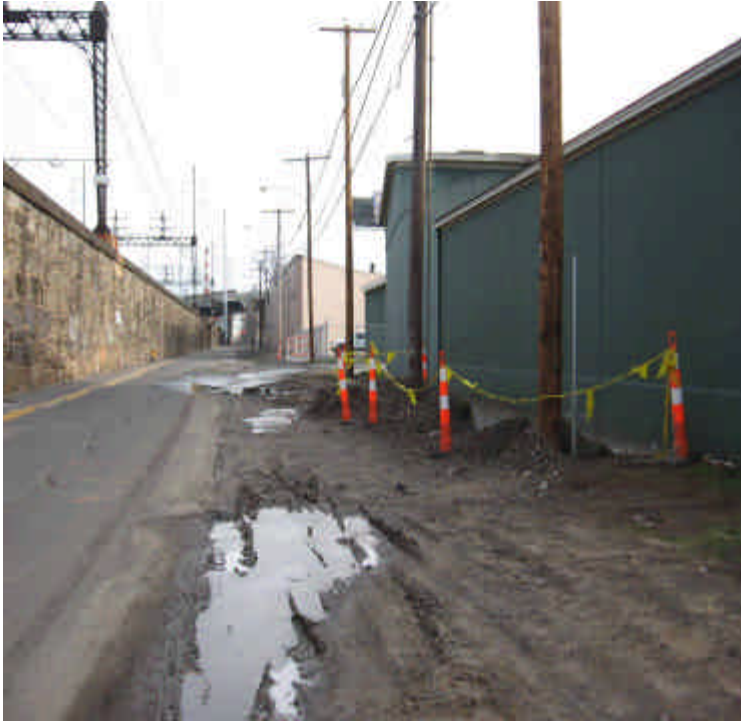
**Photograph taken on Railroad Ave. between Wordin Ave. and Iranistan Ave. of soils that have been exposed by construction activities. Temporary stabilization (mulch) is recommended.**

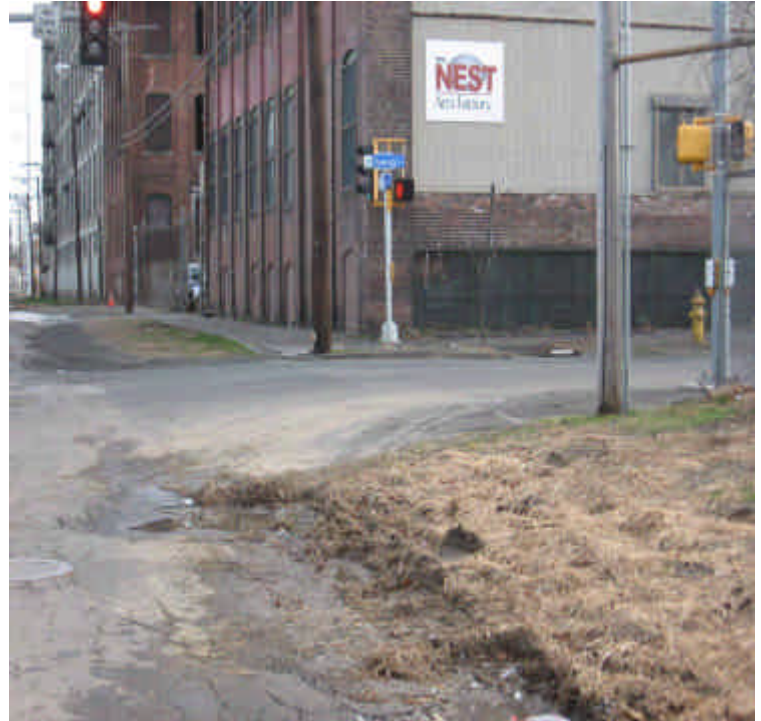
**Photograph taken at the intersection of Railroad Ave. and Hancock Ave. of some minor soil migration from the shoulder into the road. Vehicles are tracking soil through intersection.**

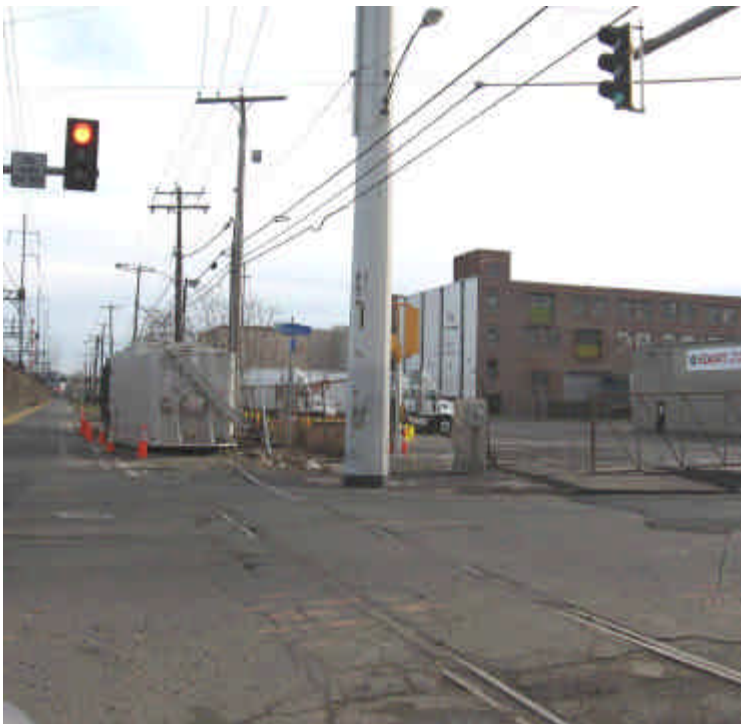
**Photograph of trenching activities and frac tanks stored on Railroad Ave. at its intersection with Howard Ave.**

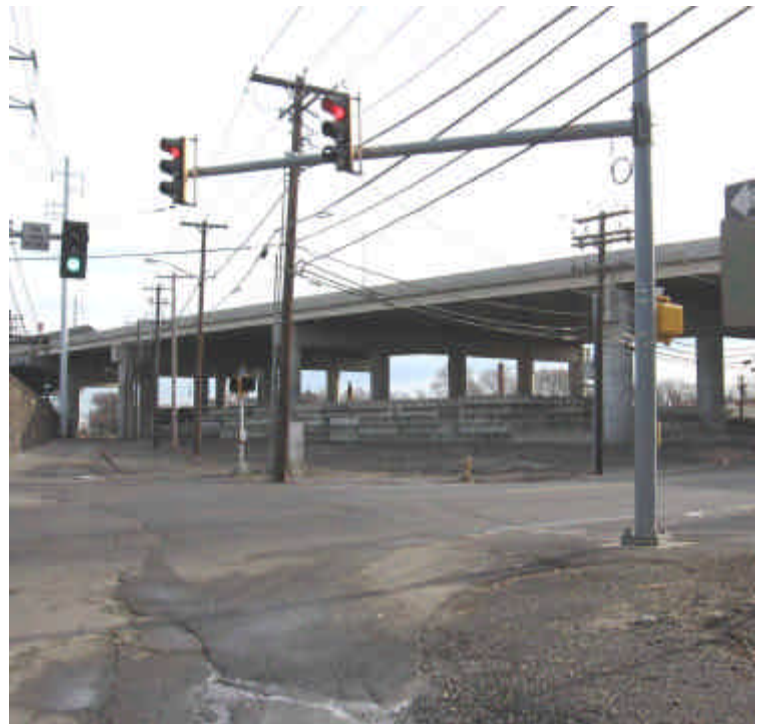
**Photograph of the former Iranistan Ave. storage area for the project that has since been abandoned.**

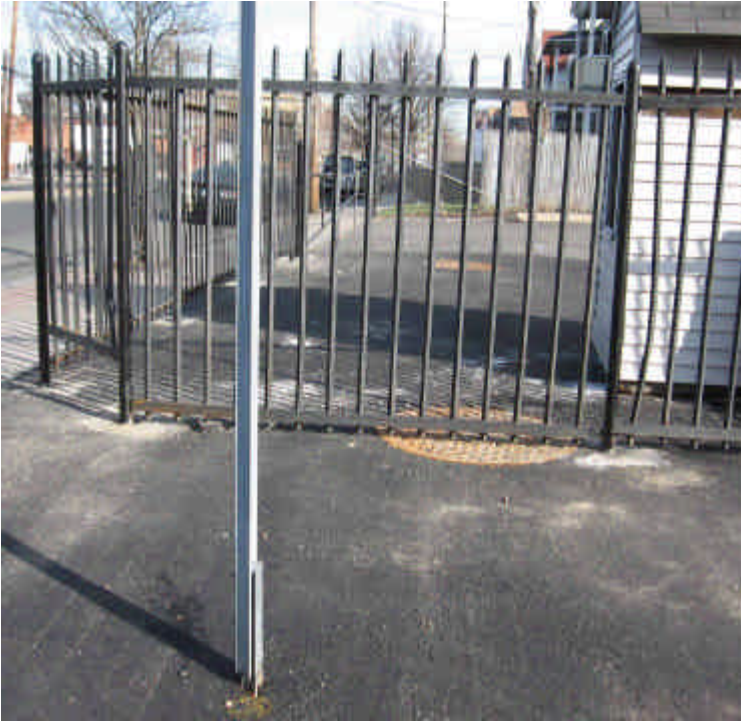
**Photograph of Vault #41. Installation is complete and the area has been restored.**

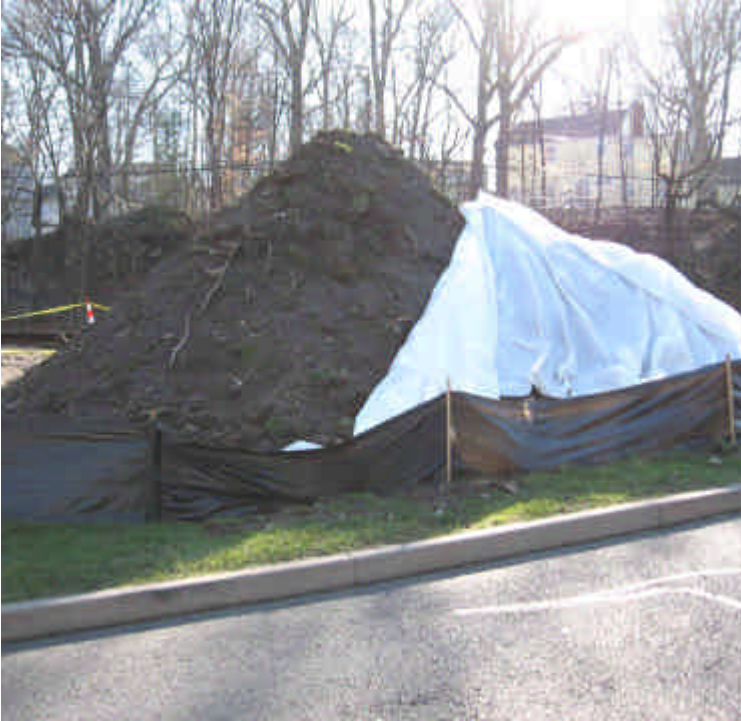
<b>Soils</b>	Soils are exposed as part of the excavation for trench, vault, and utility work. 1/03/07	Most areas are temporarily stabilized. 1/03/07	NA
	A small stockpile off Rt 1 Pequot Ave is partially covered with plastic during trenchwork. 1/03/07	Re-cover stockpile fully when feasible. Soil is contained within the silt fence. (see erosion control section.) 1/03/07	Needs attention when feasible.
<b>State species of concern, threatened and endangered species.</b>	According to the D&M plan, state-listed species are not located in this work area.	None	NA

**Photo of trenching activities along Pequot Ave. near its intersection with Rt. 1. The silt fence along this area is slumping in some areas. It is recommended that the silt fence be maintained and the plastic covering on the soil stockpile be replaced.**

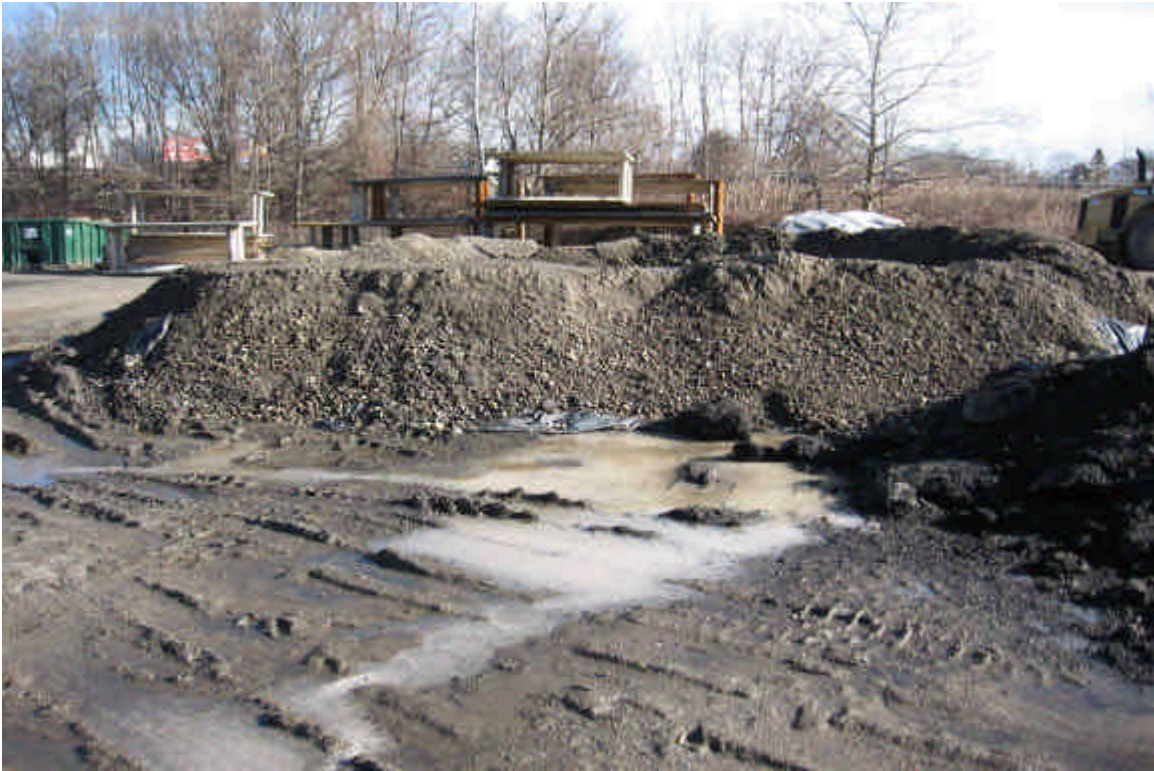
**Photo of the concrete washout basin where washout was not fully contained. Repair as feasible.**

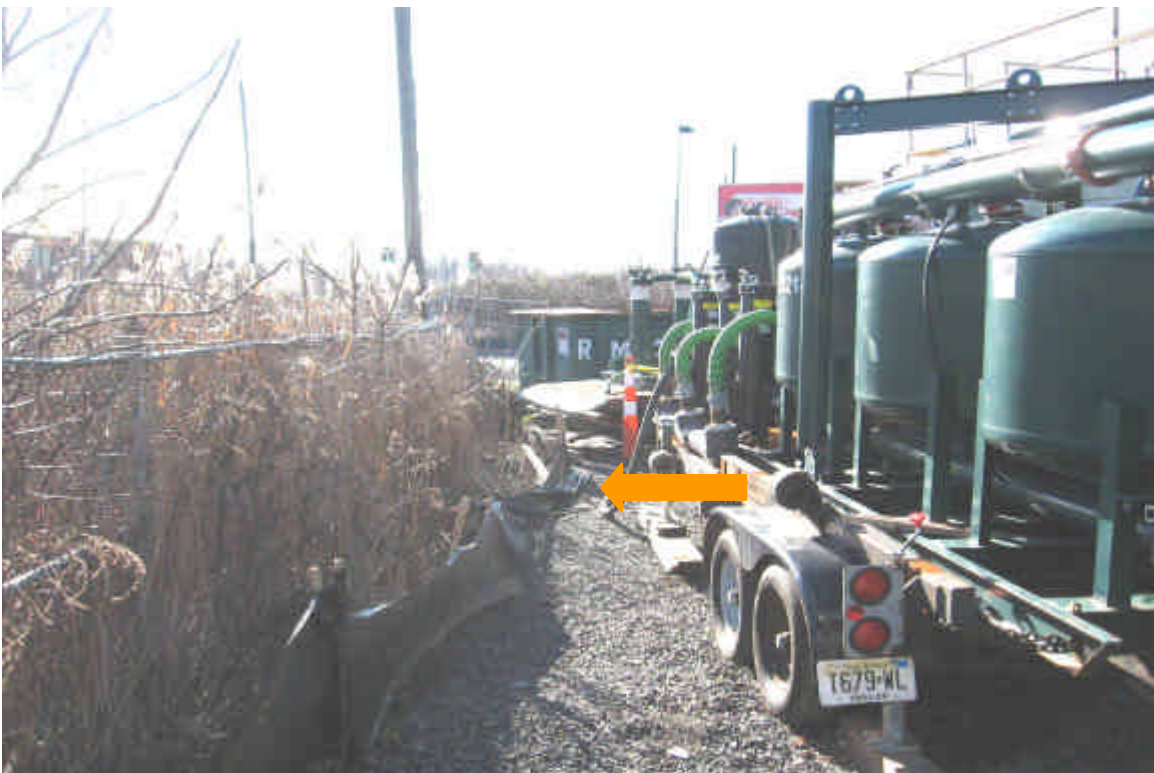
Areas of Inspection	Observation	Recommended Action	Corrected Action
	to the yard were in disrepair, including the side adjacent to the resource area. 1/03/07		
<b>Inland Wetland and Watercourse encroachment and mitigation</b>	The Kings Highway lay-down yard is located adjacent to potential resource areas and a concrete lined waterway. 1/03/07	See erosion control section. 1/03/07	NA
<b>Staging, Storage, and Parking Areas</b>	A contractor storage yard on Bostwick Ave. contains frac tanks, trailers, and available parking. Reserve spill kits are located in the equipment trailers. 1/03/07	None 1/03/07	NA
	A contractor lay-down yard is located off of Kings Highway near the Rt. 1 rotary. Reserve spill kits are located in the equipment trailers. 1/03/07	See erosion control section. 1/03/07	NA
	The temporary storage area at the intersection of Railroad Ave. and Iranistan Ave. is no longer in use. 1/03/07	None. 1/03/07	NA

**Photo of a small section of the perimeter silt fence that is in disrepair along the side of the yard that is adjacent to the resource area.**
