**Docket No. 272 – Development and Management Plan Inspection**

**Segment 4a Underground Line**

**Date:** January 9, 2007

**Location:** Singer Substation to Fairfield/Westport Town Line

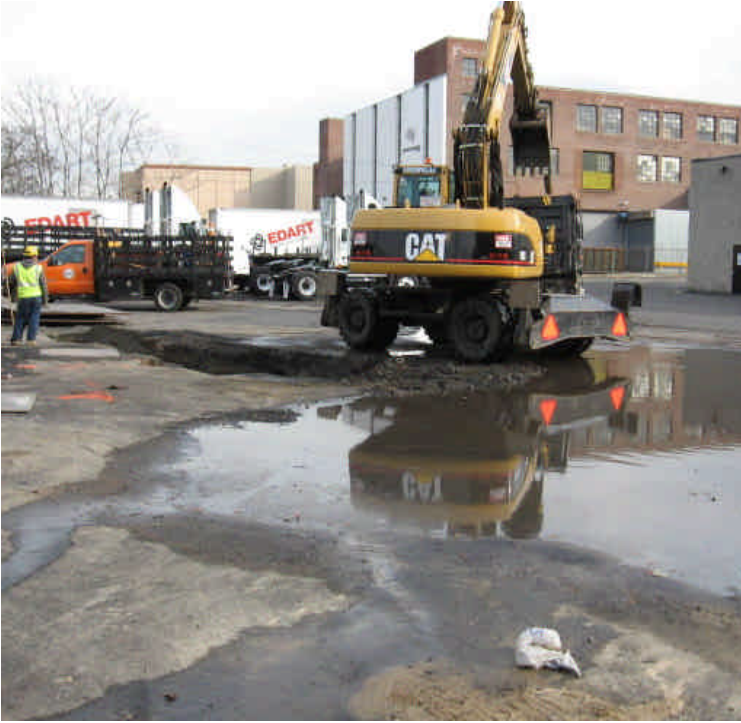
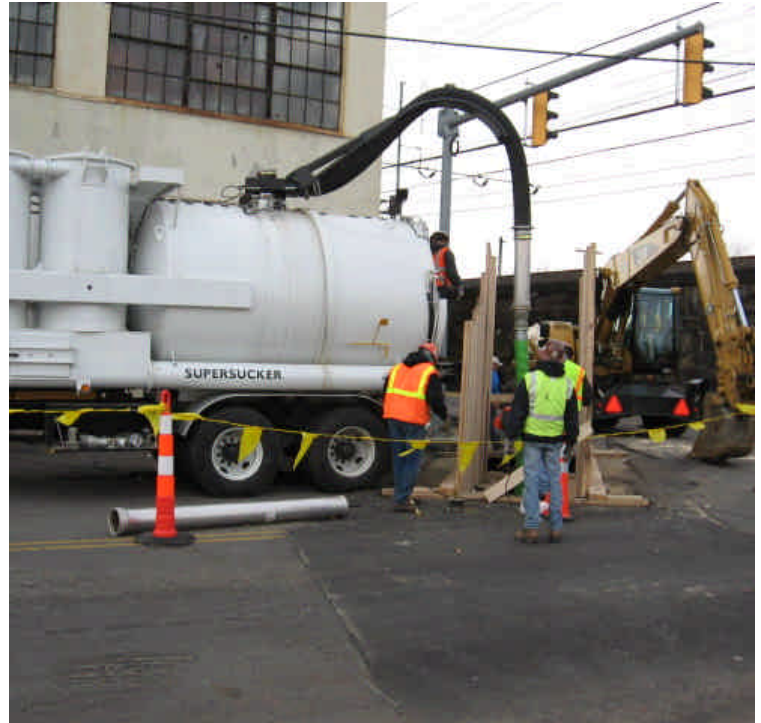
**Both photos taken of trenching activities at the intersection of Railroad Ave. and Howard Ave. Left: Trenching activities in the adjacent parking area. Run-off was not noticeably turbid and was contained to the site. Right: Crews were using a vac truck to remove soil from around the existing utilities in the trench.**

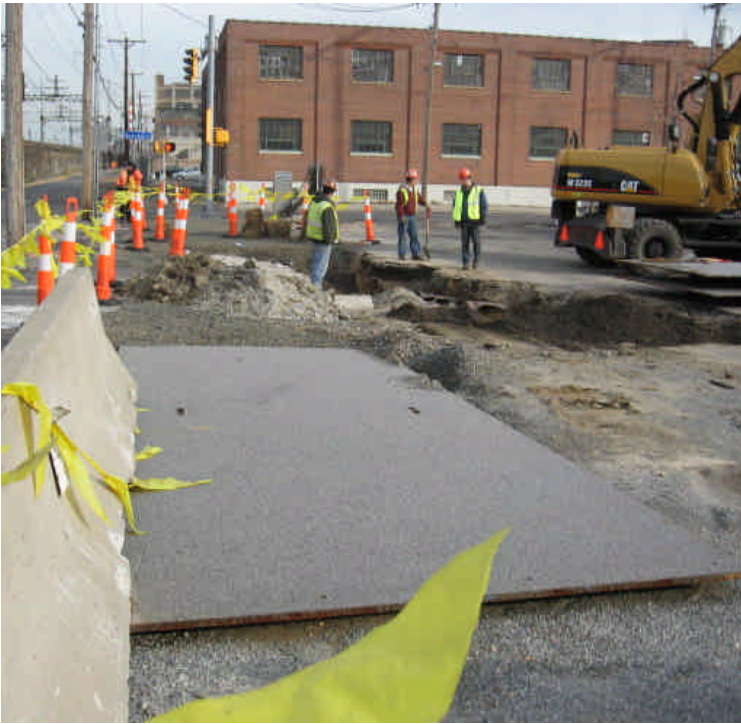
**Trenching activities along the shoulder of Railroad Ave. near its intersection with Bostwick Ave.**

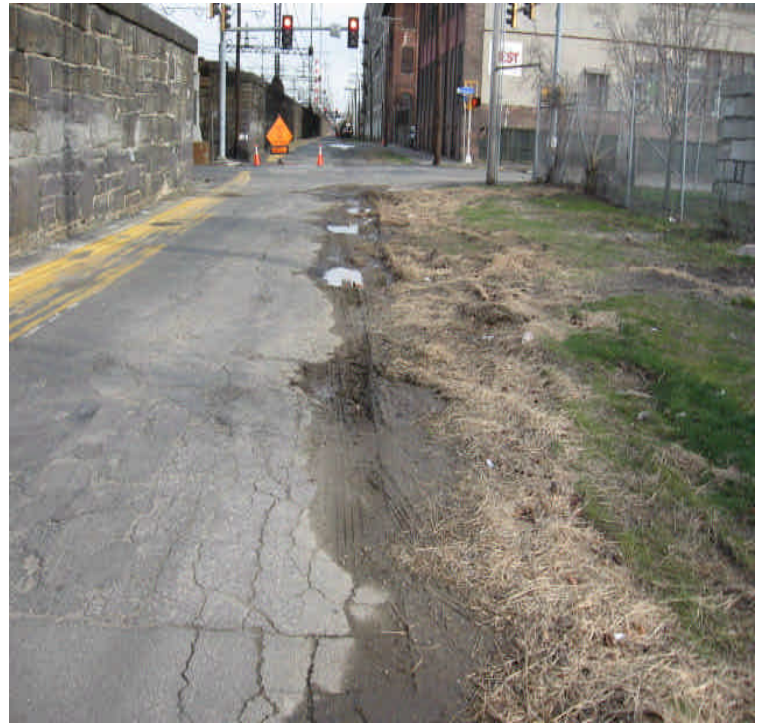
**Some soil from the shoulder of Railroad Ave. is migrating into the roadway and is being tracked by vehicles.**

<b>Areas of Inspection</b>	<b>Observation</b>	<b>Recommended Action</b>	<b>Corrected Action</b>
<b>Access Roads and Adjacent Roadways</b>	<p>All work is within or adjacent to existing paved roadways at this time.</p> <p>Some soil along the shoulder of Railroad Ave. is migrating into the roadway and being tracked by vehicle traffic. 1/3-1/9/07</p>	<p>See erosion control section.</p> <p>Further stabilize to prevent soil from migrating into roadway. 1/3-1/9/07</p>	<p>Not Applicable (NA)</p> <p>Needs attention when feasible.</p>
<b>Vault Openings and Trench Construction Bridgeport</b>	<p>Trenching activities continue: on Railroad Ave. between Howard Ave. and South Ave.; near the intersection of Railroad Ave. and Bostwick Ave.; and in the portion of land between Broad St. and Main Ave. 1/9/07</p>	<p>Continue to monitor and be proactive. Continue to mulch/ temporarily stabilize areas as they are completed. Continue to sweep roadways as soon as feasible. 1/9/07</p>	<p>Catch basins are protected.(Proactively)</p>

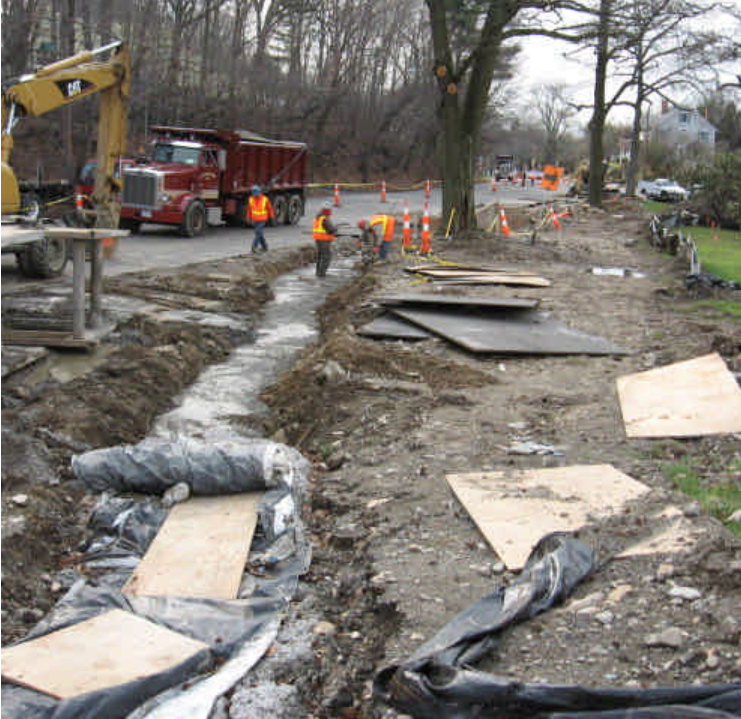
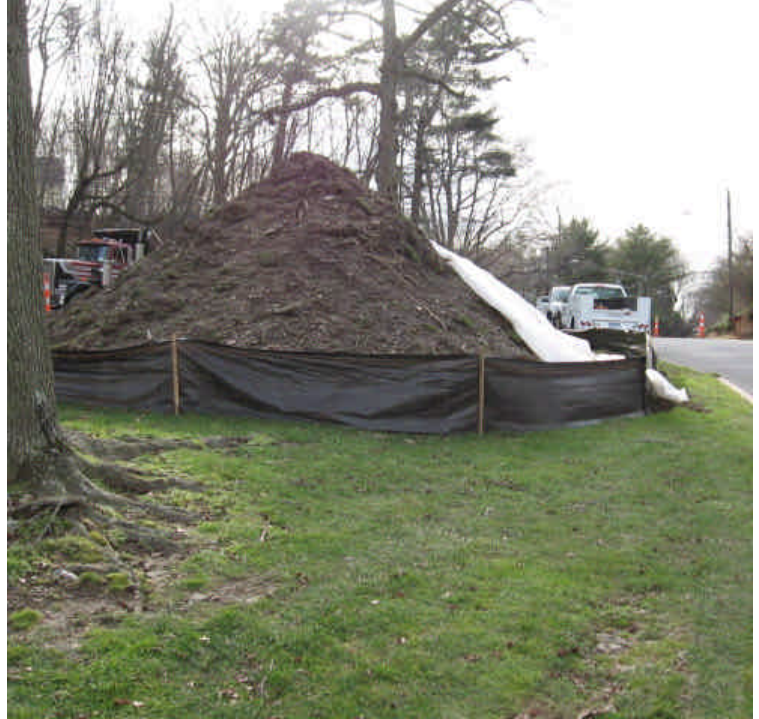
**Both photos show trenching activities in the shoulder of Pequot Ave. near its intersection with Rt. 1. Left: Trench is being backfilled; erosion controls should be re-established at the close of each workday. Right: Soil stockpile associated with trenching activities. The pile remained stable and contained after a 1" rain event. Any sections of erosion controls in disrepair should be re-established.**

<p>Silt fence is also in place along trenching activities near Pequot Ave. A few sections were down due to workspace needs.</p>	<p>Continue to monitor and contain disturbed soils resulting from the construction. Re-establish any compromised controls before the close of each workday. 1/9/07</p>	<p>Needs regular attention.</p>
	<p>A soil stockpile here is partially covered with plastic and has adjacent silt fence. It remains stable and contained even following the 1" rain event. 1/9/07</p>	<p>Continue to monitor and maintain any controls in disrepair. 1/9/07</p>	<p>Needs regular attention.</p>
<b>Kings Highway Lay-down Yard (Off Kings Highway, near Rt. 1 rotary)</b>	<p>Some of the concrete wash-out was not fully contained within the wash-out basin. 1/3-1/9/07</p>	<p>Contain all concrete wash-out in basin and provide adequate capacity. 1/3-1/9/07</p>	<p>Needs evaluation.</p>
	<p>One section of the perimeter silt fence near the entrance to the yard had been repaired.</p>	<p>Maintain controls as needed. 1/9/07</p>	<p>One section was repaired, one section still needs attention.</p>

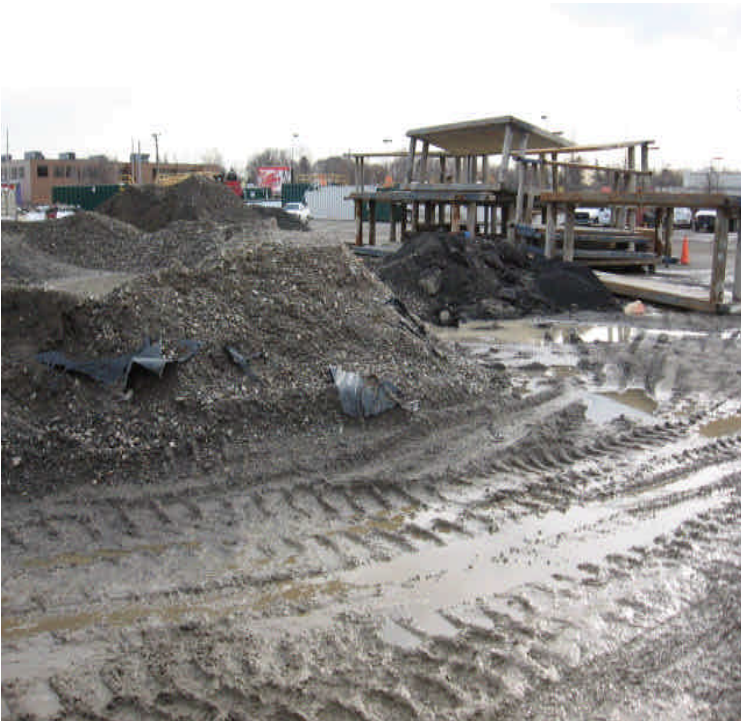
**Kings Highway Lay-down Yard**

**Concrete washout is not fully contained to the basin. It is recommended that improvements be made to contain all washout.**

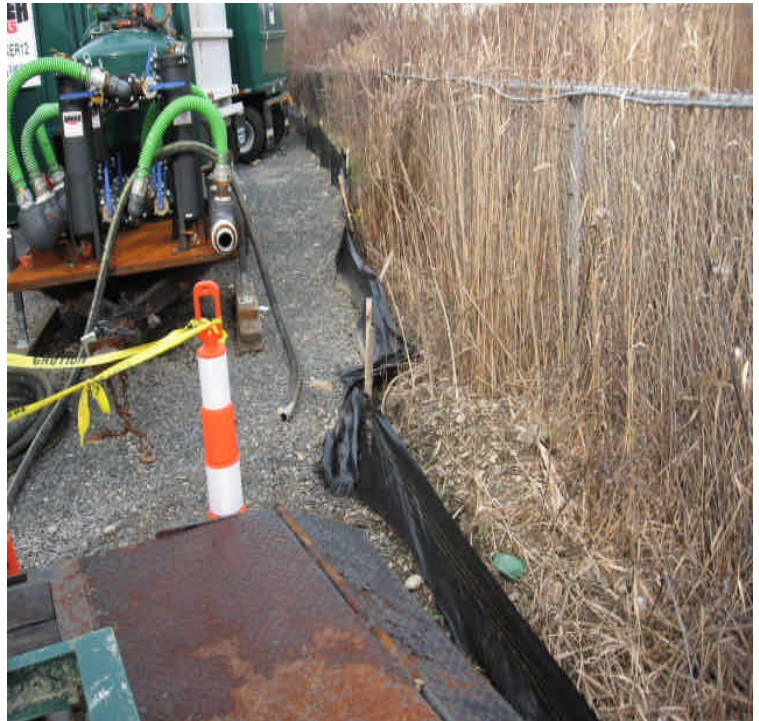
**A small section of silt fence remains down near the entrance to the yard. The other side was repaired but controls here need maintenance.**
