Docket No. 272 – Development and Management Plan Inspection

Segment 4a Underground Line

Date: January 16, 2007

Location: Singer Substation to Fairfield/Westport Town Line

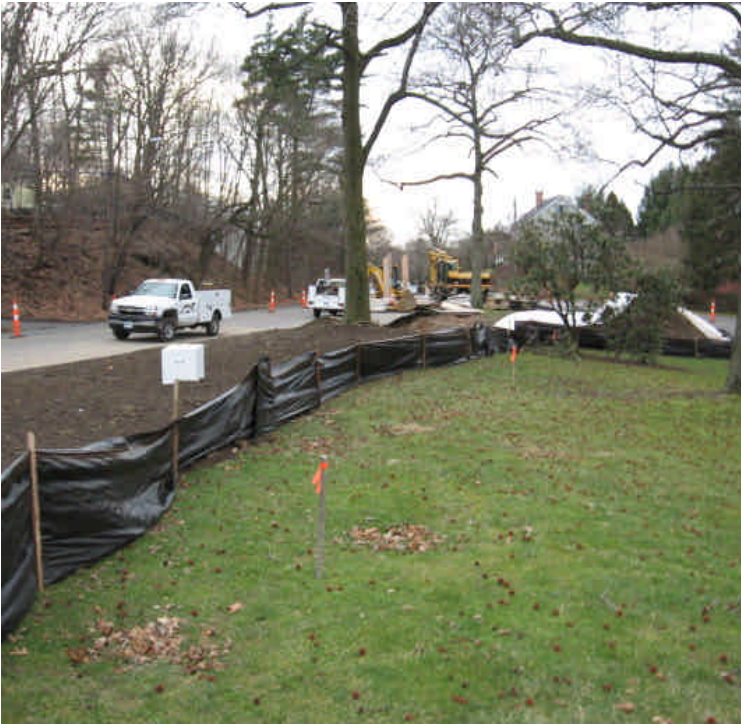
Photo of trenching activities along Pequot Ave. A portion of the trench has been backfilled and loam applied. Area remains to be and are stabilized.

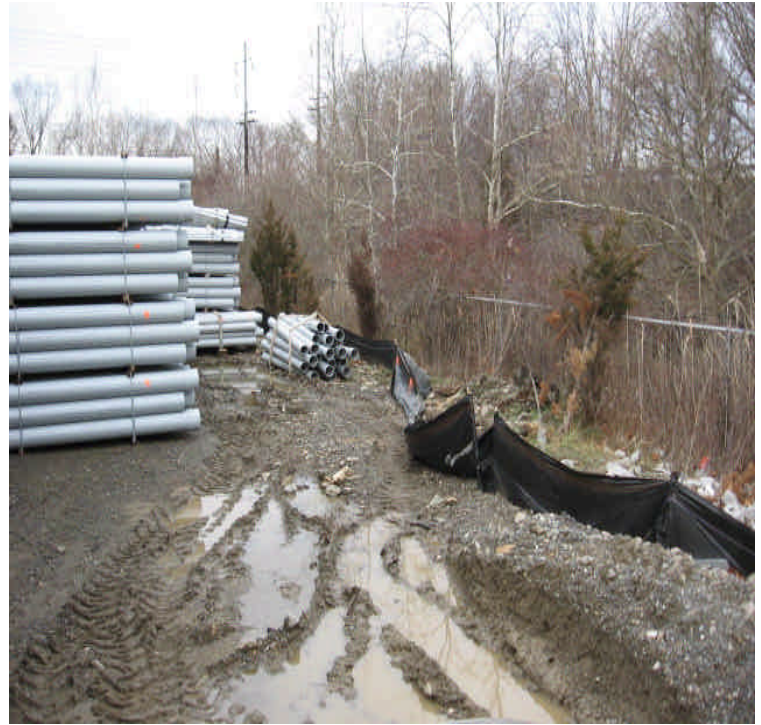
Photo of the perimeter erosion controls in the King's Highway lay-down yard. Sections of the fence have been compromised and are in need of repair.

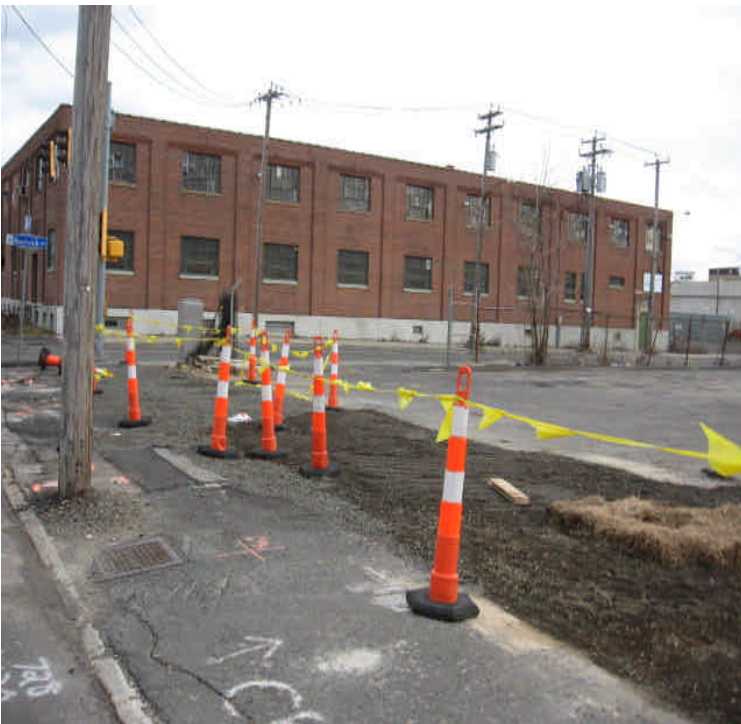
Photo of a completed section of trench along Railroad Ave. near the intersection with Bostwick Ave.

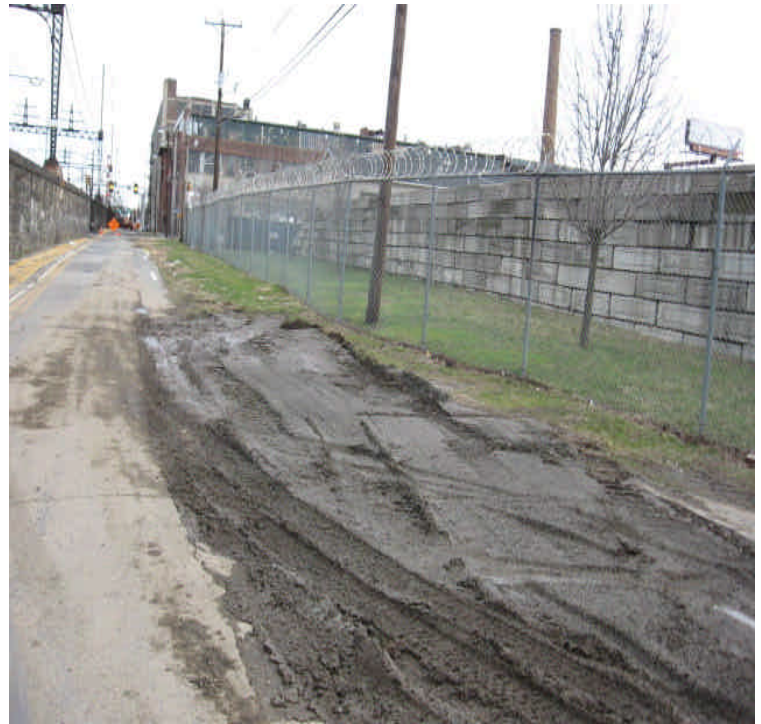
Photo of an area that has been re-graded along the shoulder of Railroad Ave. Exposed soils should be stabilized.

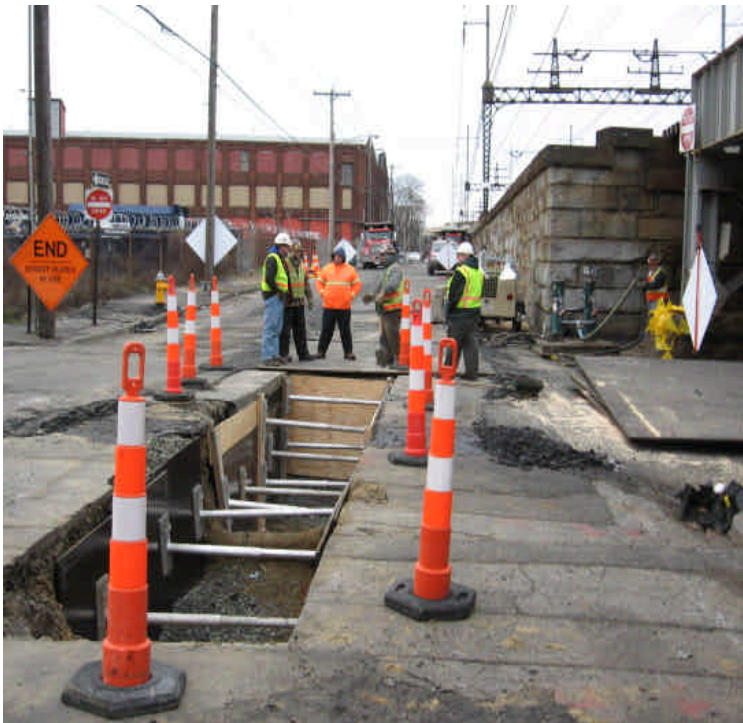
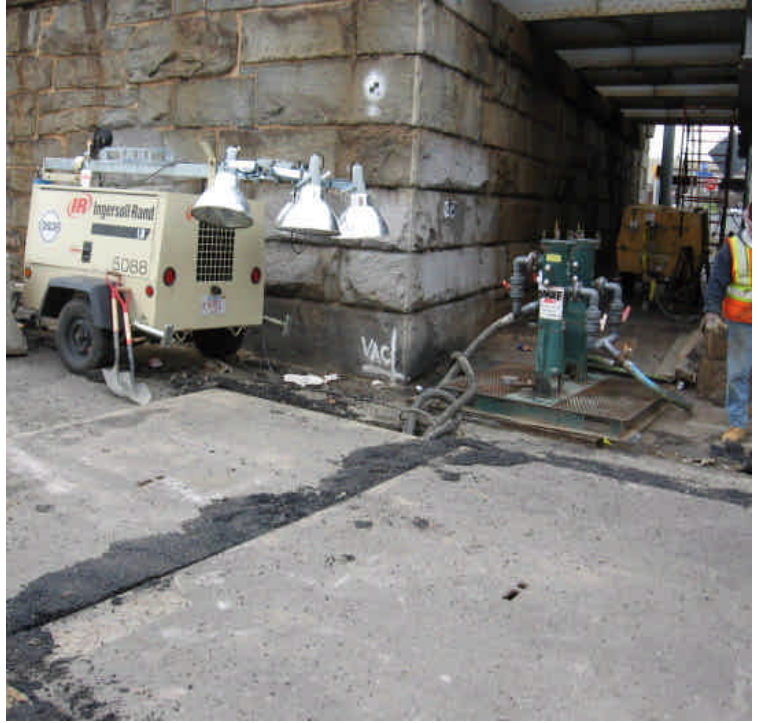
Both photos show trenching activities on Railroad Ave. at its intersection of Myrtle Ave. On the left, dewatering and filtering equipment is on-site in preparation for intercepting groundwater in the trench.
