Docket No. 272 – Development and Management Plan Inspection

Segment 4b Underground Line

Date: January 23, 2007

Location: Fairfield/Westport Town Line to Westport Avenue in Norwalk

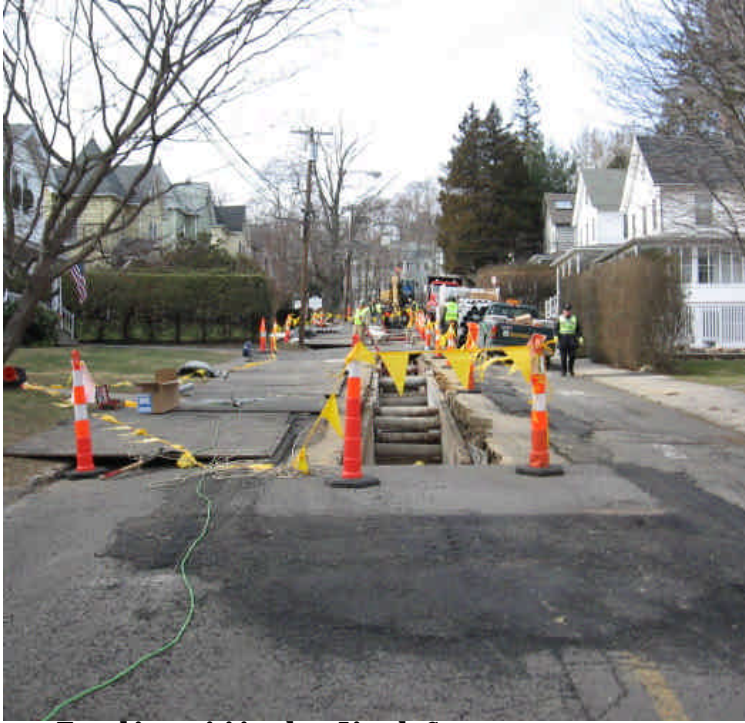
Trenching activities along Lincoln Street.

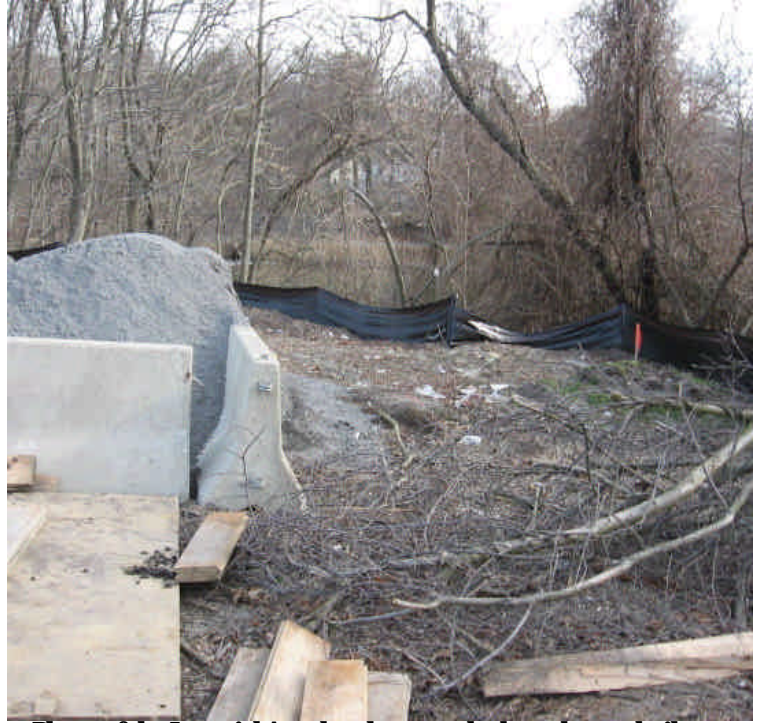
Photo of the Imperial Ave. lay-down yard where the stockpile of crushed stone is starting to overflow its containment area. Material is still contained to site at this time but prevent migration to adjacent resource areas.

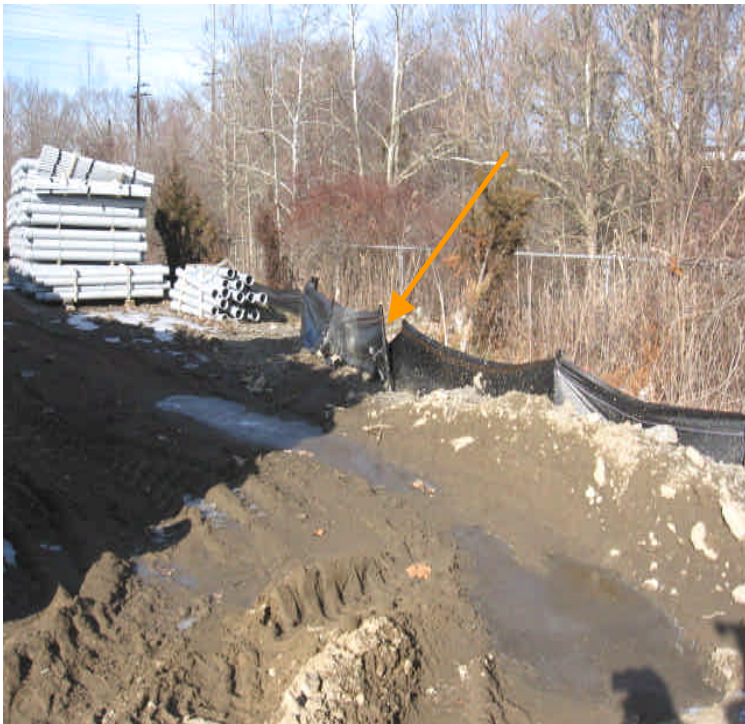
Both photos show the King's Highway lay-down yard. Left: Attempts have been made to repair silt fence; ensure that run-off will not escape at the gaps between sections. Right: Photo of material being removed from yard at the concrete washout basin.

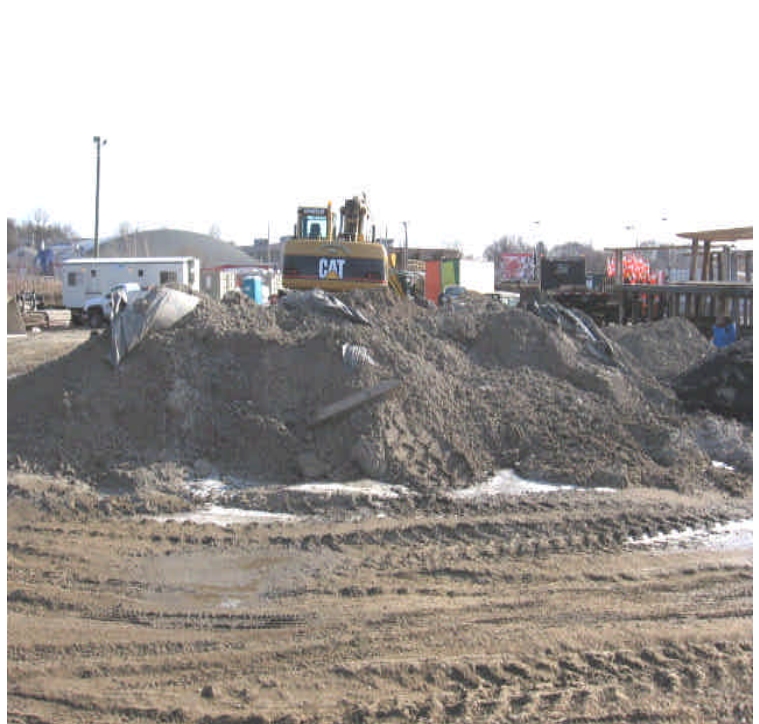
Kings Highway Lay-down Yard (Off Kings Highway) –	Concrete wash-out had not been fully contained within the basin over the past few weeks. This	Continue removing basin if it is no longer necessary in this area. Otherwise provide adequate	Efforts were noted to remove the basin materials. Needs further attention.
