Docket No. 272 – Development and Management Plan Inspection

Beseck Switching Station Inspection

Date: July 24, 2007

Location: Beseck Switching Station

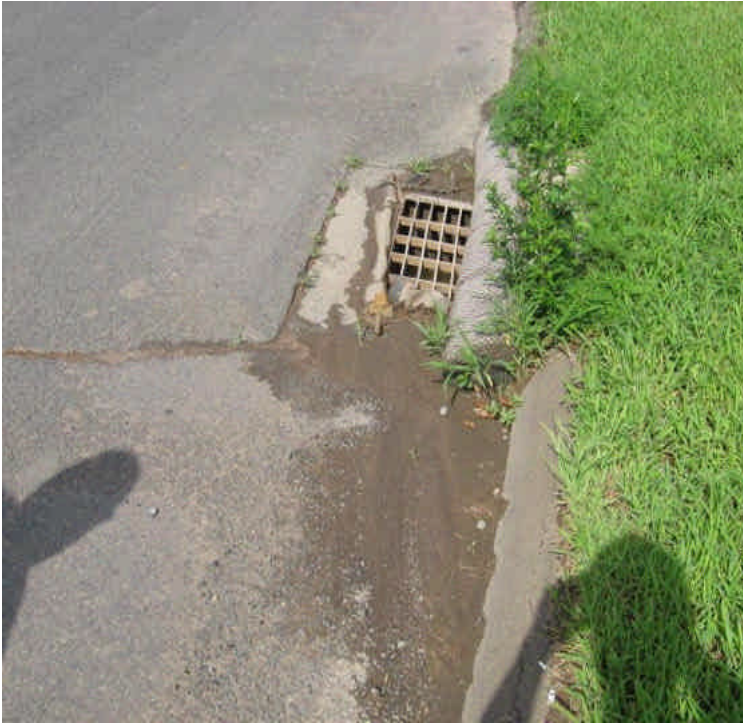
Sediment accumulation was noted in the gutters along Carpenter Lane as a result of heavy rains. Remove sediment from roadway on a regular basis.

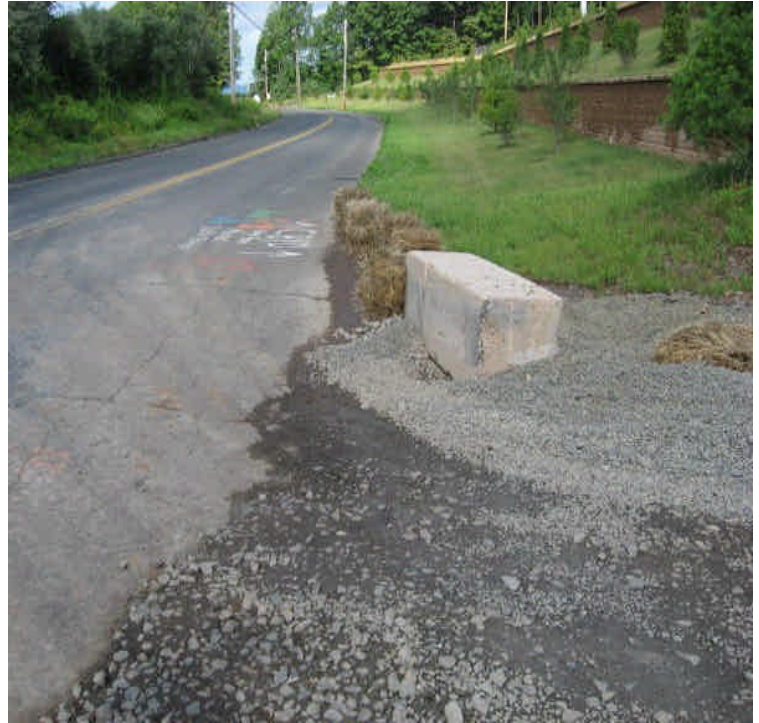
View of the eastern site exit at Carpenter Lane. Haybales, a concrete block, and additional stone were in place at the corner of the drive, in an effort to contain run-off.

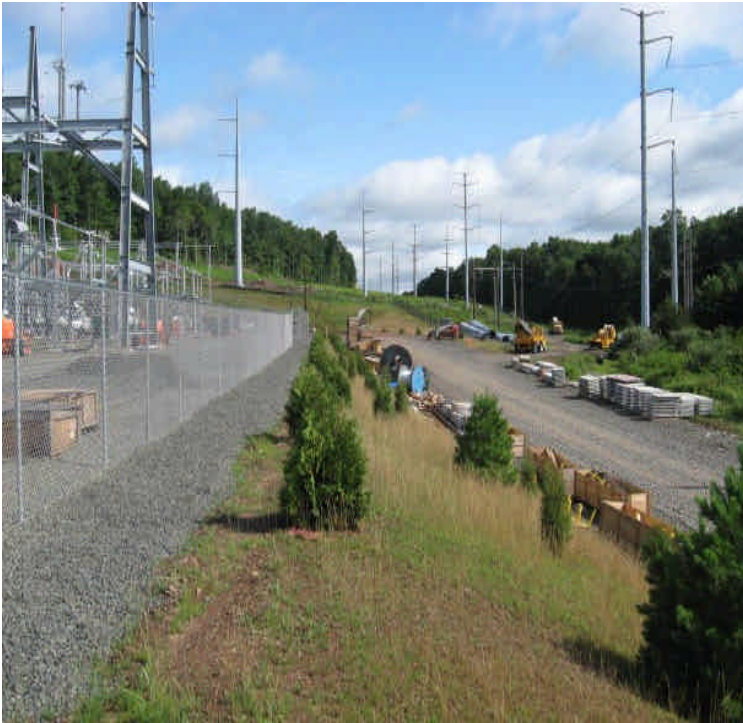
New grass growth noted among the recently landscaped plants along the outer slopes of the site.

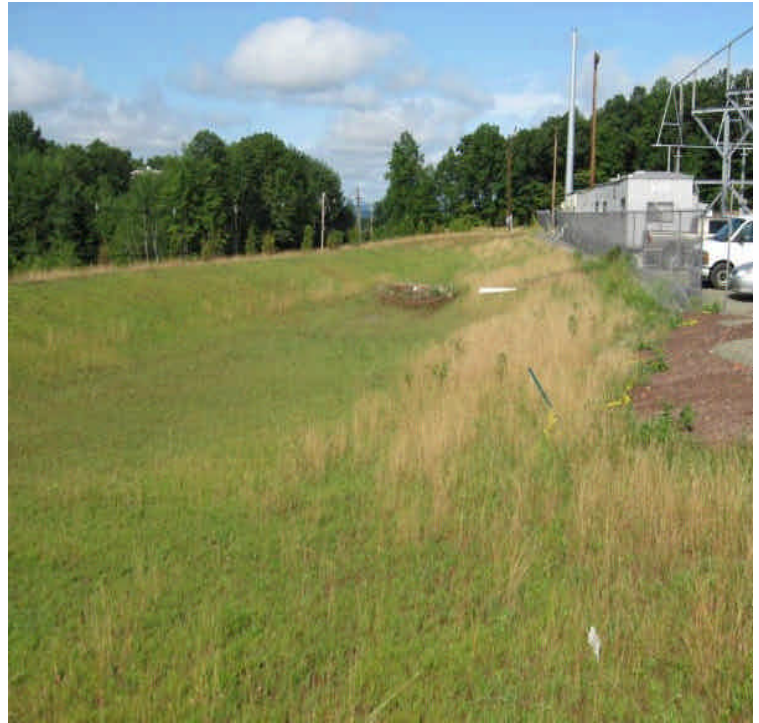
Haybales and controls remain in place at the inlet of the detention basin. Grass cover continues to establish well in hydroseeded areas. The basin appears to have 75% vegetative cover and is stable.

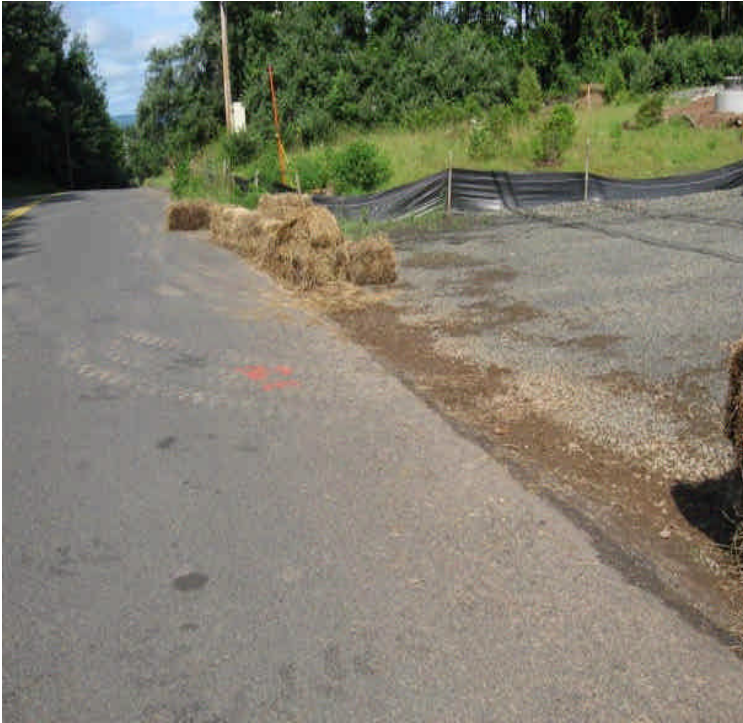
The haybales line was moved from across the site entrance at Carpenter Lane. Restore when feasible.

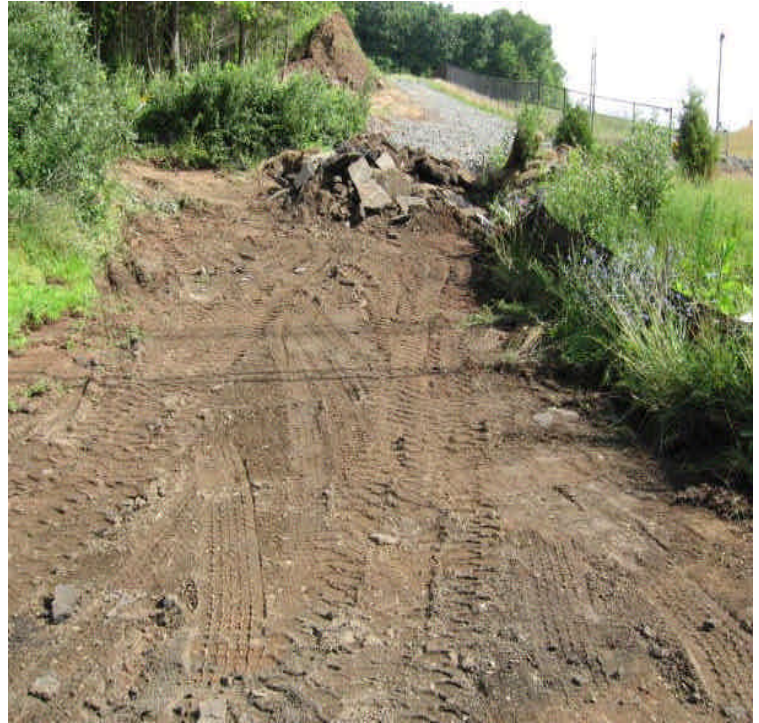
Pavement being removed from original driveway entrance. Add controls upon completion of grading. Stabilize exposed soil when feasible.

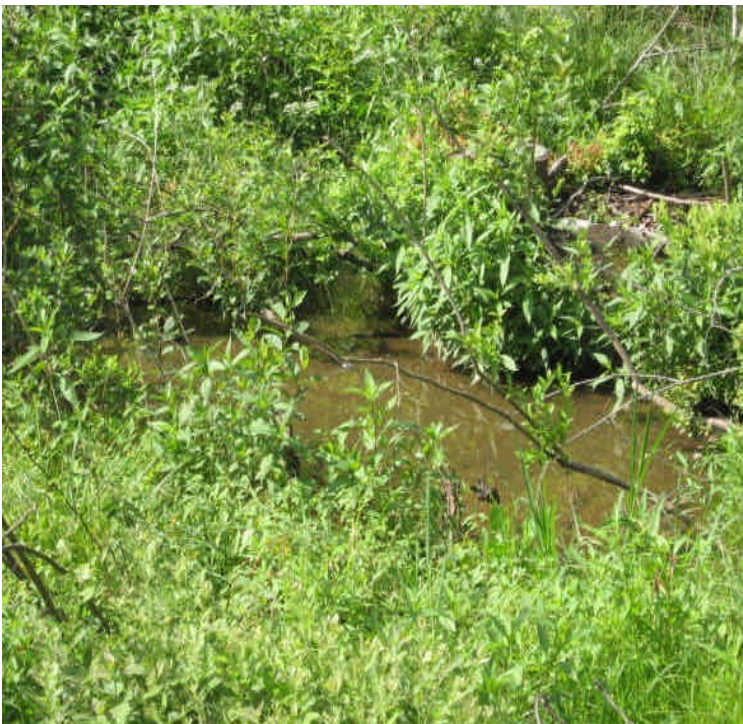
Mostly clear water noted within the wetlands across Carpenter Lane.

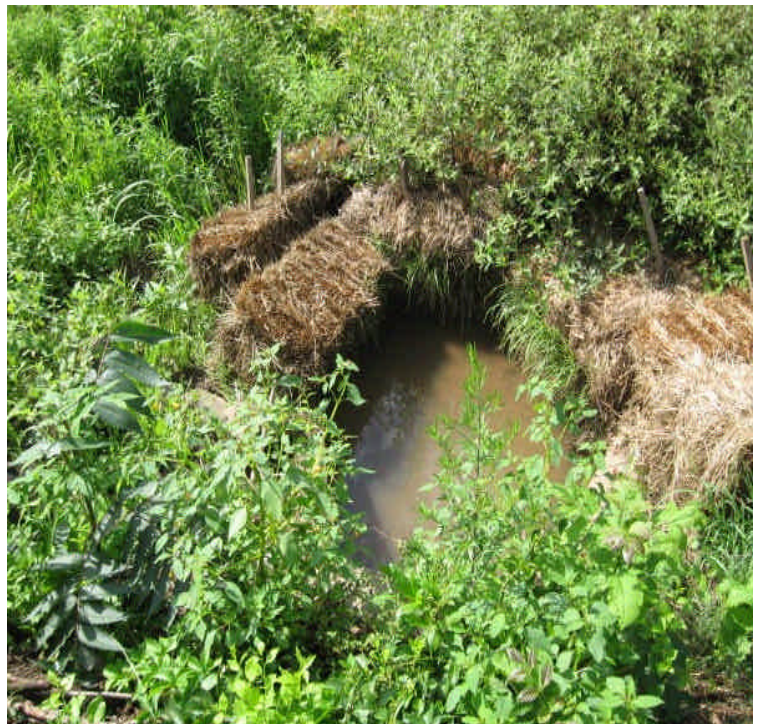
Turbid water was observed within the culvert. Clear water was observed entering the wetlands. The haybales help to filter out the sediment. Evaluate whether the amount of sediment accumulation justifies the disturbance needed to remove it, once the water subsides.
