Docket No. 272 – Development and Management Plan Inspection

Segment 1a Inspection

Date: July 9, 2007

Location: Segment 1a – Scovill Rock Switching Station to Chestnut Junction, Oxbow Junction to Beseck Switching Station (excluding Royal Oak Bypass), and Black Pond Junction to Beseck Switching Station

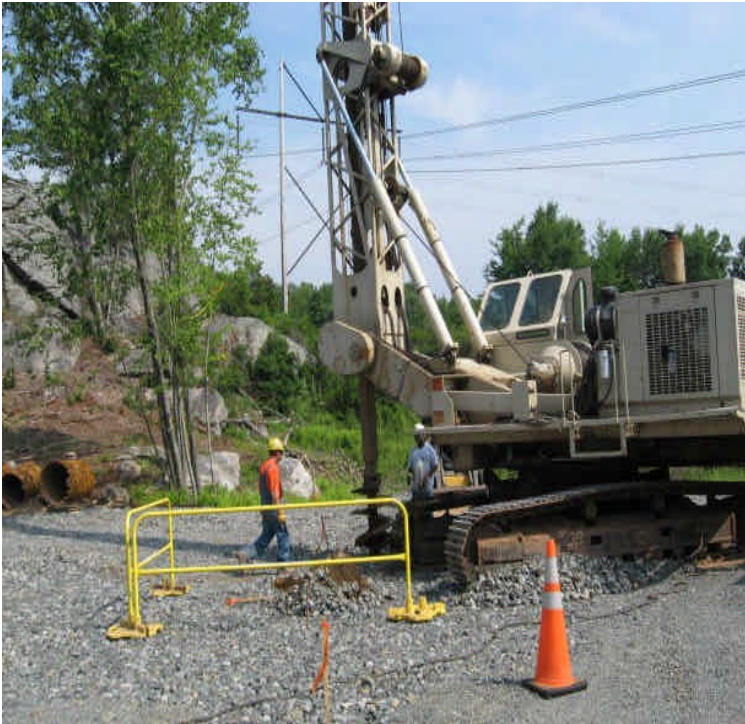
Foundation drilling noted west of Scovill SS off Rte 9.

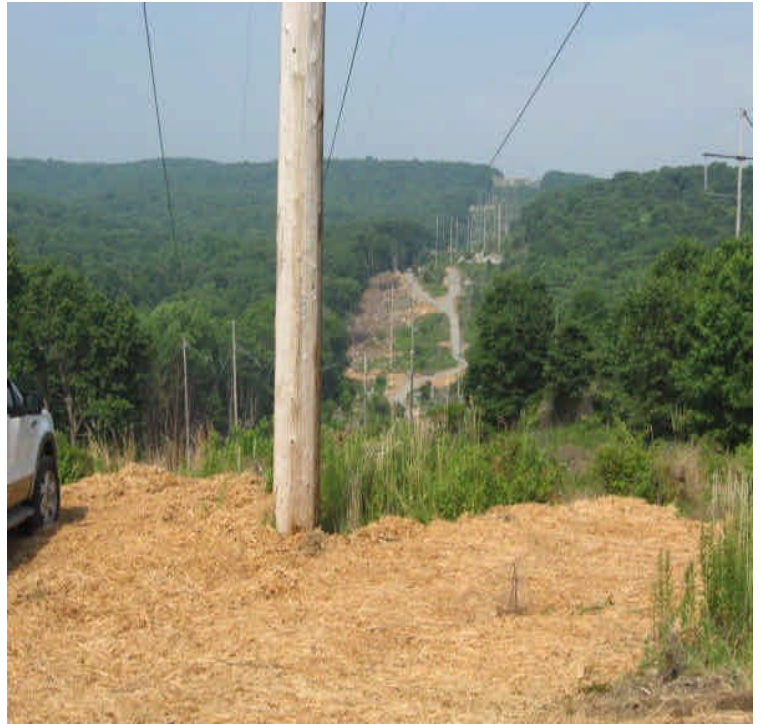
Crews were spreading mulch along exposed soil areas west of Scovill SS off Rte 9.

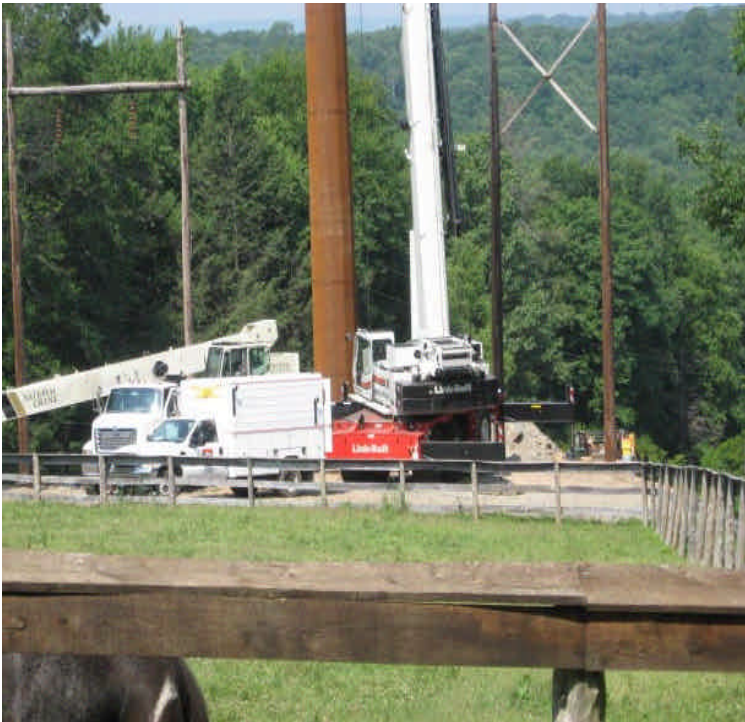
Pole installation was occurring off Foot Hills Rd.

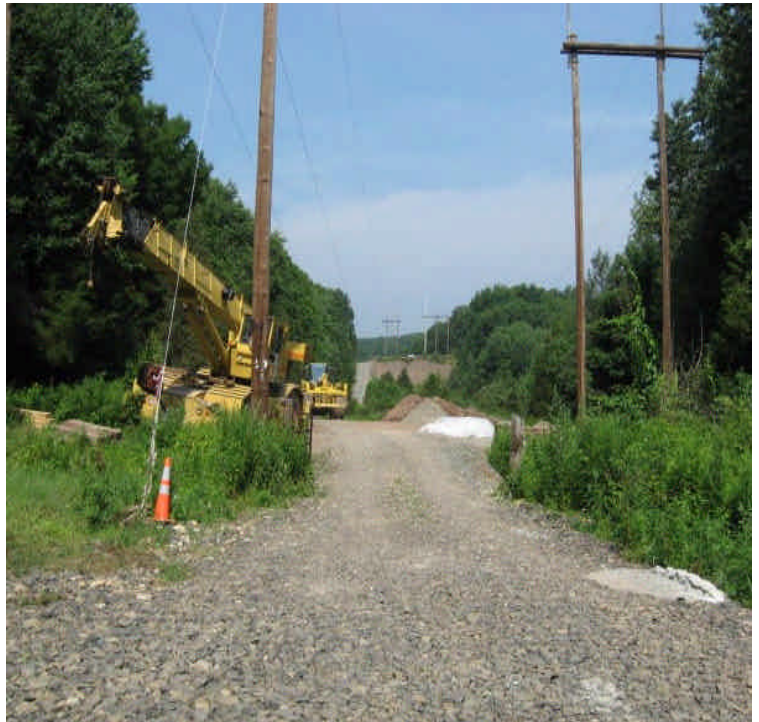
Foundation and pole installation was occurring off Arbutus Street.

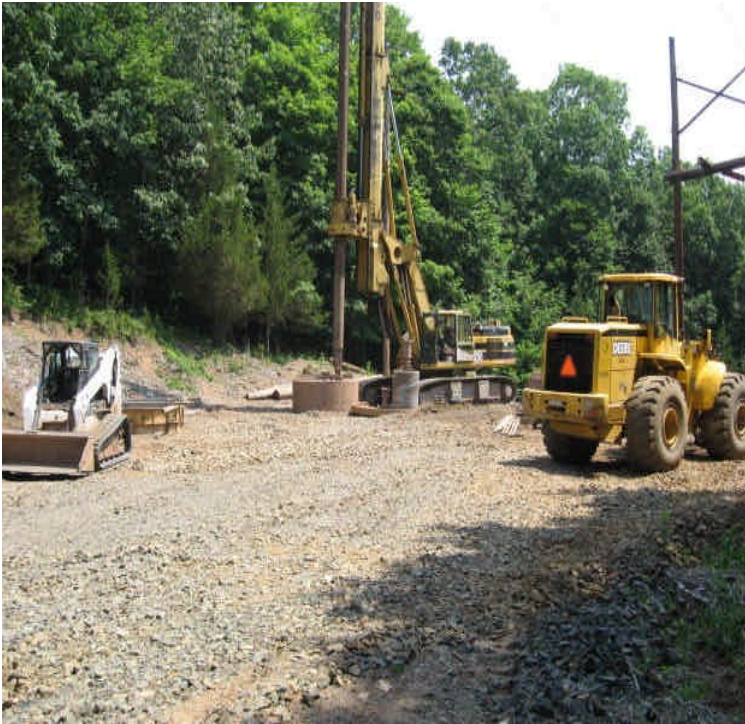
Foundation drilling off Black Walnut Drive upgradient from Ball Brook.

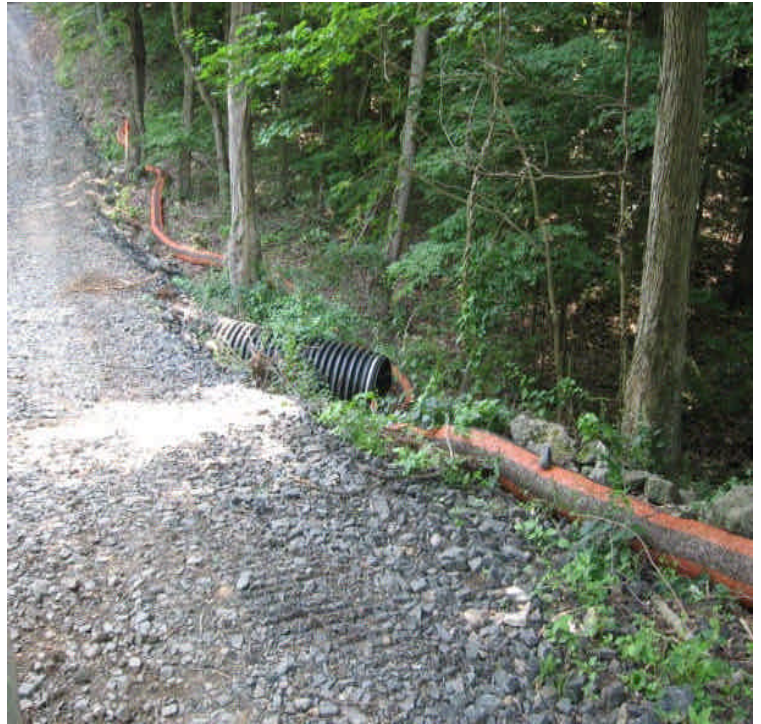
View of the wetland crossing off Black Walnut Drive. Filter socks remain in place.

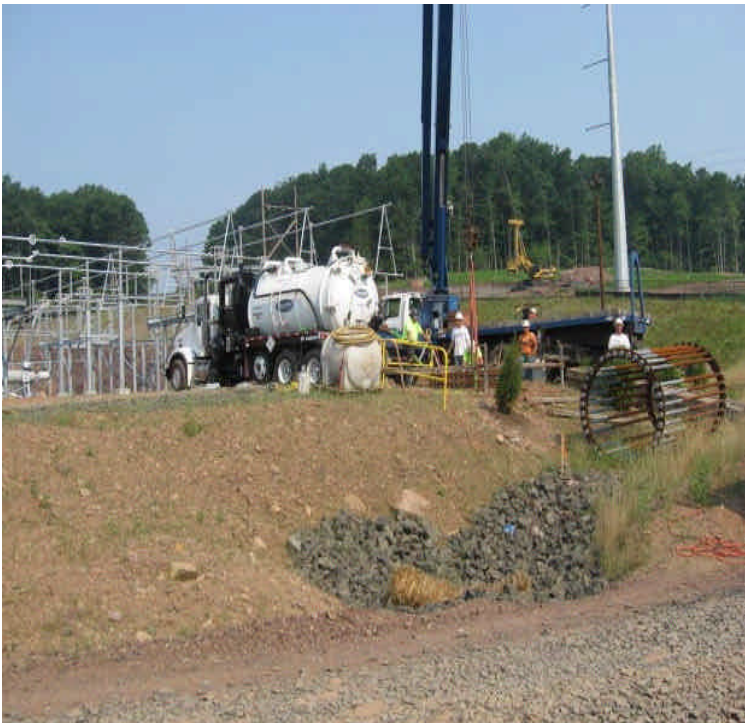
Foundation installation and pump truck at the perimeter of Beseck SS.

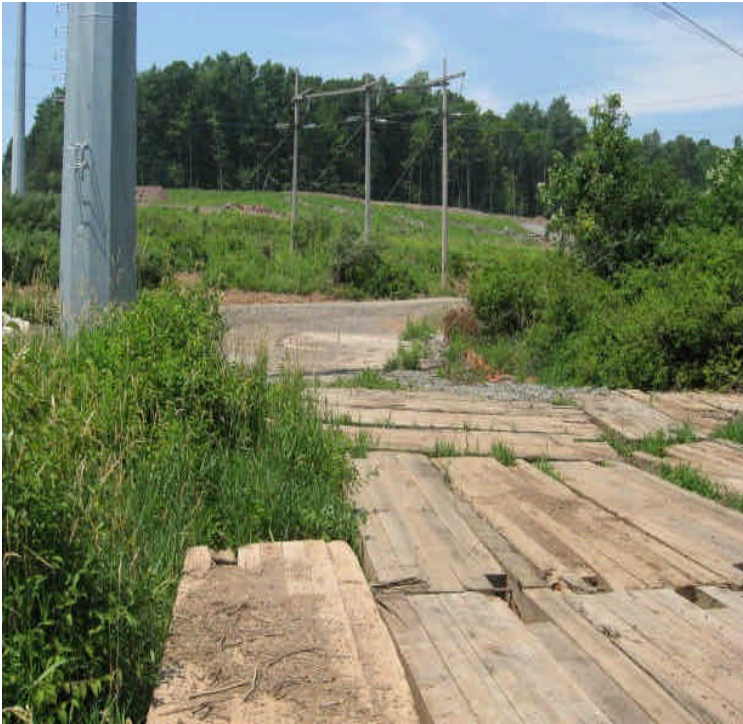
<p>East of Beseck SS</p>	<p>Timber mat staging areas are in and adjacent to wetlands. Sediment was noted on and beyond the filter sock at the wetland's edge. 4/2-7/9/07</p> <p>An additional timber mat</p>	<p>Adequately contain all sediment; the soil in the wetland will have to be removed carefully by hand. 4/2-7/9/07</p> <p>Controls are needed</p>	<p>Needs attention</p> <p>Needs evaluation</p>

View of timber mats within wetlands east of Beseck SS.

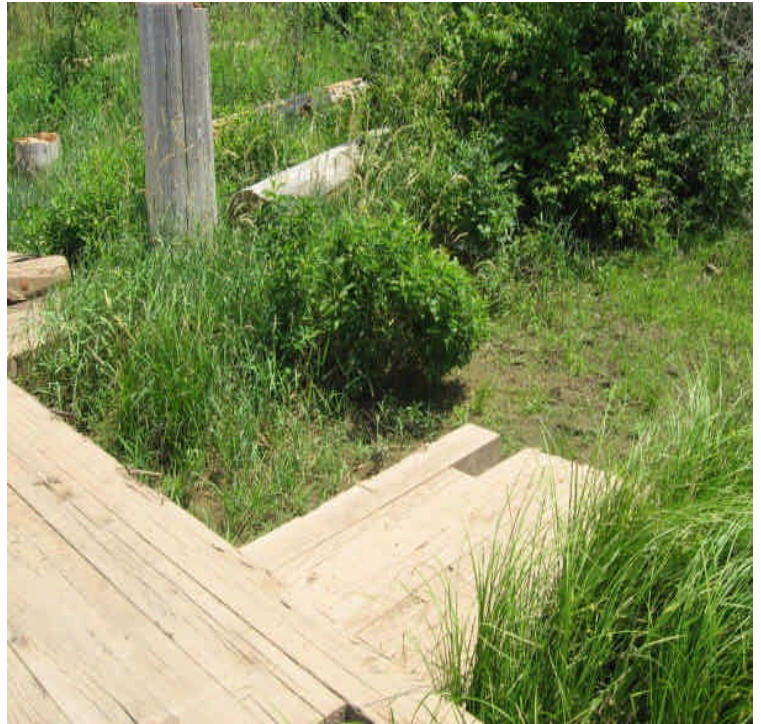
Timber mats within a small pond east of Beseck SS. The pond is dry at this time.

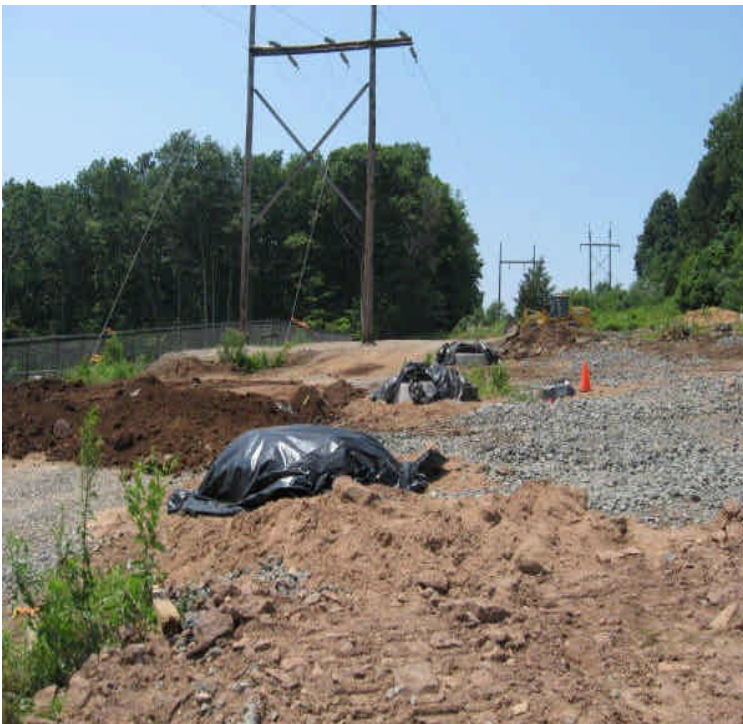
View of pad and road grading and foundation installation north of Beseck SS.

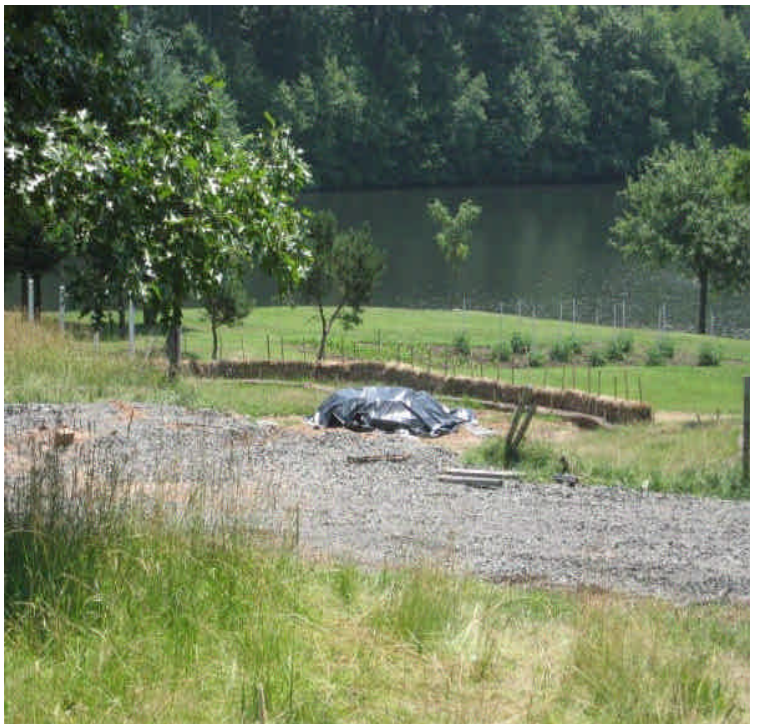
Foundation was installed and controls were in place off Fleming Road

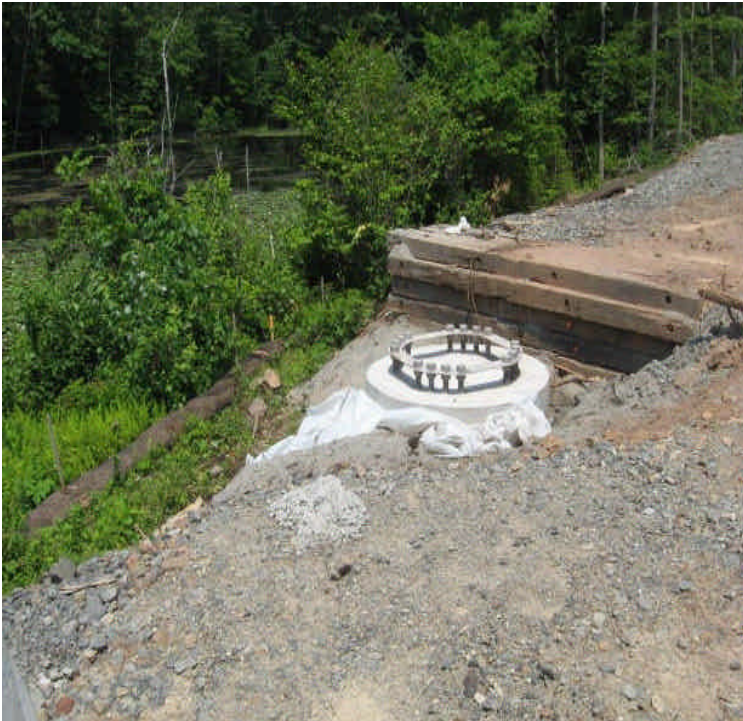
View of the foundation installed west of East Meriden SS.

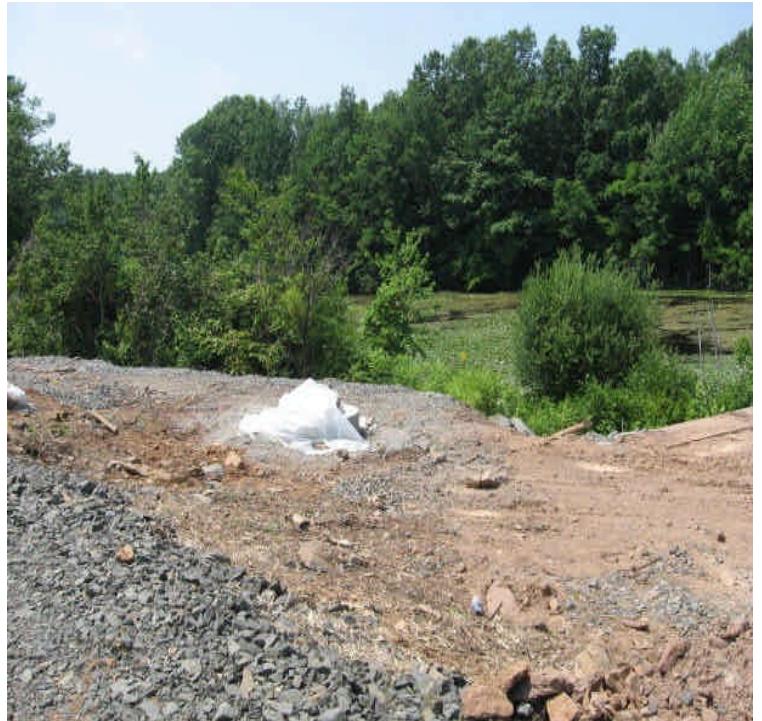
View of another foundation installed west of East Meriden SS.

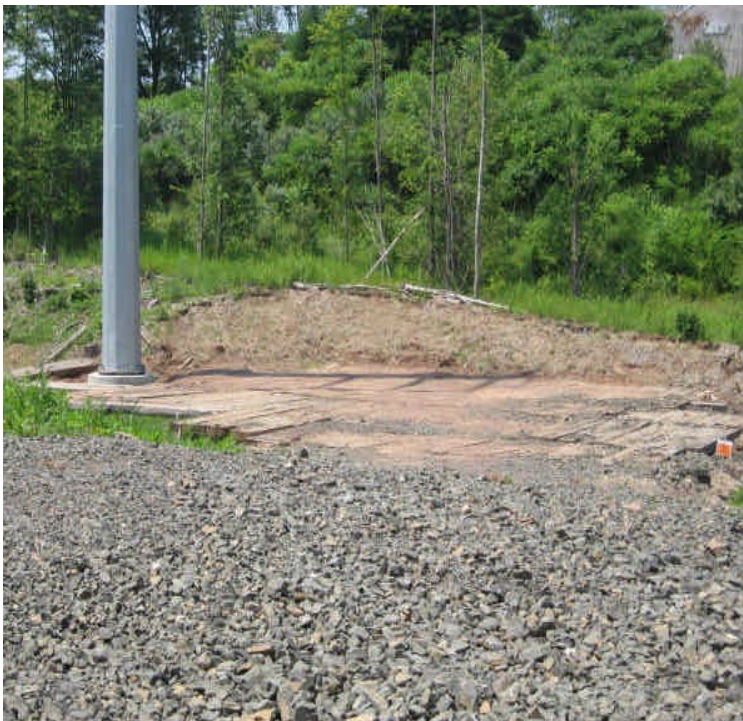
Timber mats and controls at pole within wetlands off High Hill Road. Grass growth was noted on slope.

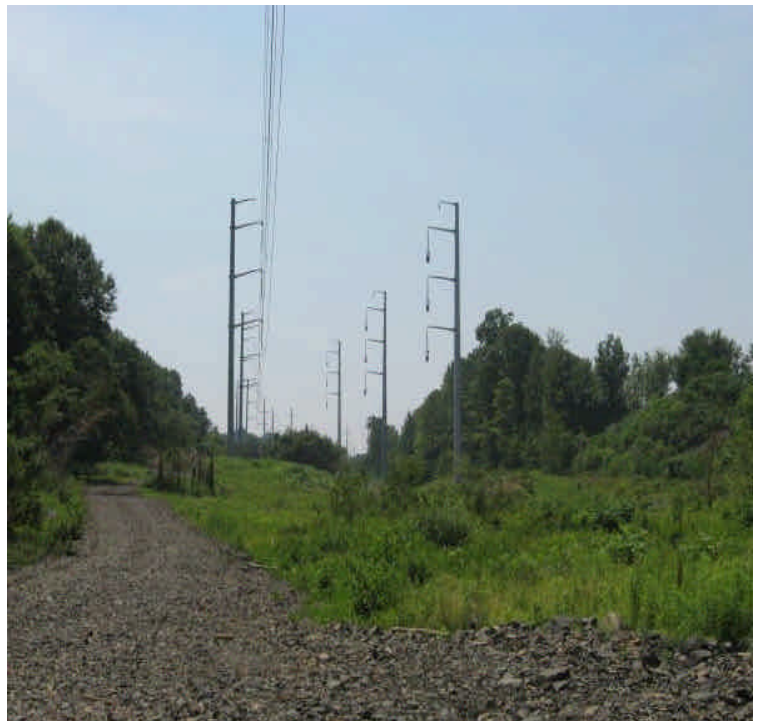
Looking south near High Hill Road toward Beseck SS. Re-establishment of vegetation was noted.
