**Docket No. 272 – Development and Management Plan Inspection**

**Segment 1a Inspection**

**Date:** July 16, 2007

**Location:** Segment 1a – Scovill Rock Switching Station to Chestnut Junction, Oxbow Junction to Beseck Switching Station (excluding Royal Oak Bypass), and Black Pond Junction to Beseck Switching Station

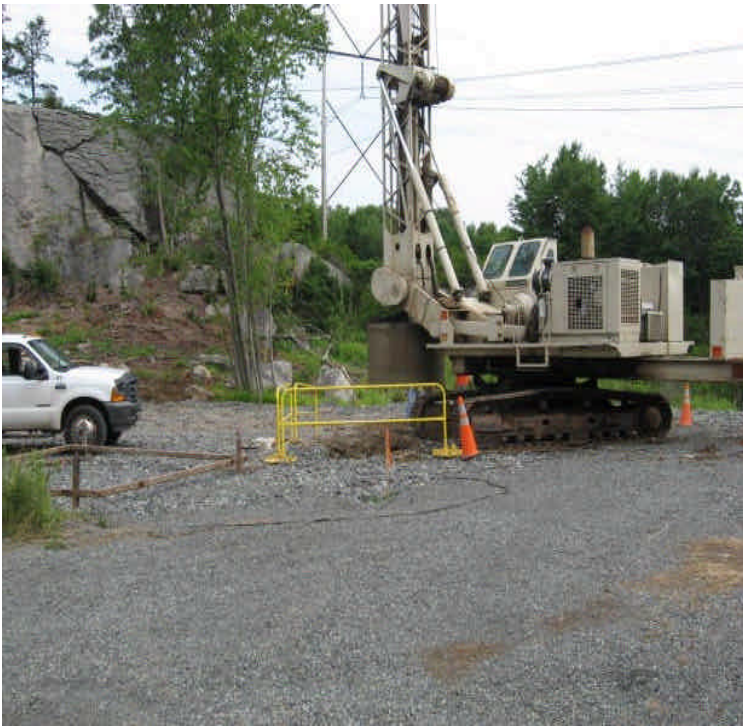
**Drilling was occurring west of Scovill SS off Rte 9.**

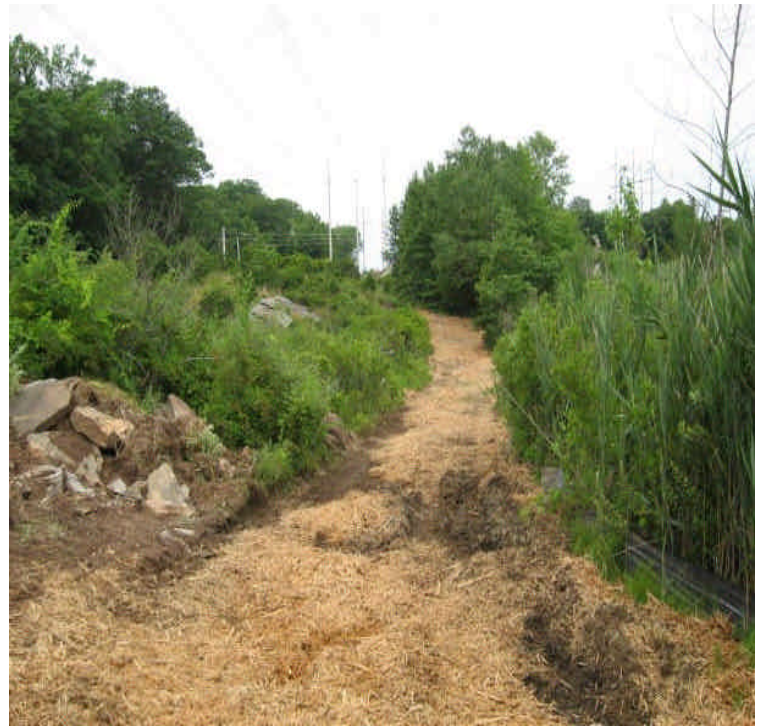
**Crews have been spreading mulch along previously disturbed areas west of Scovill SS off Rte 9.**

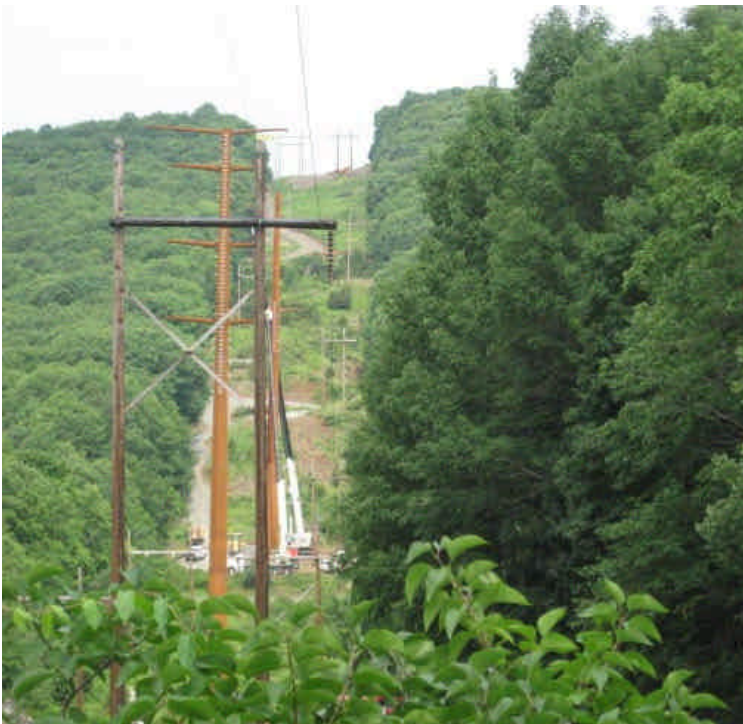
**Pole installation was occurring off Johnson Lane.**

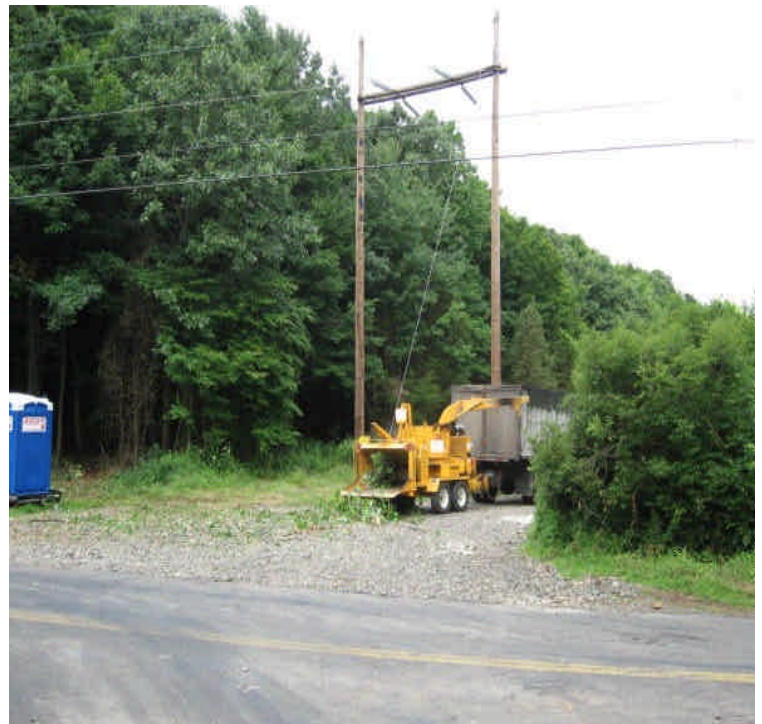
**Minor shrub removal and stump grinding/chipping off Arbutus Street**

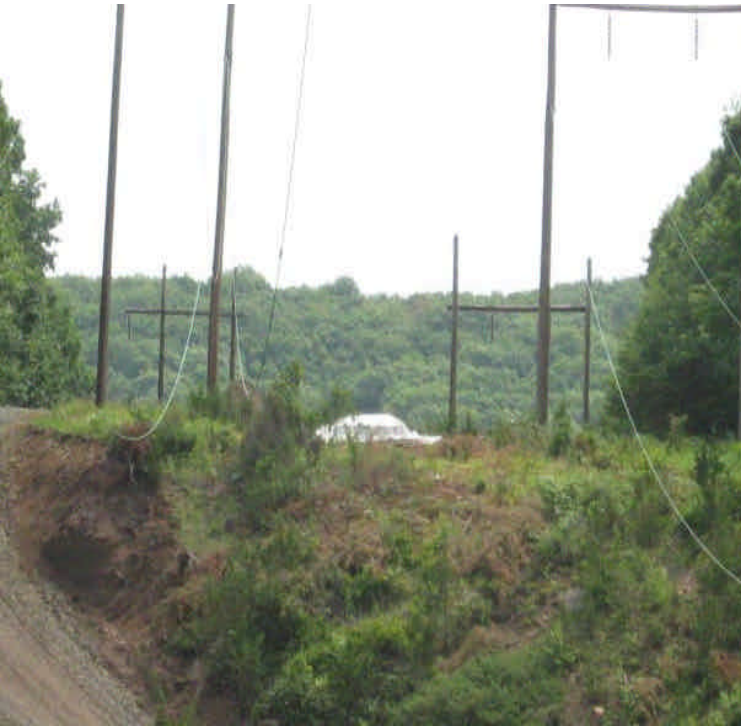
**The foundation was installed off Black Walnut Drive, upgradient from Ball Brook.**

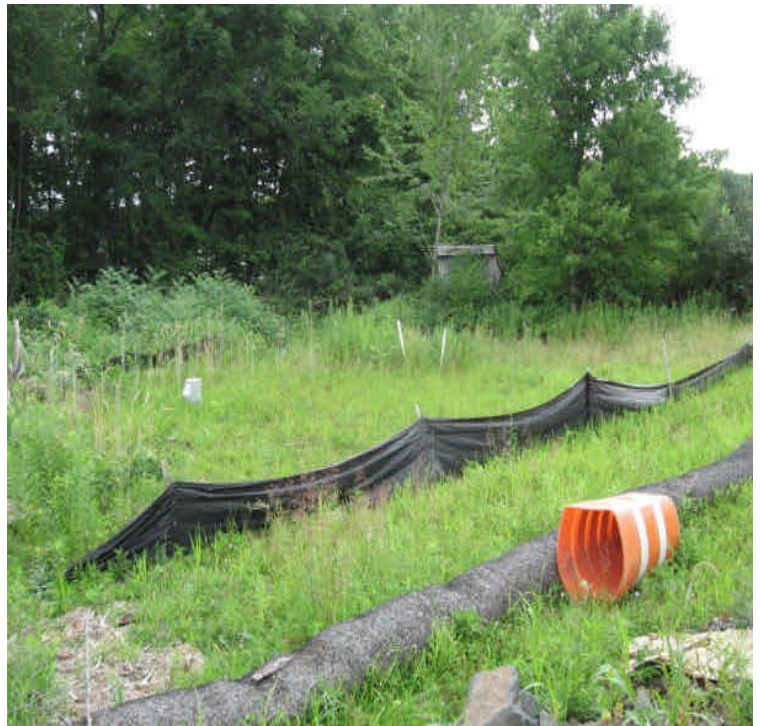
Areas of Inspection	Observation	Recommended Action	Corrected Action
<p><b>Contractor Receiving Yard and Storage Area</b></p>	<p><b>Bark mulch, haybales and filter socks remain along the steep slope of the pad upgradient of Ball Brook. 7/16/07</b></p> <p><b>A few fiber rolls have been run over along the access drive. 2/12-7/16/07</b></p> <p><b>Silt fence and fiber rolls are in place at the perimeter of the yard and along drainage areas/swales but several sections have fallen. 4/23-7/16/07</b></p>	<p><b>7/9/07 Check sediment traps for accumulated sediment. 7/16/07</b></p> <p><b>Continue to adjust controls as needed and ensure that the filter socks and drainage ditches are adequate to filter run-off. 7/16/07</b></p> <p><b>Repair/replace damaged fiber rolls as needed. 2/12-7/16/07</b></p> <p><b>Continue to add, maintain, and monitor controls as necessary. Repair fallen/untoed sections of silt fence 4/23-7/16/07</b></p>	<p><b>NA</b></p> <p><b>Needs repair when feasible.</b></p> <p><b>Needs repair</b></p>

**View of the existing controls within the shipping and receiving yard. Repair deteriorating sections as needed.**

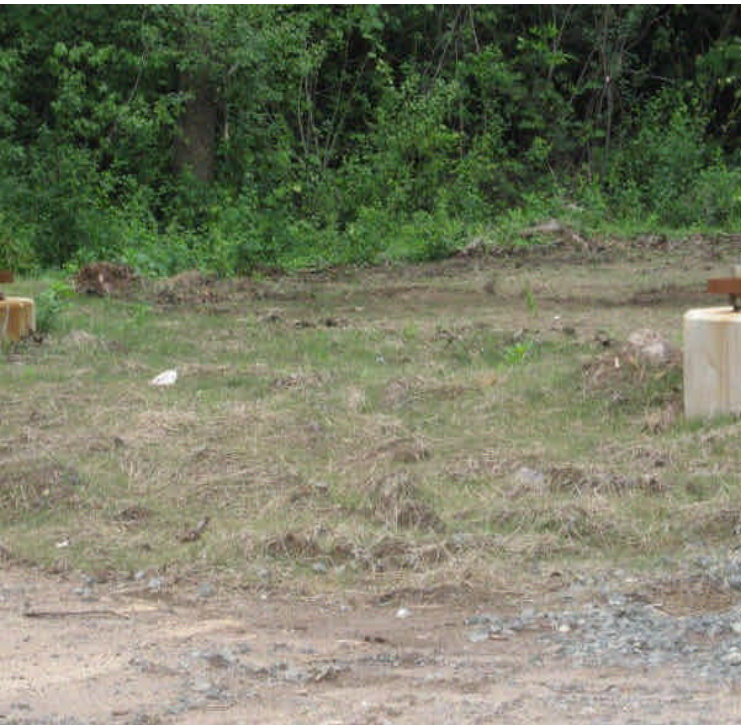
**Some grass growth was noted along wetlands off Little Lane.**

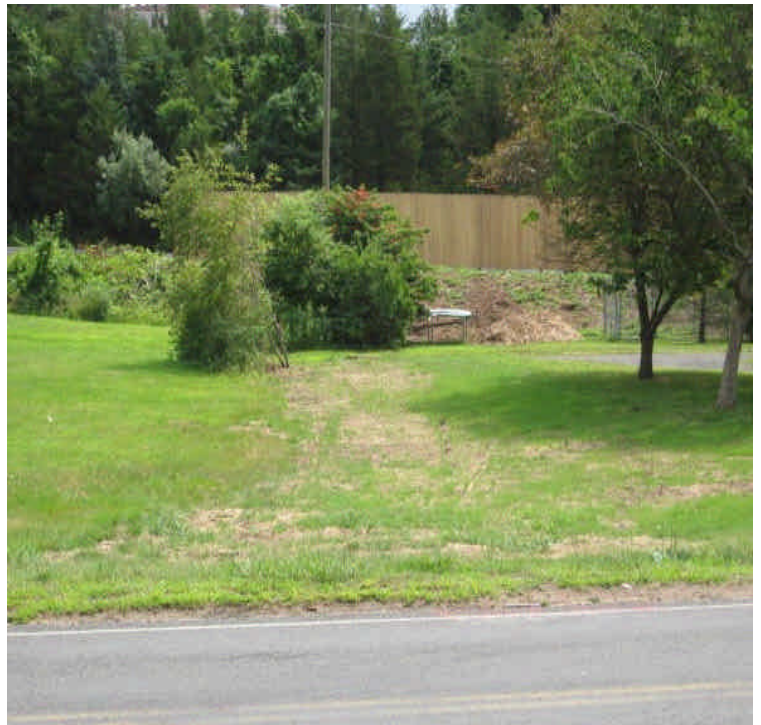
**Grass growth was noted within the recently restored lawn off Cherry Hill Rd.**

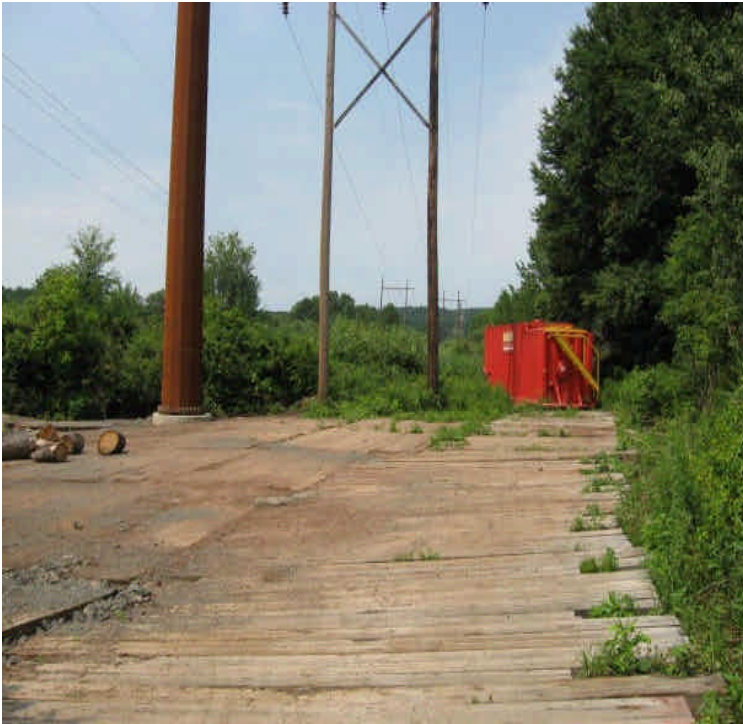
**Timber mats remain within wetlands off Durham Rd. A settling tank is also in place here.**

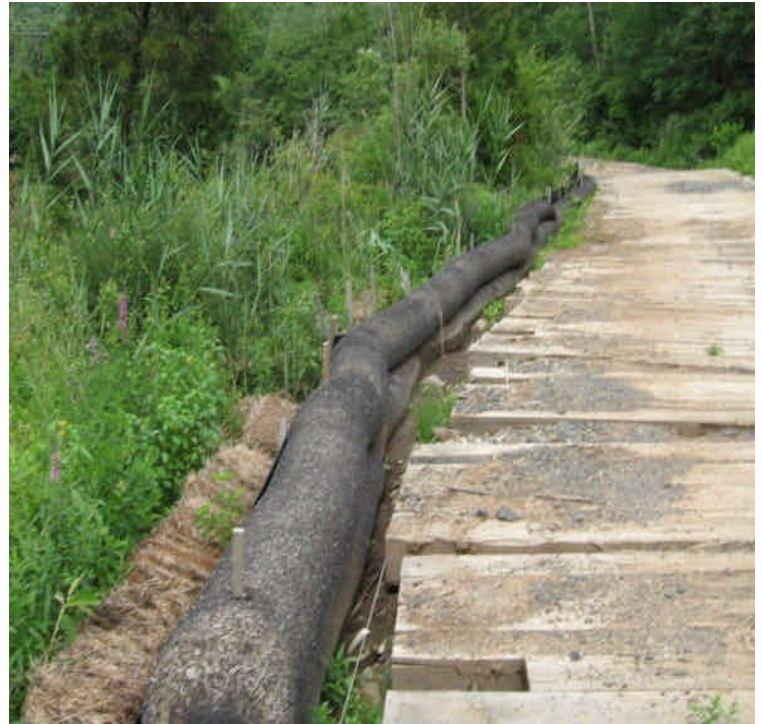
Areas of Inspection	Observation	Recommended Action	Corrected Action
Powder Hill Rd.	<p>Numerous controls remain in place along the access road. Filter socks and haybales remain upgradient of the stream and pond (both sides) at the base of slope. Sediment accumulation has occurred at the controls. Vegetation is helping to trap sediment before it reaches streams. 7/16/07</p> <p>Accumulated sediment from past heavy rains can be seen in the wetlands west of Powder Hill Rd. when standing water recedes. 6/11-7/16/07</p>	<p>Remove sediment accumulated around the controls and vegetation. Stream crossings/culverts are temporary and will be removed at the end of the work. Despite good efforts on controls, turbid run-off is still an issue during larger storms. 7/16/07</p>	<p>Needs proactive attention/evaluation when feasible.</p> <p>Grass growth continues in hydroseeded areas.</p>
East of Beseck SS	<p>At the spot adjacent to the wetlands east of Beseck SS, fiber rolls (filter socks) remain adjacent to the timber mat pads but sediment (likely from snow clearing) has been piled on and over the socks. 4/2-7/16/07</p>	<p>Any sediment accumulation over 2" should be carefully removed from the wetland by hand. 5/29-7/16/07</p> <p>Adequately contain all sediment; the soil in the wetland will have to be removed carefully by hand. 4/2-7/16/07</p>	<p>Needs evaluation</p> <p>Needs attention</p>

**View of the existing controls within wetlands off Powder Hill.**

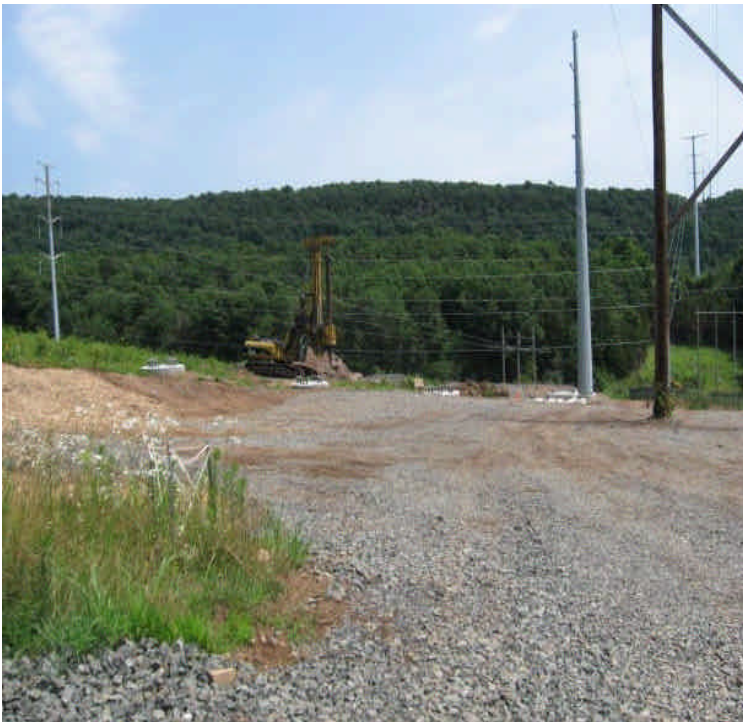
**Several foundations were installed north of Beseck SS.**

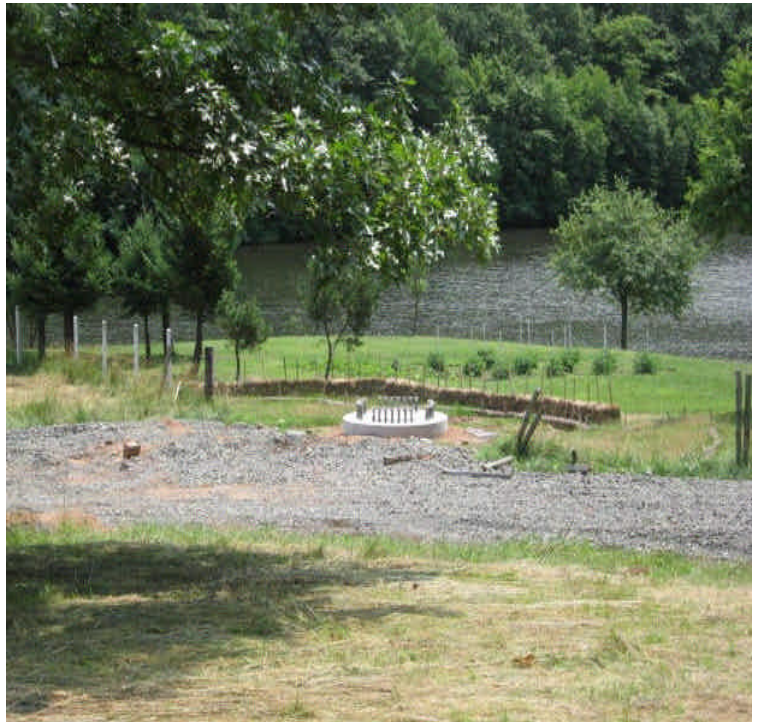
**View of the foundation and controls installed off Fleming Road.**

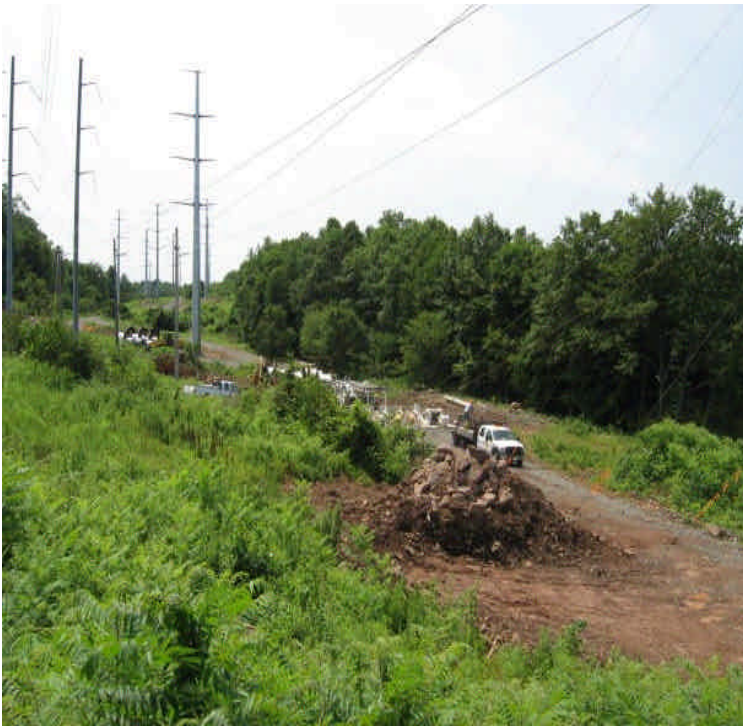
**Line pulling was occurring in the ROW west of East Meriden SS.**

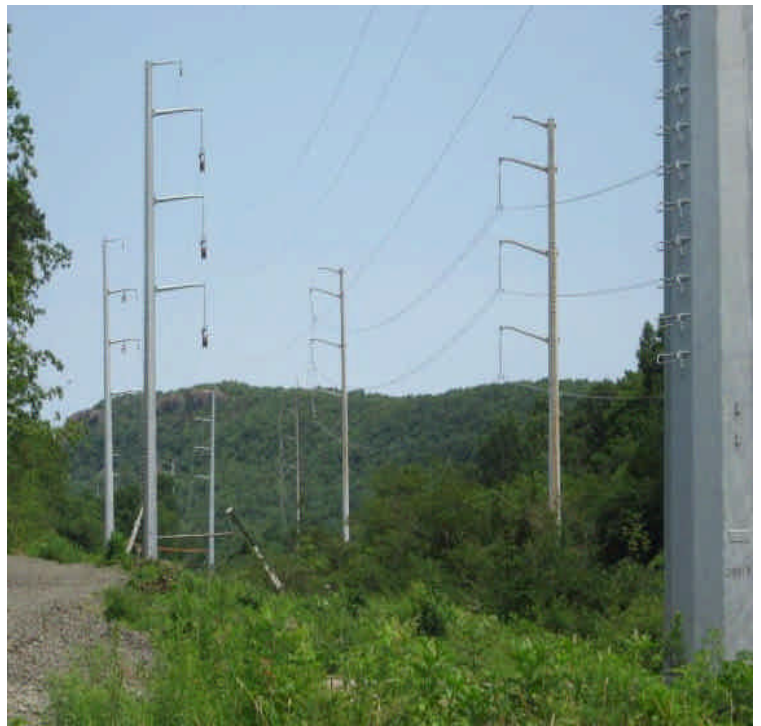
**View of line pulling work on recently installed poles off High Hill Rd.**

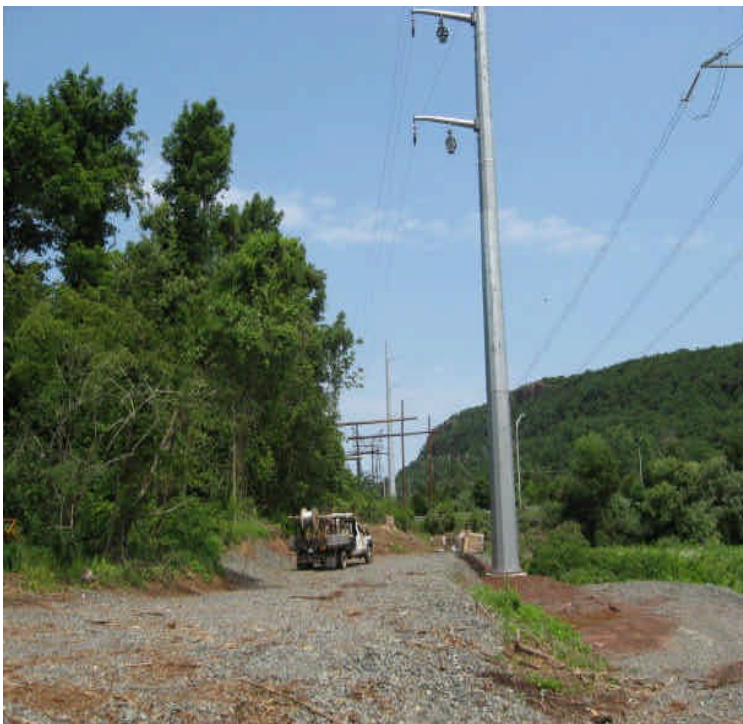
**View of the pad site with the new pole off East Main Street.**

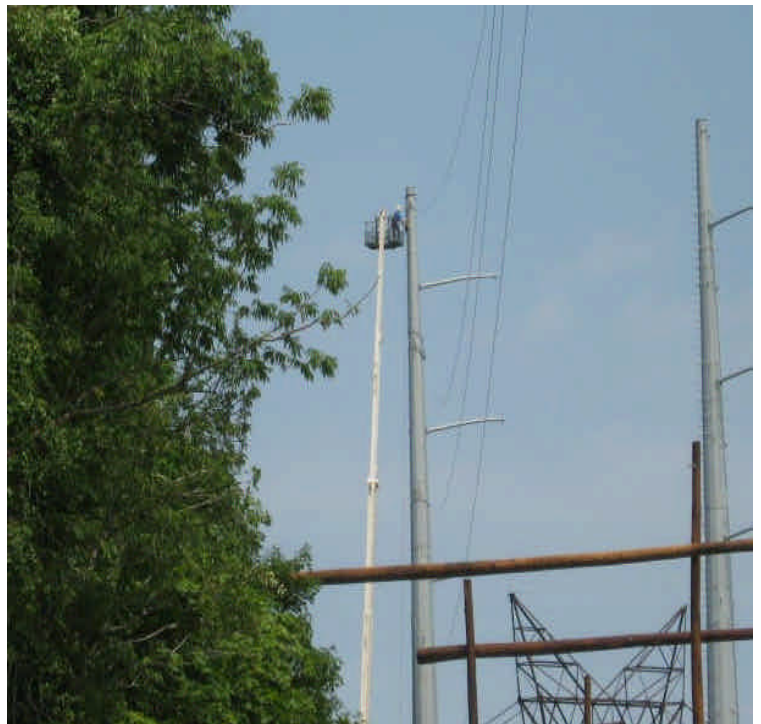
**View of the line work occurring at Black Pond Junction.**
