Docket No. 272 – Development and Management Plan Inspection

Segment 1a Inspection

Date: July 23, 2007

Location: Segment 1a – Scovill Rock Switching Station to Chestnut Junction, Oxbow Junction to Beseck Switching Station (excluding Royal Oak Bypass), and Black Pond Junction to Beseck Switching Station

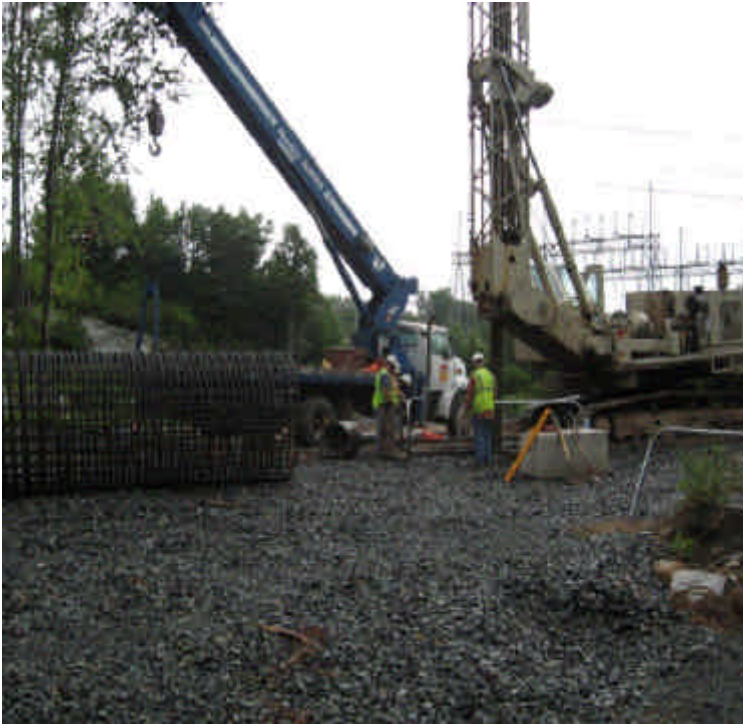
Drilling was occurring west of Scovill SS off Rte 9.

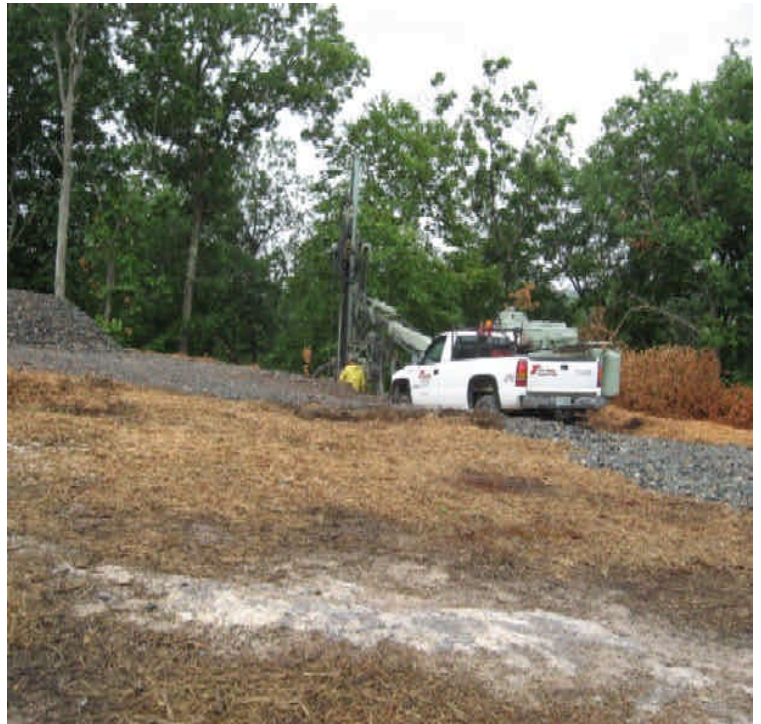
Crews have been spreading mulch along previously disturbed areas west of Scovill SS off Rte 9. Photo also shows a view of foundation drilling occurring in the area.

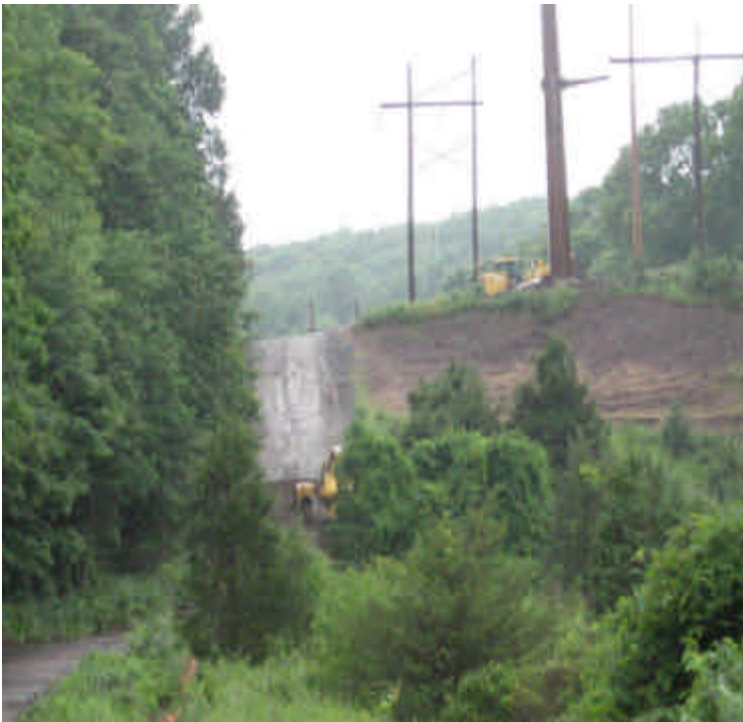
Minor grading activities were occurring off Arbutus Street.

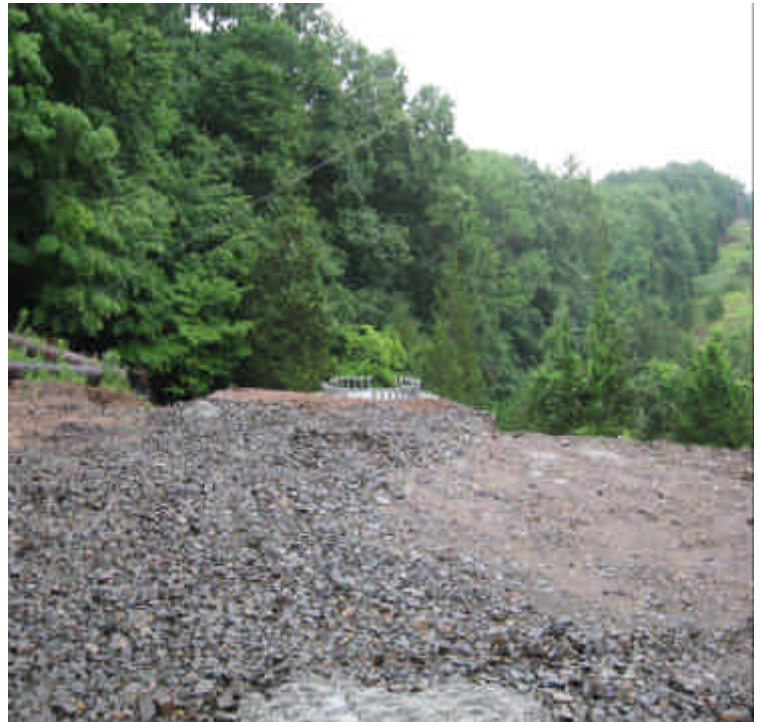
View of the foundation off Black Walnut Drive, upgradient from Ball Brook.

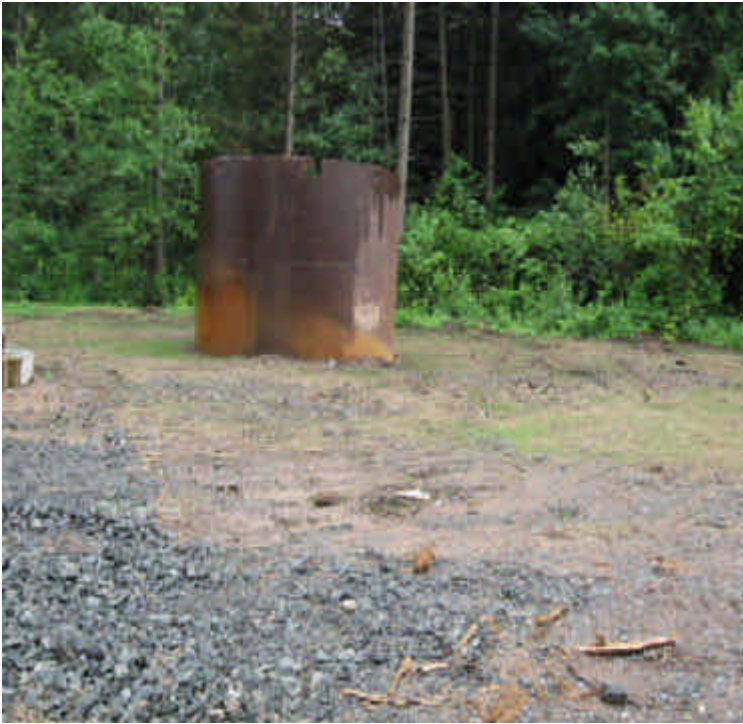
Some grass growth was noted at the recently seeded area near Little Lane and Rte 17

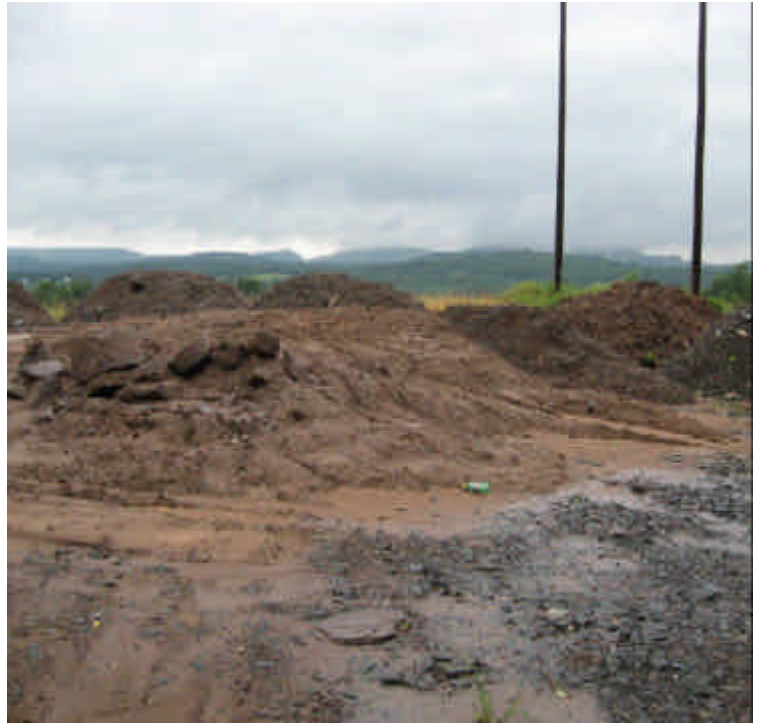
View of soil stockpiles resulting from foundation drilling between Little Lane and the Durham Transfer Station off Cherry Hill Road. Ensure that soil is contained appropriately.

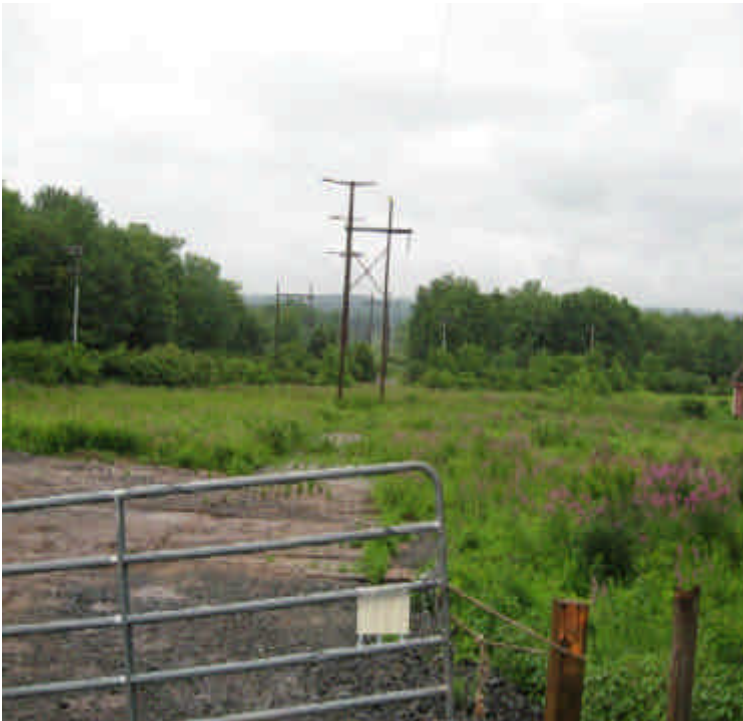
Vegetative growth noted along work areas and wetlands off Cherry Hill Road

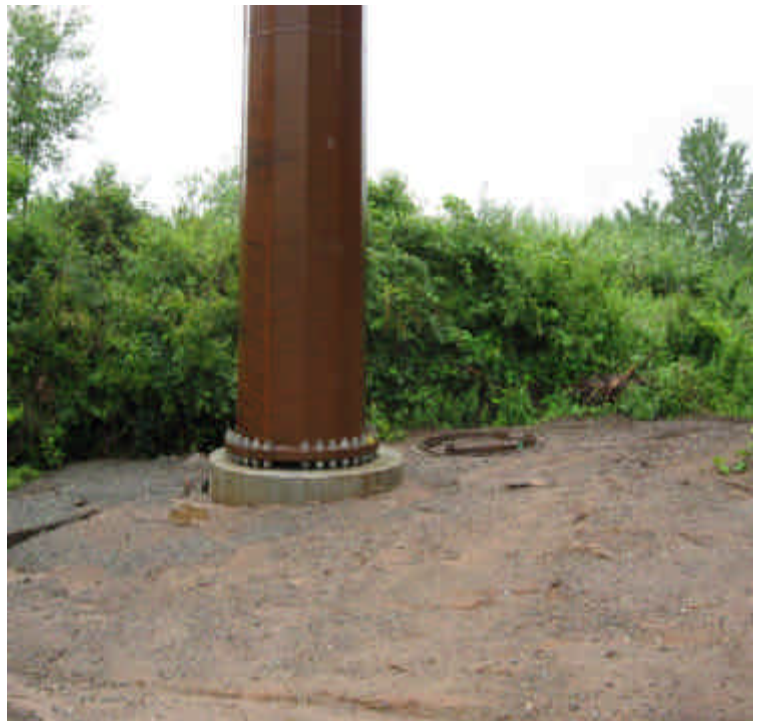
Pole installed off Durham Road. Sediment accumulation was noted on timber mats in the wetlands. Remove sediment to the extent feasible and install controls where needed.

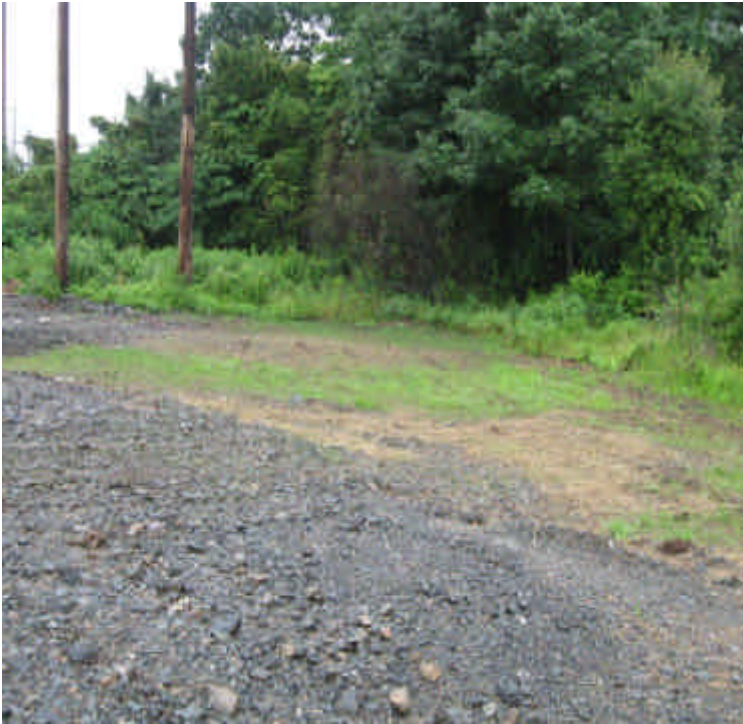
Grass growth noted in the recently seeded area off Elihu Drive.

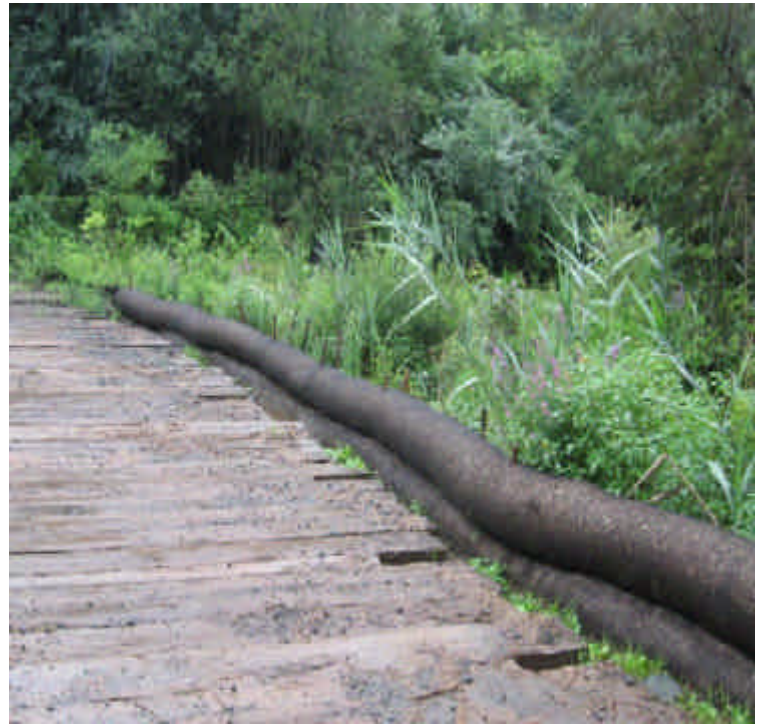
View of the existing controls within wetlands off Powder Hill Rd.

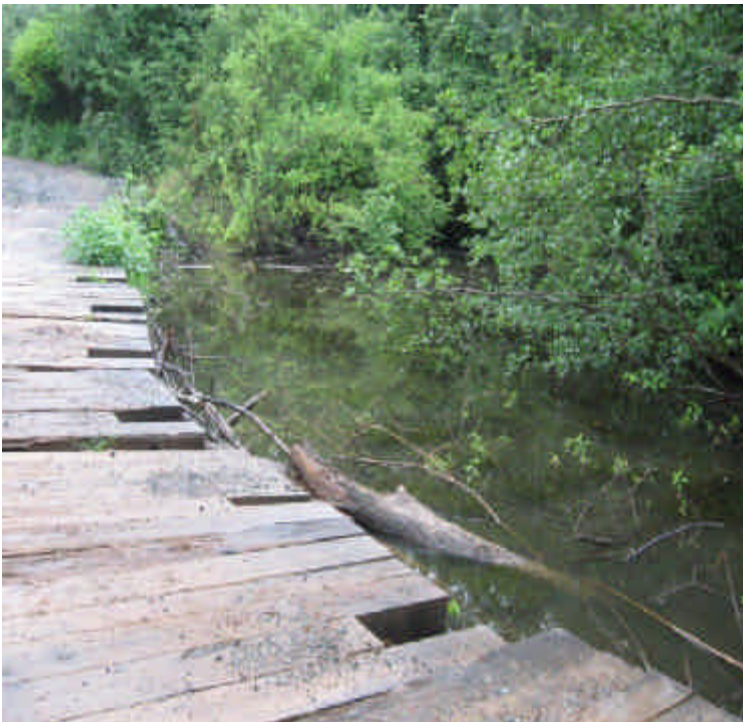
View of the wetland crossing off Powder Hill Rd.

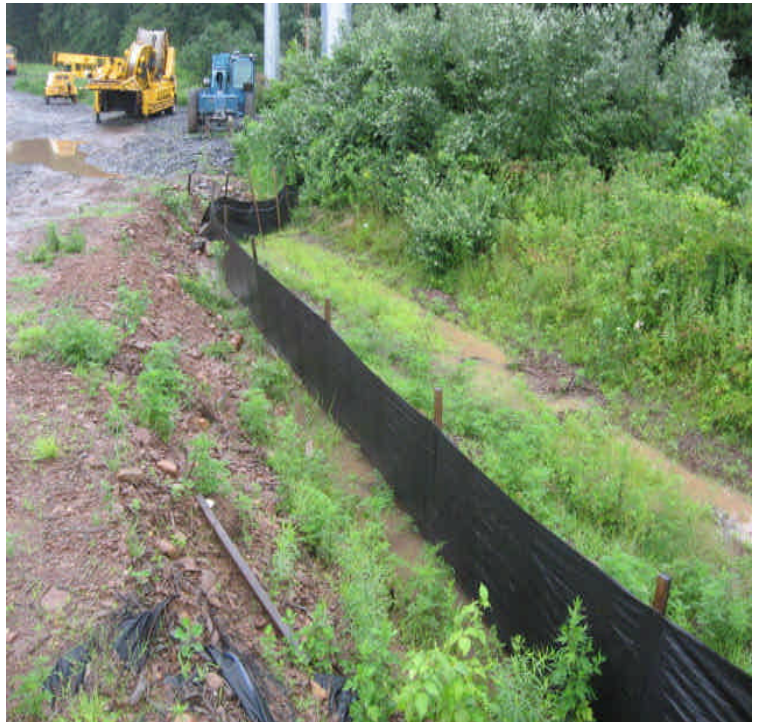
Turbid water flowing from the access road, through controls, and off site to the sediment trap/basin east of Beseck SS.

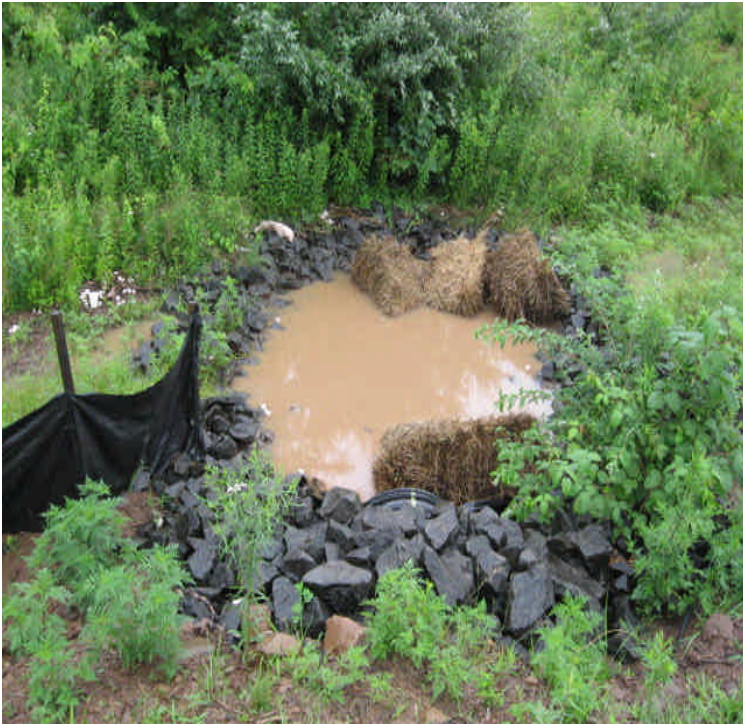
View of the sediment trap east of Beseck SS. The trap is also receiving turbid water from the switching station and does not have the capacity during larger rain events.

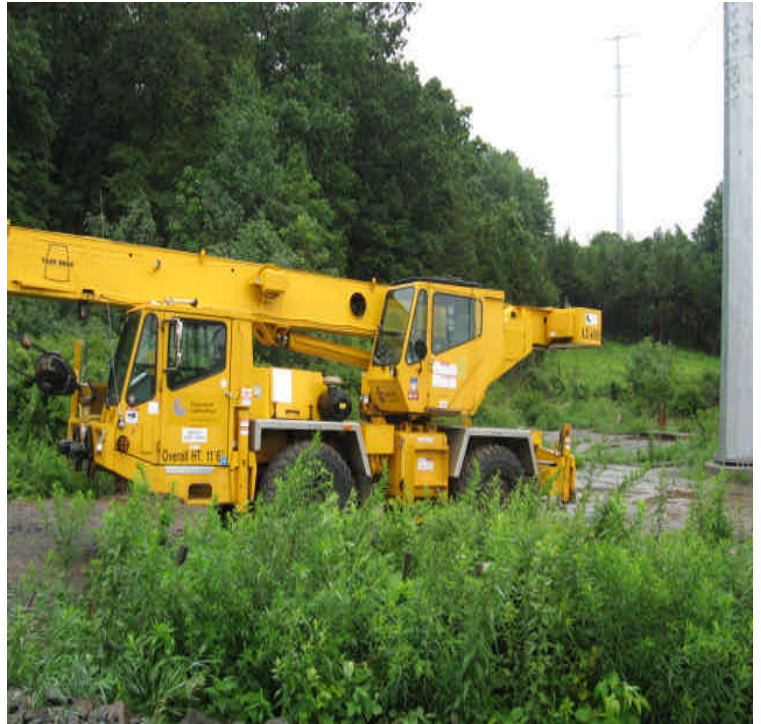
Areas of Inspection	Observation	Recommended Action	Corrected Action
	<p>Three pieces of equipment were parked on timber mats, within two separate wetland areas in this section of ROW. This included north of Beseck SS and off High Hill Road. The equipment near Beseck was moved by the next day for line pulling. 7/23/07</p>	<p>Avoid storage and parking of equipment within wetlands, even temporarily. Attempt to keep them over 100ft from sensitive areas whenever feasible. 7/23/07</p>	<p>The equipment near Beseck SS had been removed the day after the inspection and the contractor was looking into the other vehicles.</p>
<p>Additional Observations</p>	<p>NA</p>

Equipment was parked on mats within wetlands north of Beseck SS. Equipment was moved the next day and used for line puling in this area. Avoid equipment storage in wetlands, even if it is temporary.

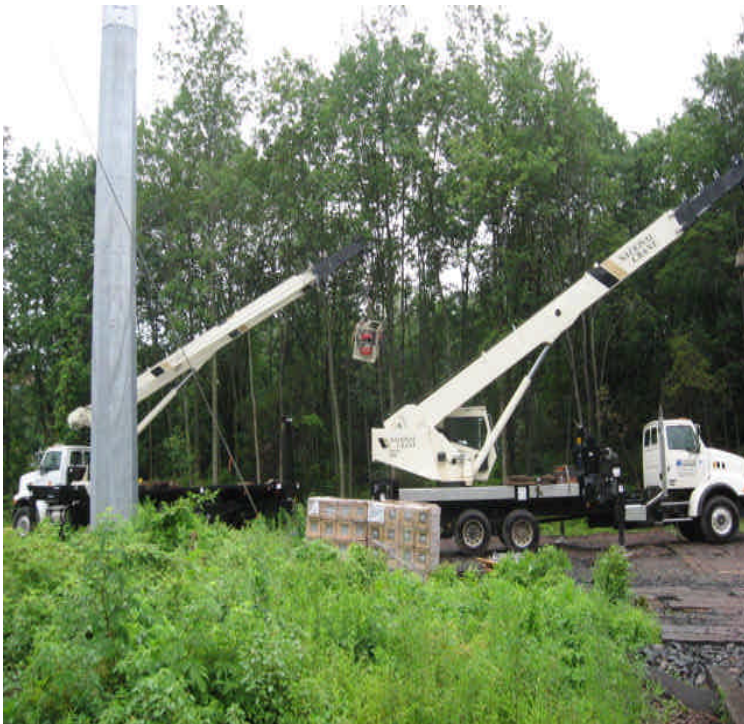
Two pieces of equipment were parked on mats within wetlands off High Hill Road. Avoid equipment storage in wetlands, even if it is temporary

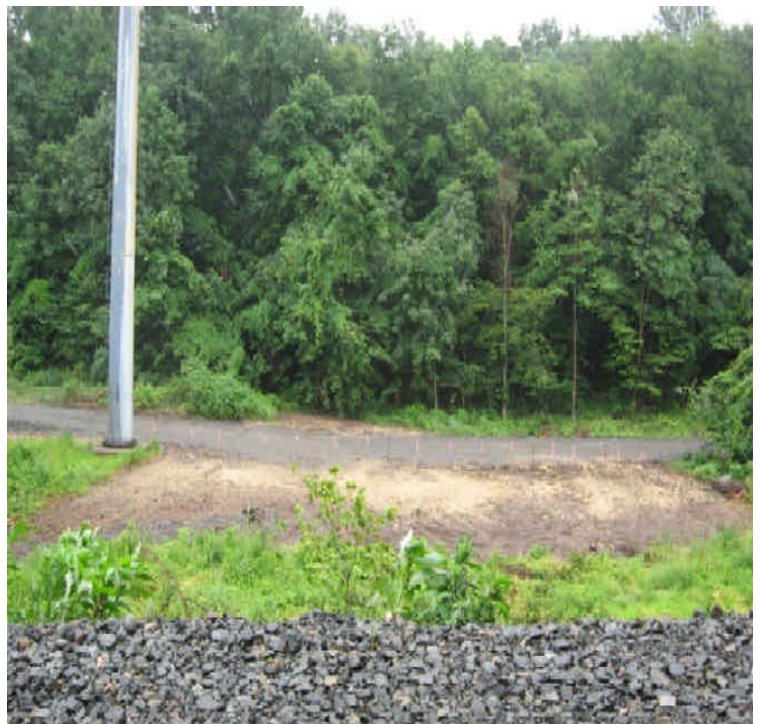
Hay and seed spread to stabilize soils north of High Hill Road along the slope to a stream.
