Docket No. 272 – Development and Management Plan Inspection

Segment 1b (Royal Oaks Bypass) Inspection

Date: July 2, 2007

Location: Segment 1b (Royal Oaks Bypass)

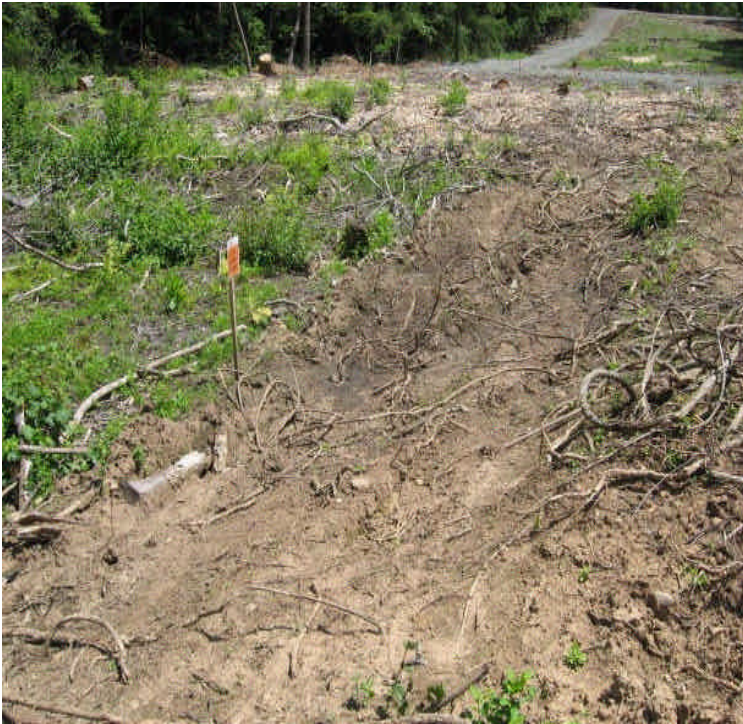
Water was no longer flowing into the pond from the equipment ruts created between Rte 17 and Black Walnut Drive. Controls are still needed. Also, confirm that the “entering wetland” sign is actually at the boundary and not within the wetland.

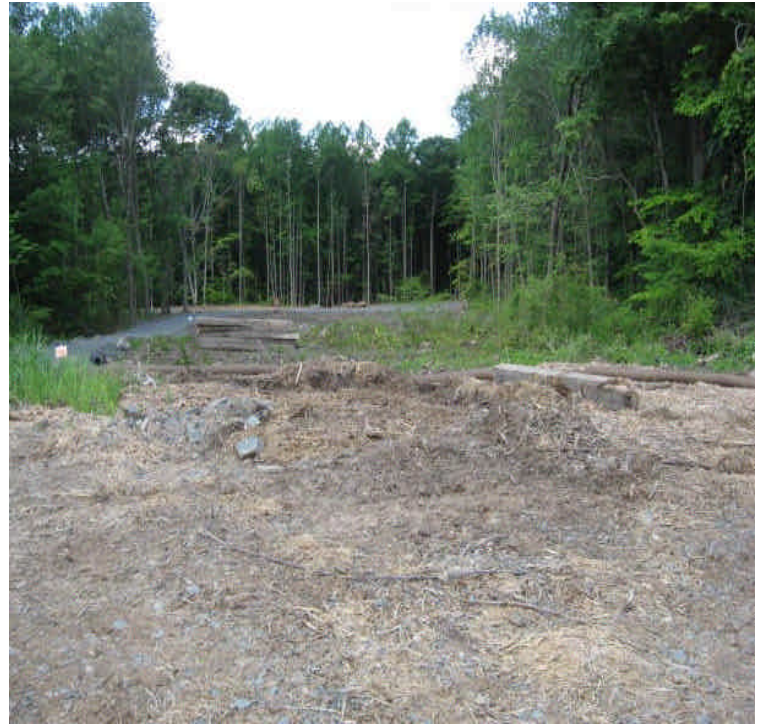
Site entrance within the receiving yard. Timber mats were stockpiled in/adjacent to a wetland area and should be relocated

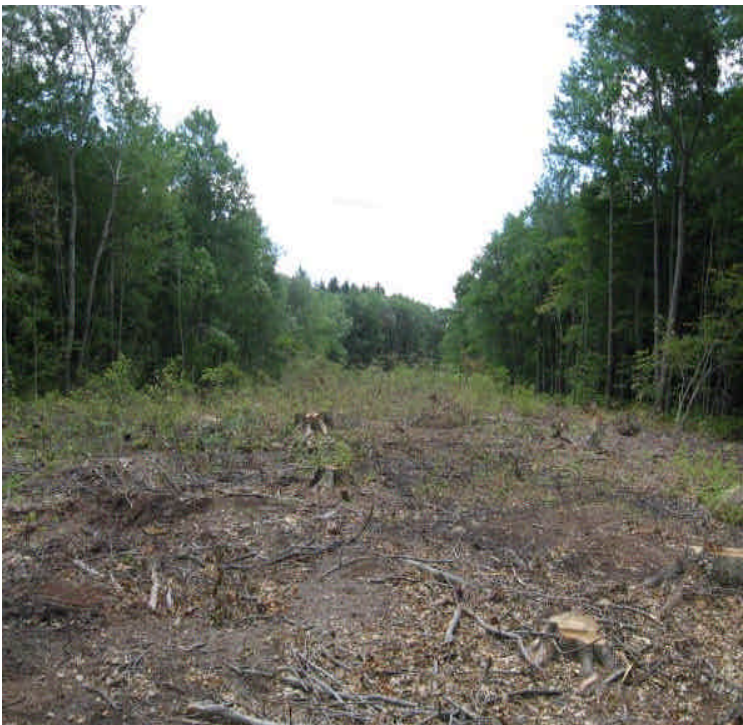
View of the sensitive crossing in the ROW that was recently cleared via helicopter and low impact techniques. Stumps and low growing vegetation were retained to stabilize soils.

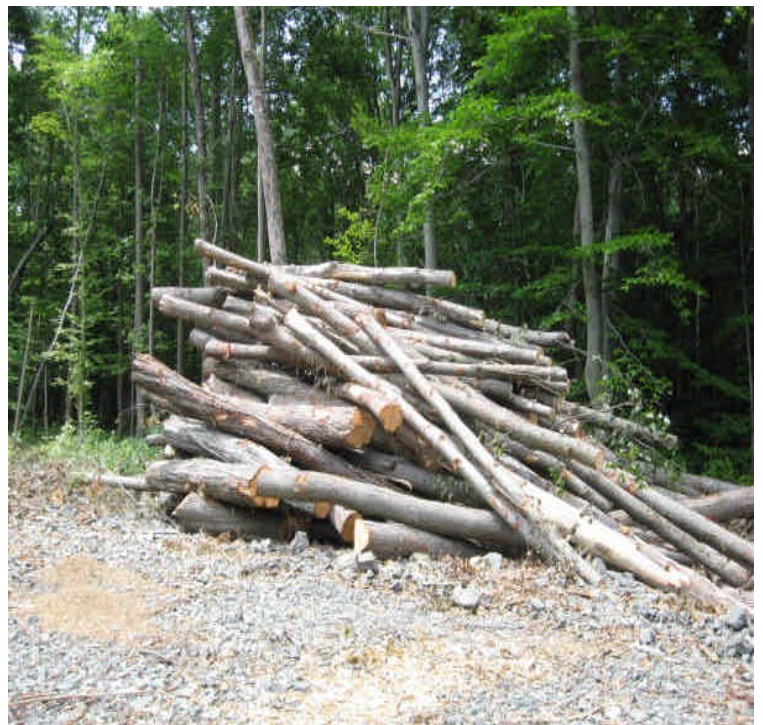
View of the remaining timber stockpile to be removed from the site.
