**Docket No. 272 – Development and Management Plan Inspection**

**Segment 1b (Royal Oaks Bypass) Inspection**

**Date:** July 30, 2007

**Location:** Segment 1b (Royal Oaks Bypass)

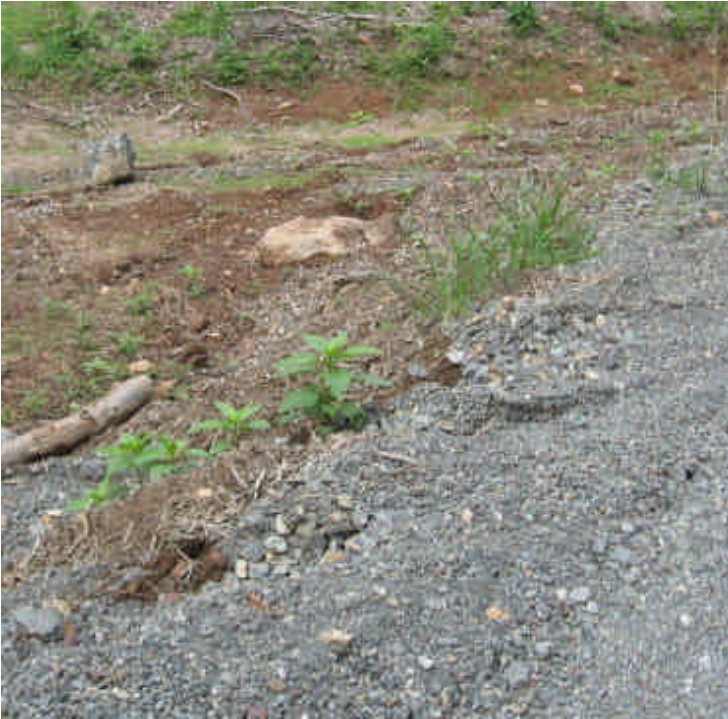
**Ruts/washouts are occurring along a steep slope in the access road off Black Walnut Drive.**

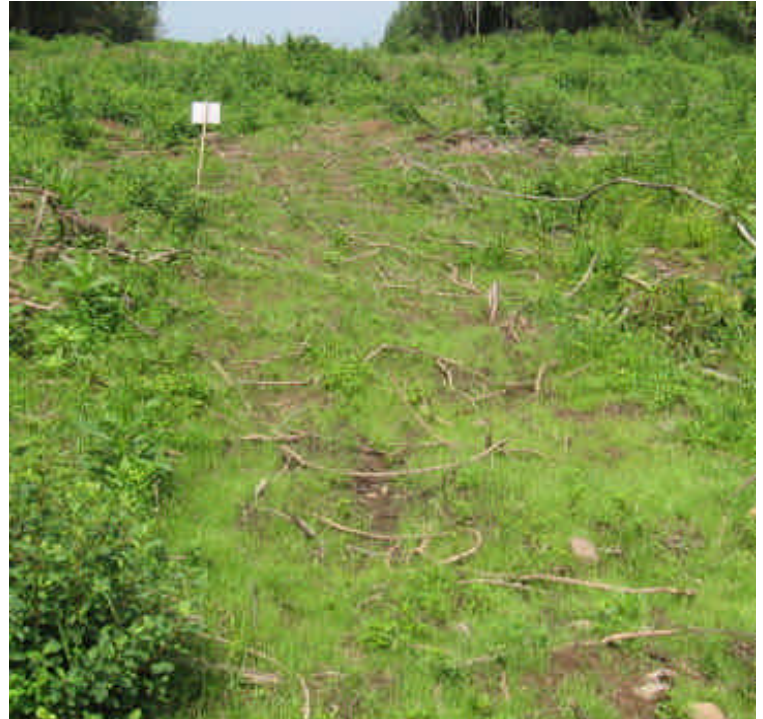
**Vegetative growth/cover was starting to fill in where the equipment ruts had been created between Rte 17 and Black Walnut Drive. The area was seeded a few weeks ago. Add controls as needed.**

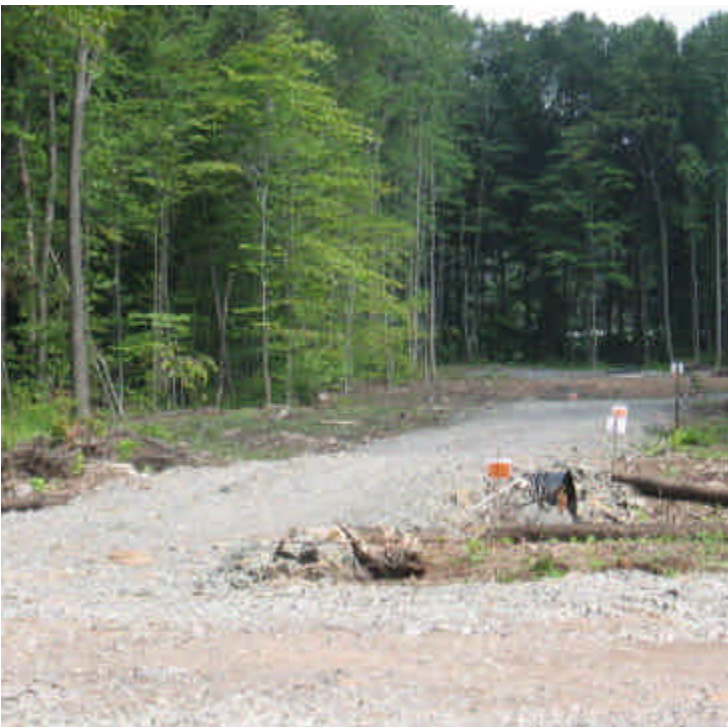
**Environmental controls are in place at the wetland crossing and along the access road near the contract shipping/receiving yard. Monitor flow from the culvert for turbidity and adjust controls as needed.**

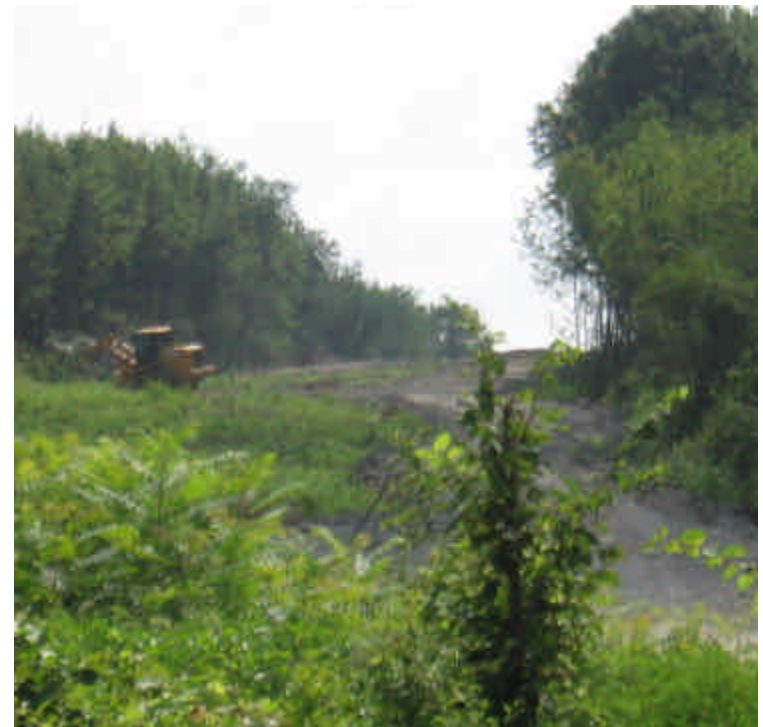
**A view of road/pad construction east of Route 17.**
