Docket No. 272 – Development and Management Plan Inspection

Segment 2a Inspection

Date: July 3, 2007

Location: Segment 2a – Beseck Switching Station to Cheshire/Hamden Town Line

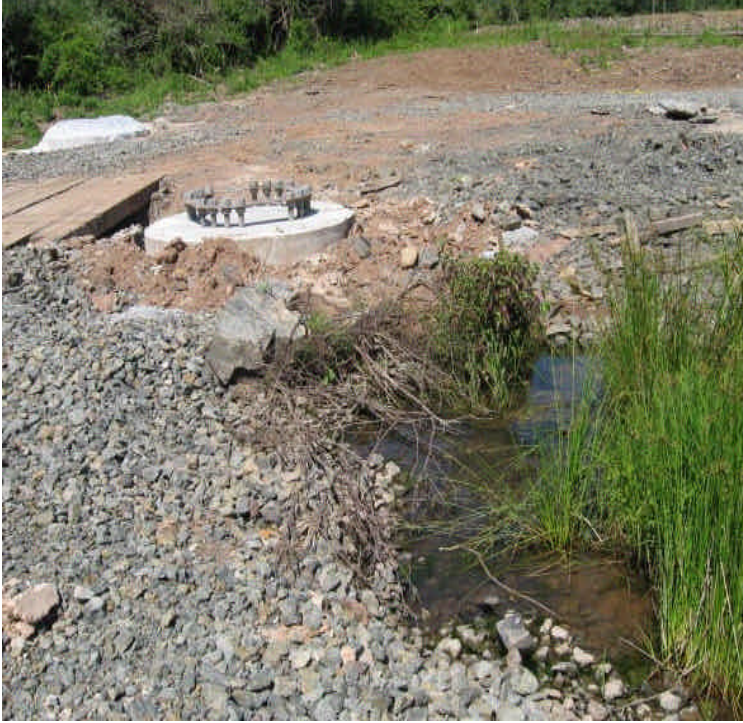
Foundation was placed in a small stream channel off Carpenter Lane. Create a new channel/or provide stream restoration to re-establish the hydrology.

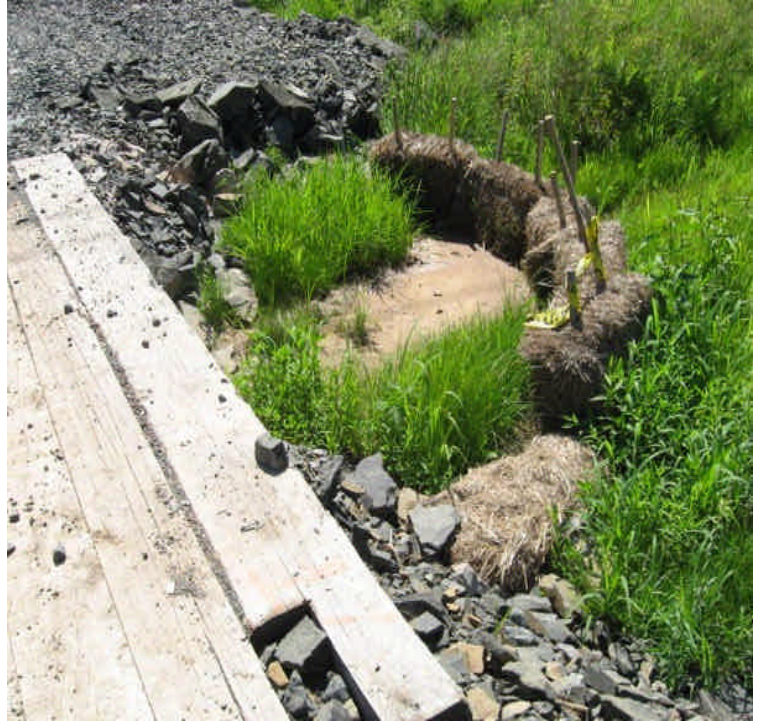
Sediment/turbid run-off was appropriately filtered by a haybale check-dam within wetlands off Carpenter Lane. Remove sediment when feasible to restore capacity.

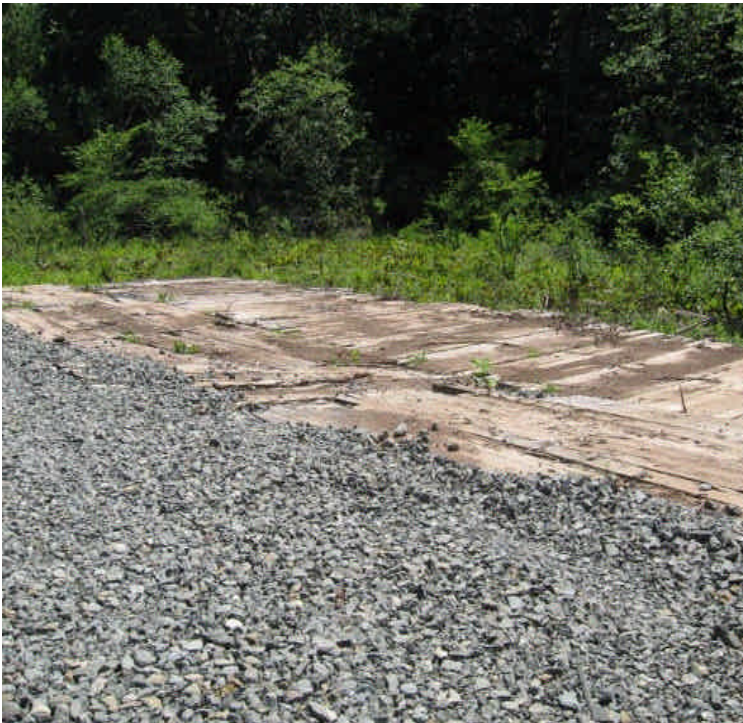
Timber mats installed within the wetlands off Liney Hall Ln.

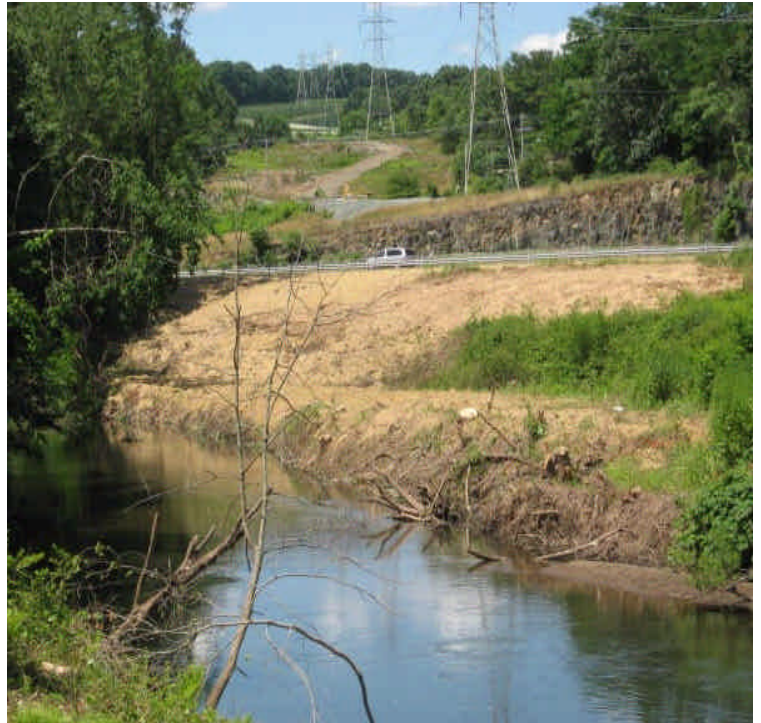
Mulch in place on the slope off Merritt Parkway, adjacent to the river. Monitor carefully for any erosion and install erosion control mats if necessary. Root systems remain in place.

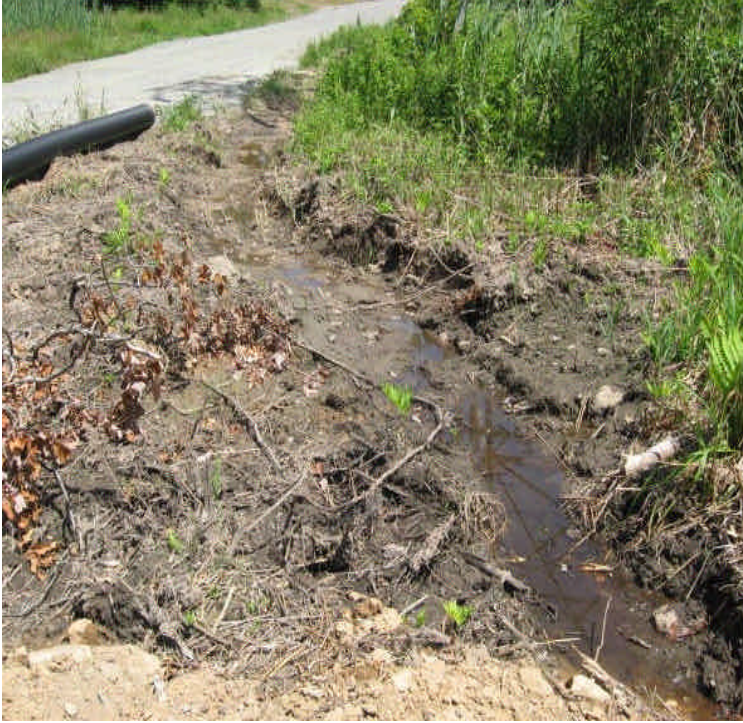
A drainage channel was dug within the apple orchard off Mansion Rd. A culvert appears to be necessary to reduce sedimentation

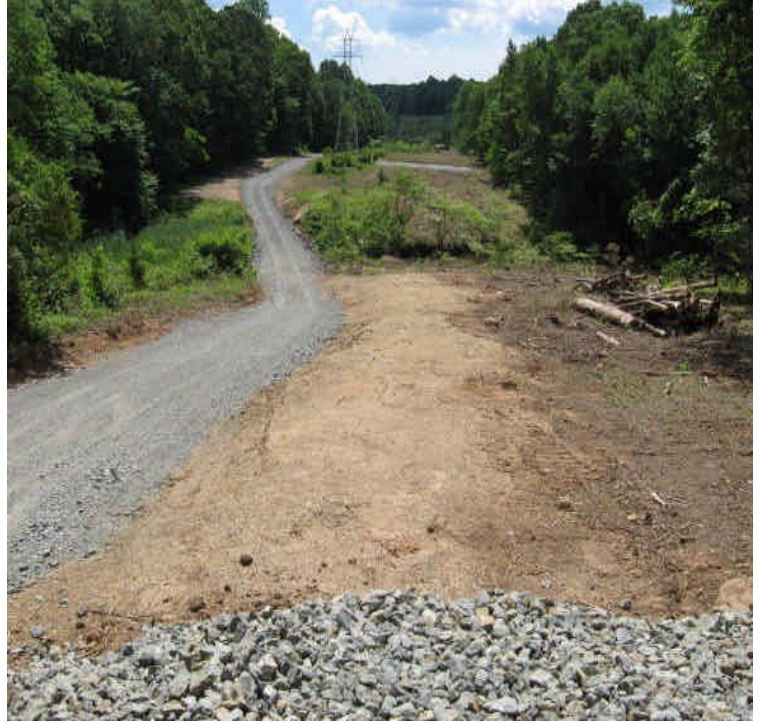
Access road has been installed off of Tuttle Ave. Filter socks, hay mulch and seed remain in place for control and stabilization

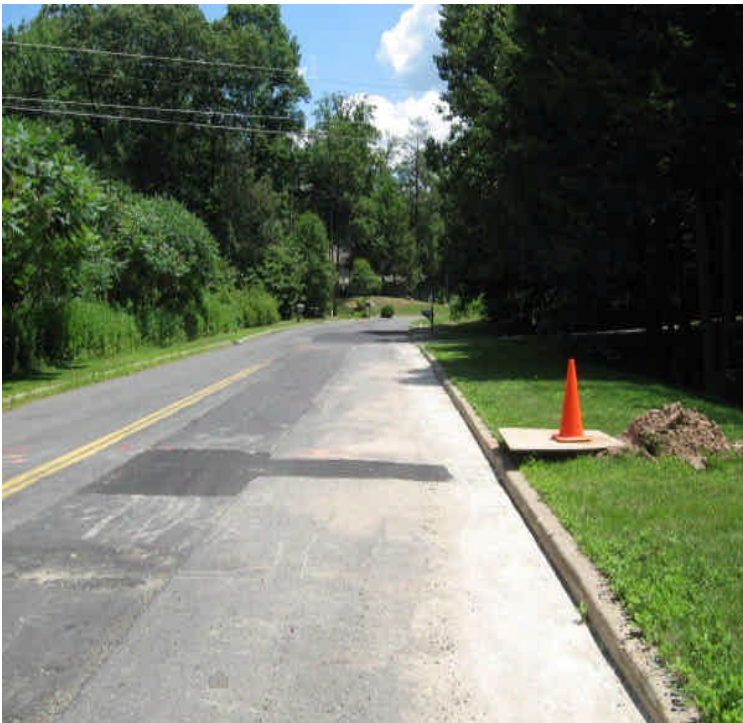
Sediment accumulation was noted in the gutter along the roadway on Old Farms Rd.

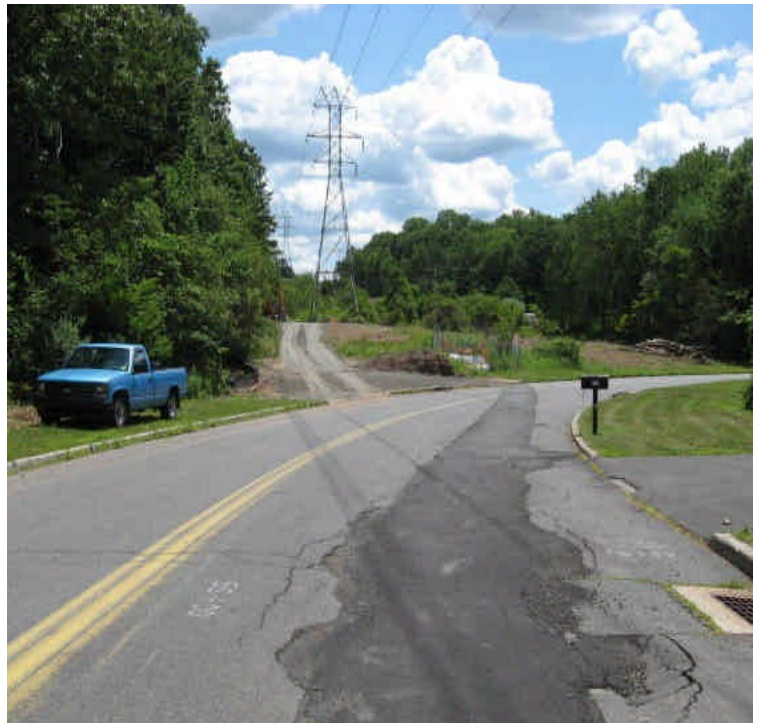
The trench patch along Old Farms Rd. still needs repair in some locations. A new pad site was being constructed.
