**Docket No. 272 – Development and Management Plan Inspection**

**Segment 2a Inspection**

**Date:** July 10, 2007

**Location:** Segment 2a – Beseck Switching Station to Cheshire/Hamden Town Line

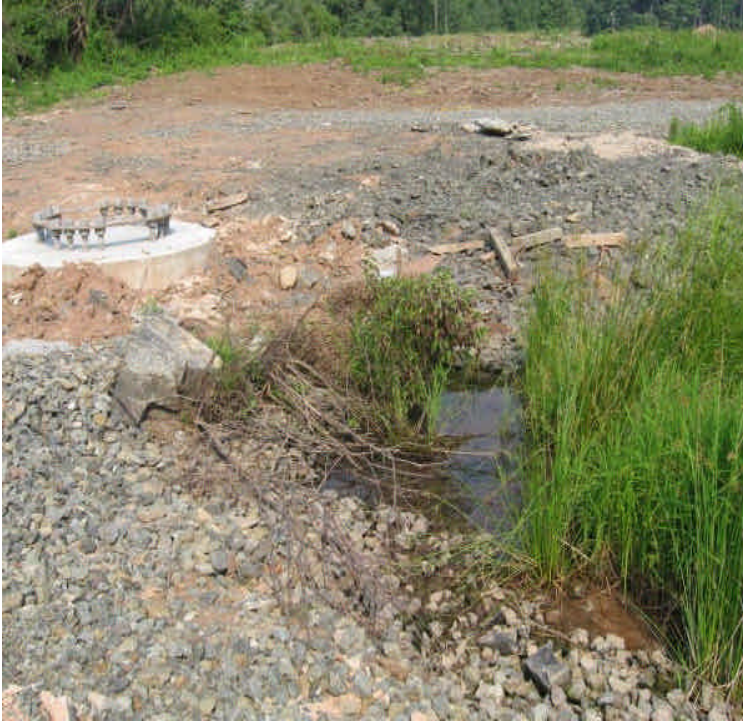
**Foundation was placed in a small stream channel off Carpenter Lane. Create a new channel/or provide stream restoration to re-establish the hydrology.**

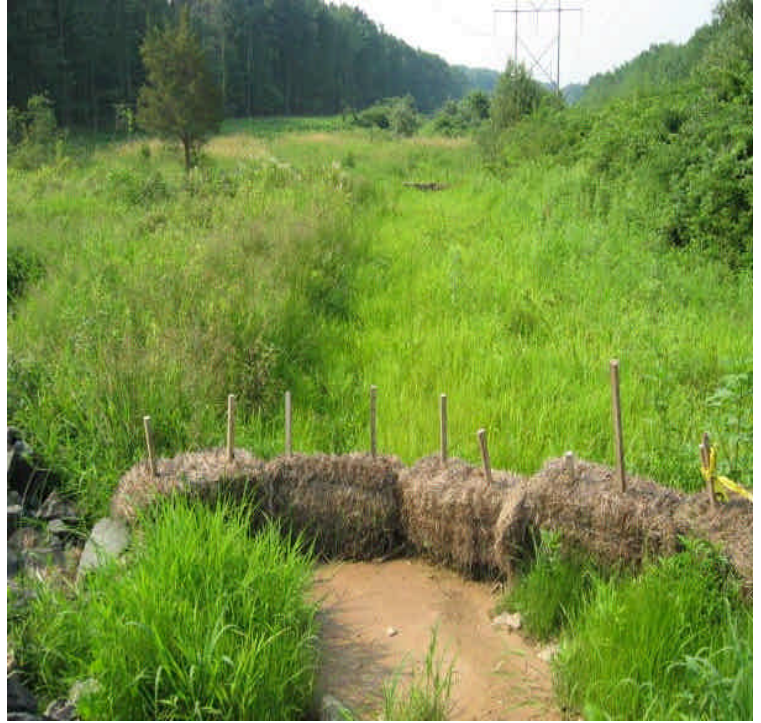
**Sediment/turbid run-off was appropriately filtered by a haybale check-dam within wetlands off Carpenter Lane. Remove sediment when feasible to restore capacity.**

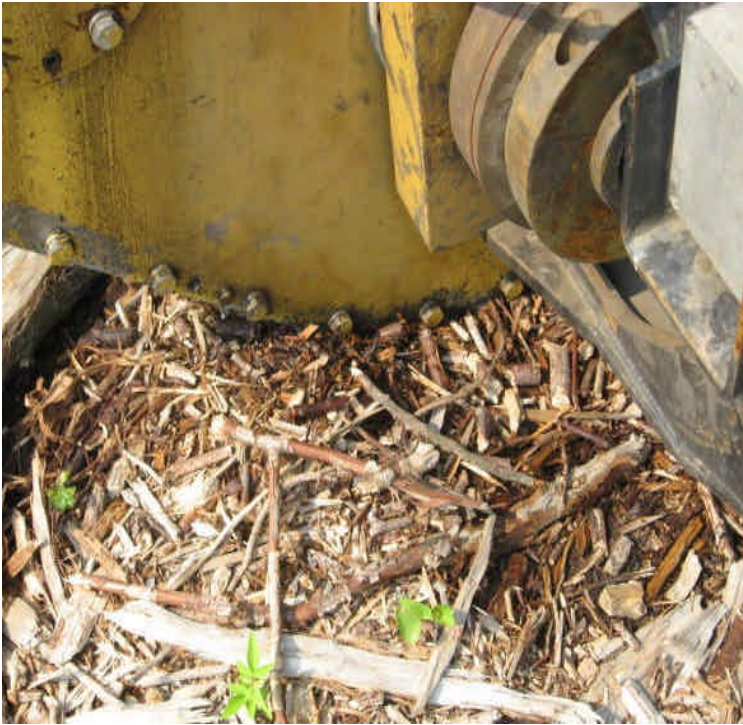
**Hydraulic fluid dripping from equipment parked off Carpenter Ln.**

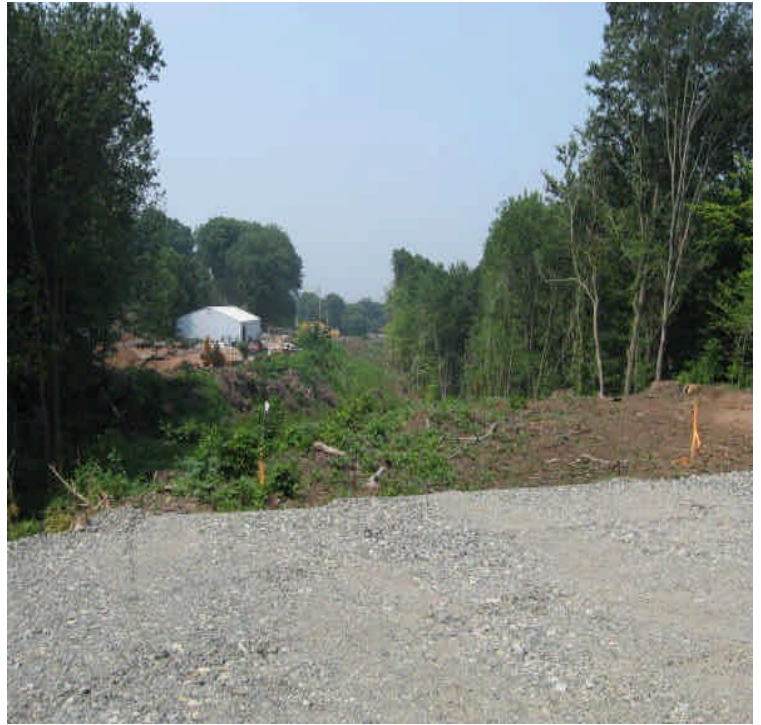
**Clearing off Woodhouse Ave looking toward Harrison Rd.**

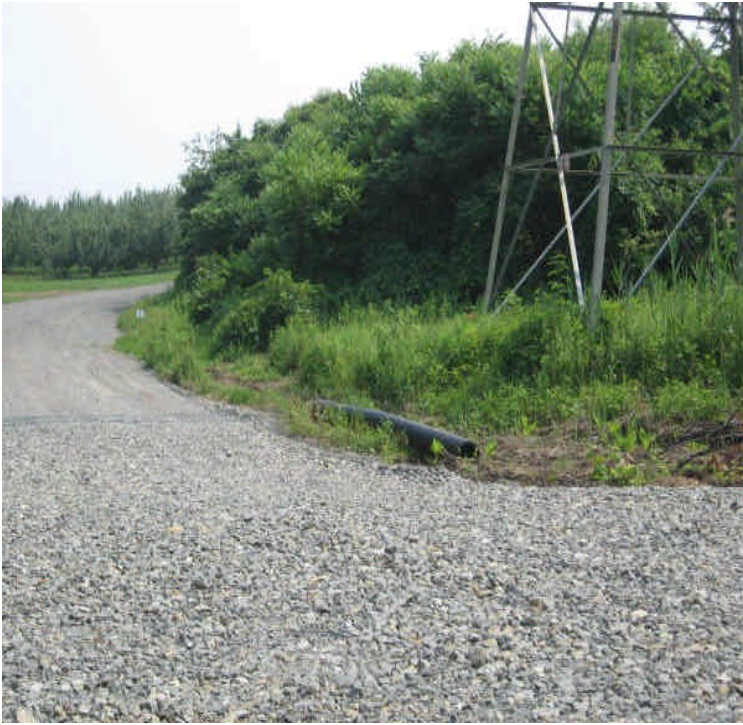
**A drainage channel was dug within the apple orchard off Mansion Rd. A culvert appears to be necessary to reduce sedimentation**

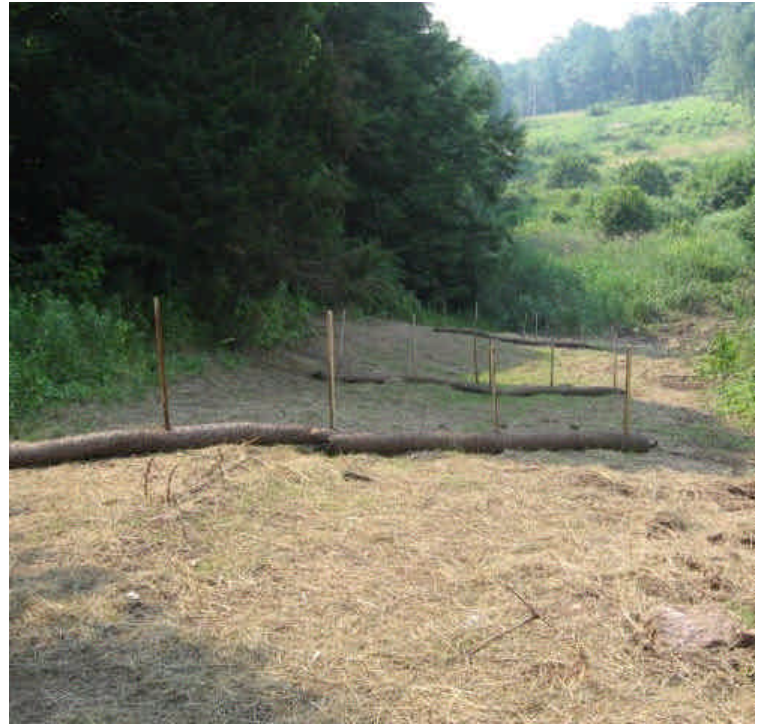
**Mulch and filter socks are in place along recently cleared slopes in the Tuttle Ave area.**

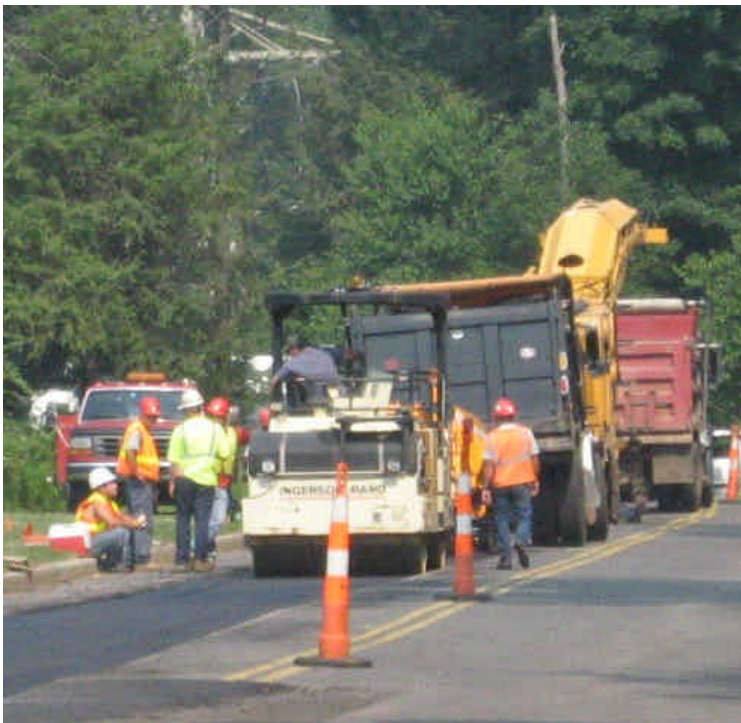
**The roadway and trench patch along Old Farms Rd. was being repaved.**

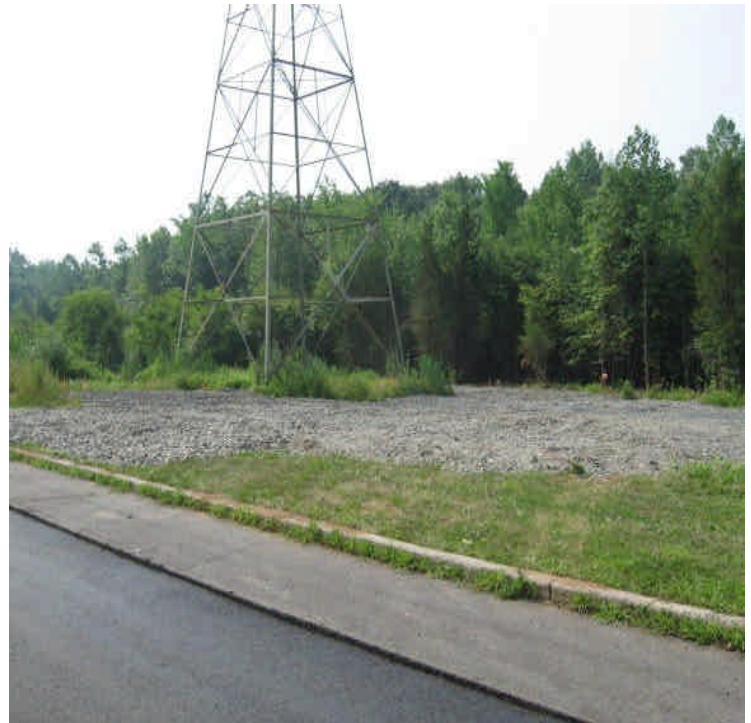
**New pad site was installed off Old Farms Road.**
