Docket No. 272 – Development and Management Plan Inspection

Segment 2a Inspection

Date: July 17, 2007

Location: Segment 2a – Beseck Switching Station to Cheshire/Hamden Town Line

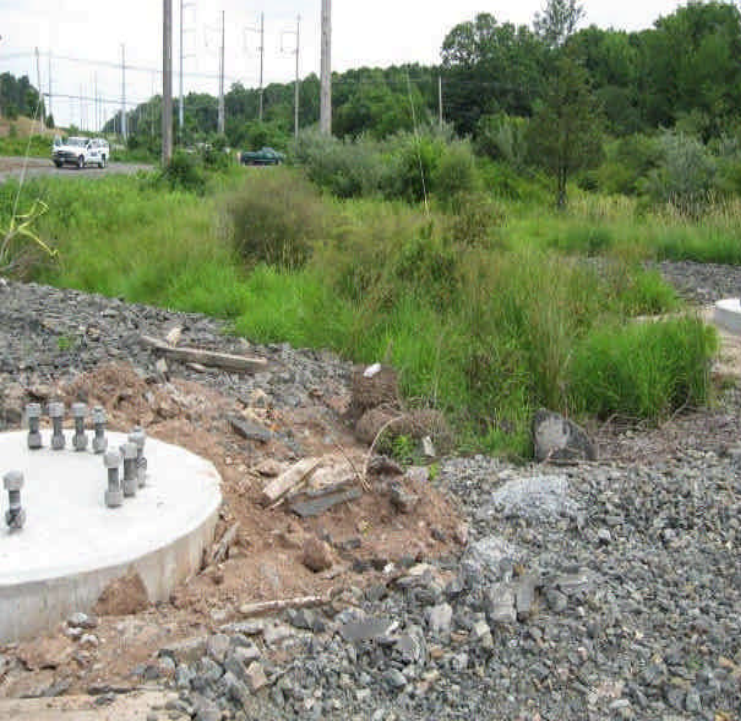
Foundation was placed in a small stream channel off Carpenter Lane. Create a new channel/or provide stream restoration to re-establish the hydrology.

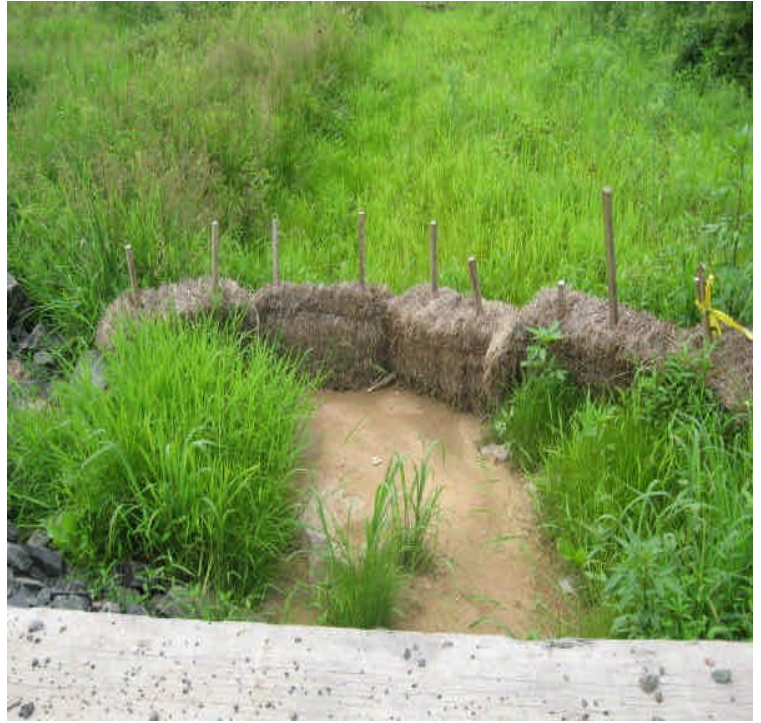
Sediment/turbid run-off was appropriately filtered by a haybale check-dam within wetlands off Carpenter Lane. Remove sediment when feasible to restore capacity.

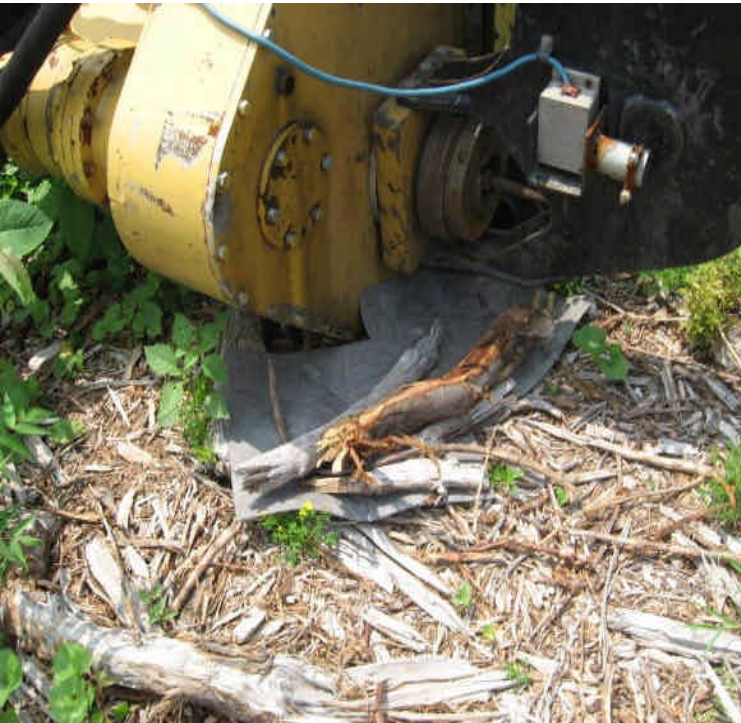
Hydraulic fluid dripping from equipment parked off Carpenter Ln. Some controls were placed but additional attention is needed to clean the affected area.

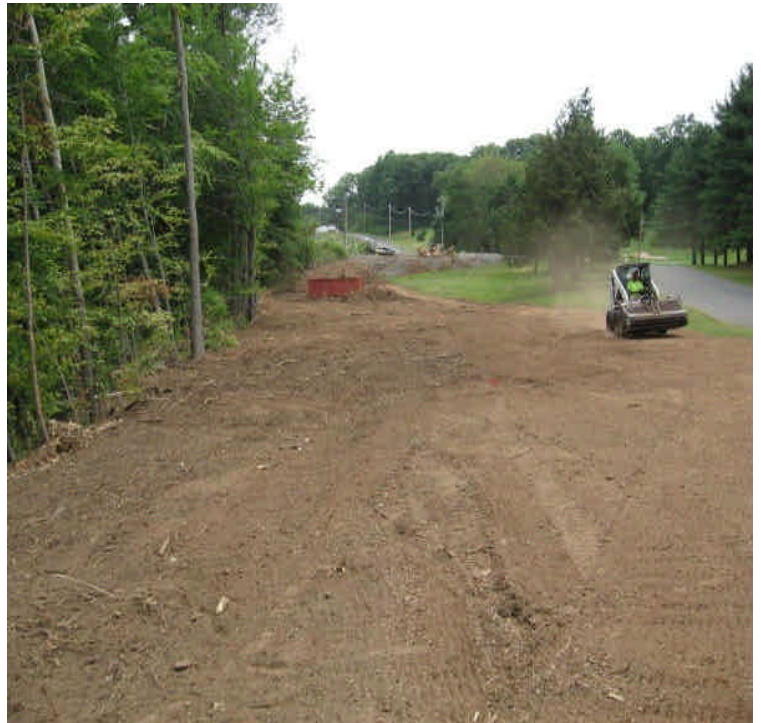
Grading noted off Harrison Rd. as the area is being prepared for hydroseeding.

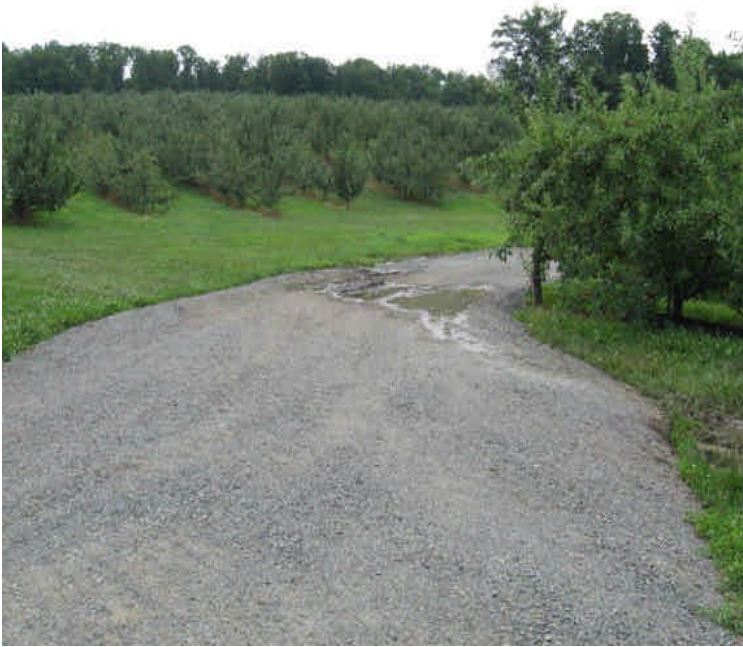
A drainage channel was dug within the apple orchard off Mansion Rd. A culvert appears to be necessary to reduce sedimentation

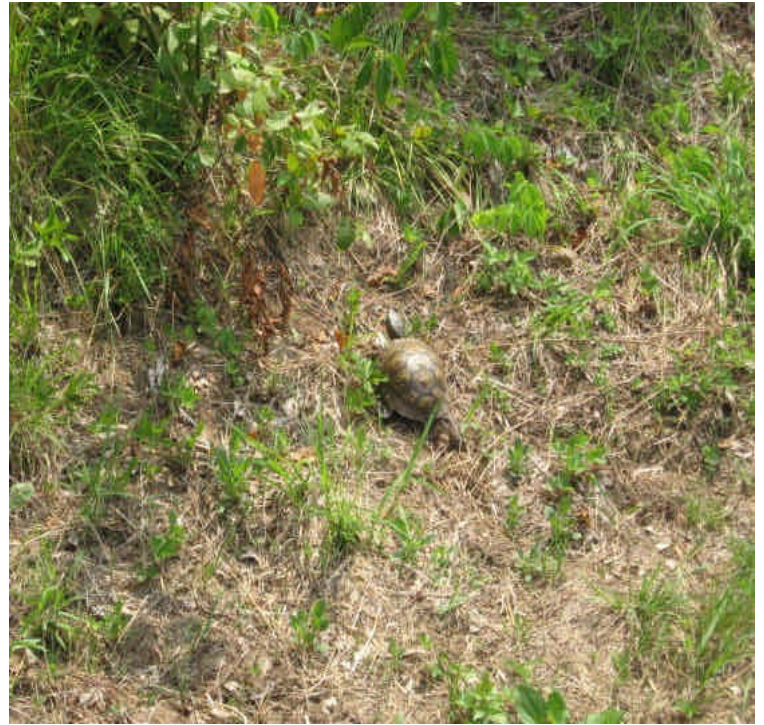
An Eastern box turtle was observed adjacent to wetlands in the Tuttle Ave and Mansion Rd. area. This was not a previously mapped habitat according to NDDB correspondence but should now be treated as such, and regularly swept.

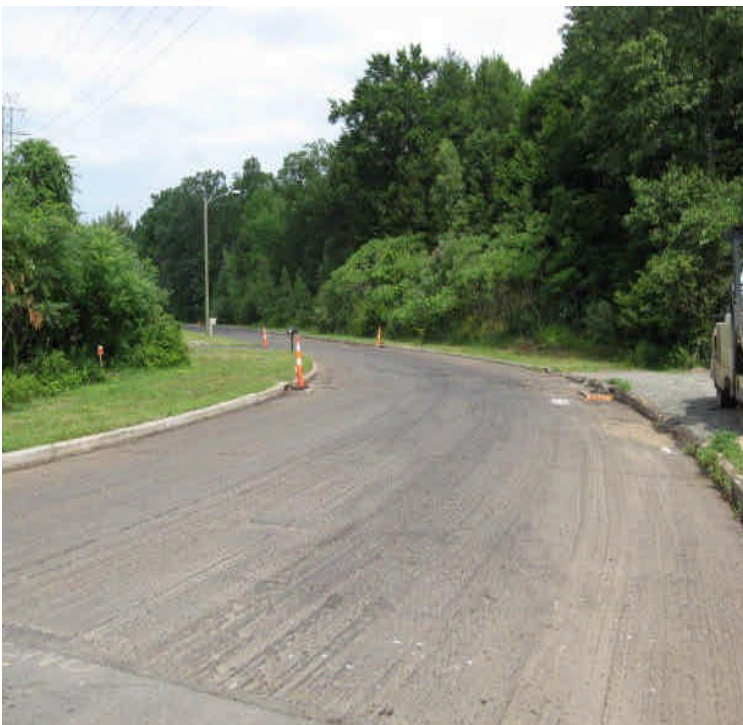
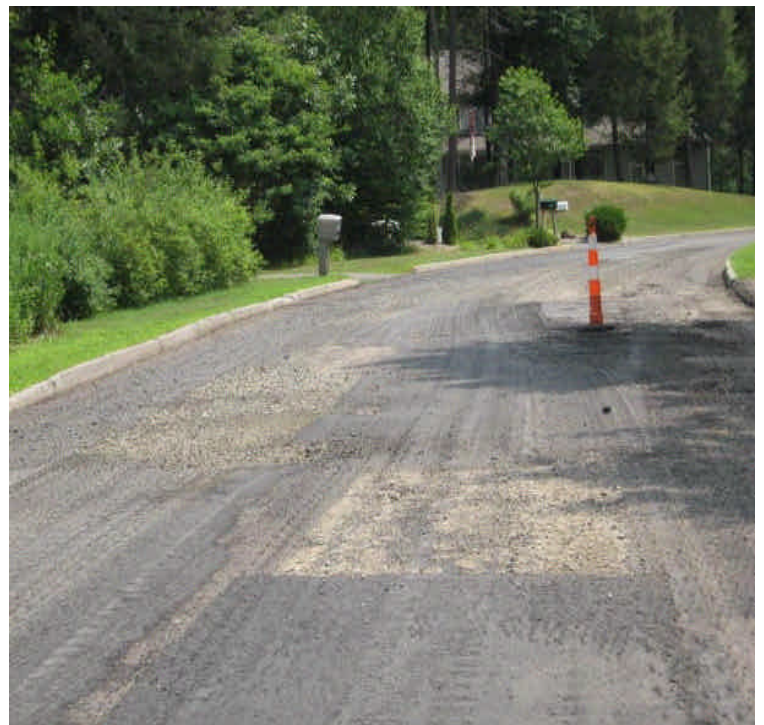
Both photos show the grinding work along Old Farms Rd., in preparation for repaving the roadway and repairing the deteriorating trench patch
