Docket No. 272 – Development and Management Plan Inspection

Segment 3 Underground Line

Date: July 13, 2007

Location: East Devon Substation to the Housatonic River Crossing

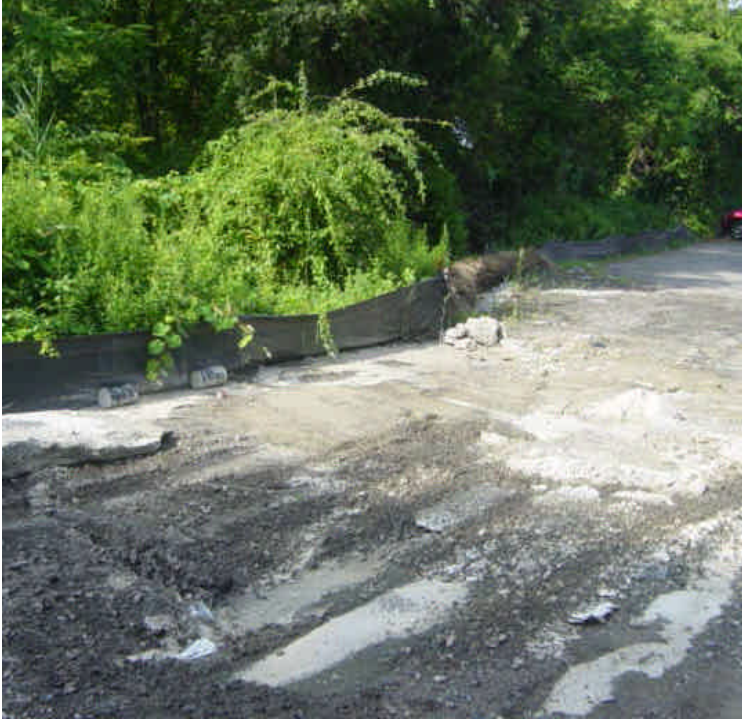
Concrete slurry appears to have been deposited near the backfilled area of vault 1, (potentially by other contractors on a separate project). Concrete washouts should be performed in a contained area. Multiple sections of silt fence are in need of repair between sta. #1015 to #1020.

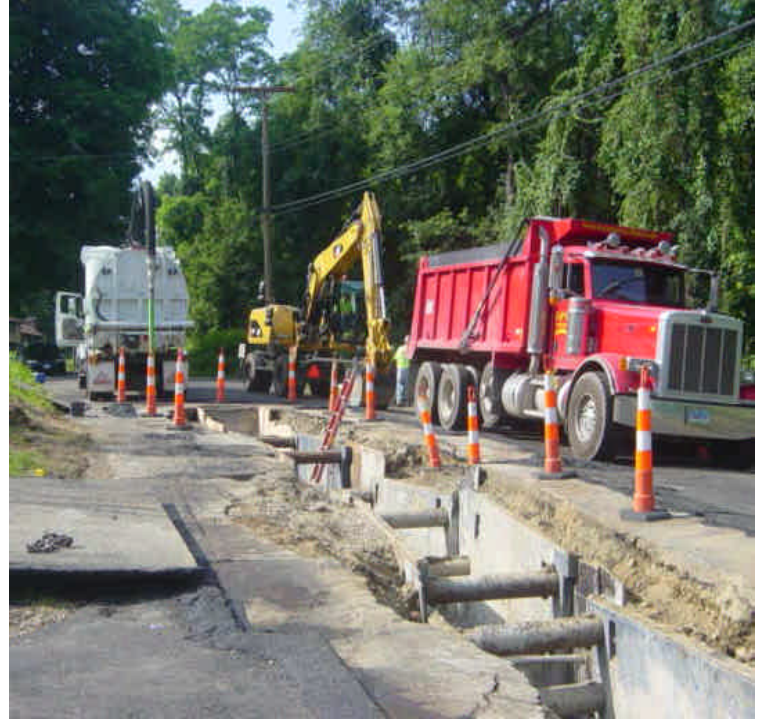
Trench excavation activities continue at sta. #1048. The exposed soil along the slope on the left side of the photo should be contained/stabilized to prevent erosion.

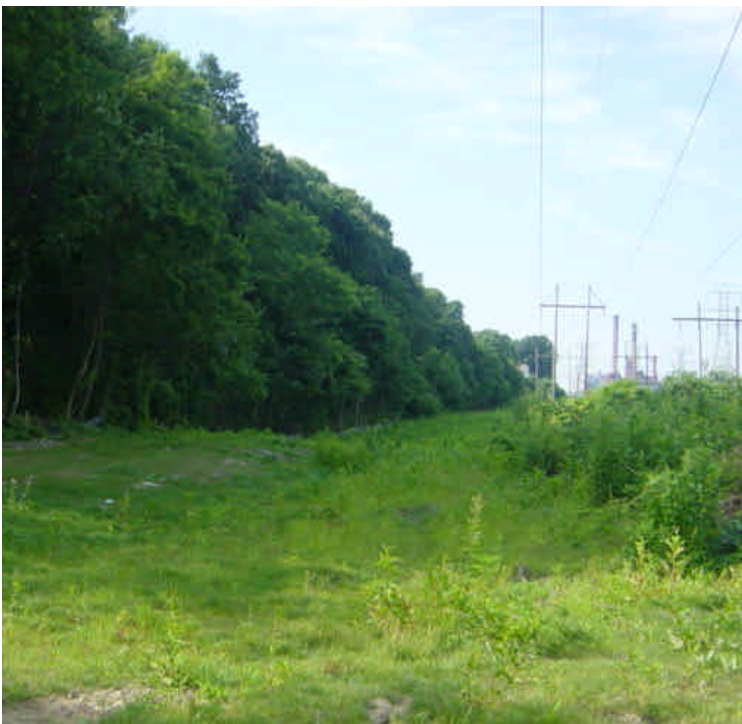
Vegetation growth varies throughout the cross country portion of the project. Photo shows the area near sta. #1073 which is approximately 75% stabilized, and represents one of the most vegetated areas.

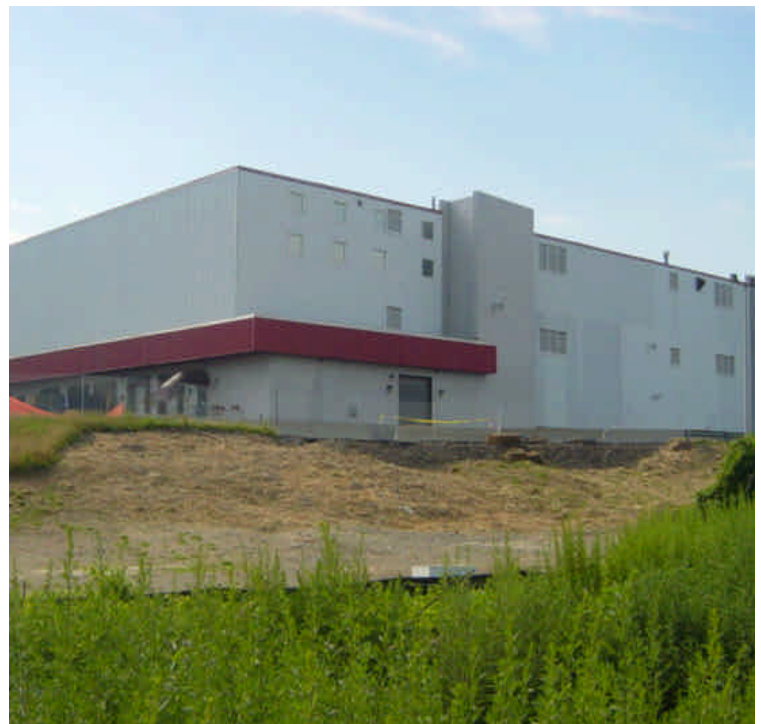
The slope near sta. #1078 has been stabilized with hay mulch.
