Docket No. 272 – Development and Management Plan Inspection

The Connecticut Light and Power Company Certificate of Environmental Compatibility and Public Need for the construction of a new 345-kV electric transmission line and associated facilities between Scovill Rock Switching Station in Middletown and Norwalk Substation in Norwalk, Connecticut, including reconstruction of portions of existing 115-kV and 345-kV electric transmission line, the construction of Beseck Switching Station in Wallingford, East Devon Substation in Milford, (and Singer Substation in Bridgeport), modifications at Scovill Rock Switching Station and Norwalk Substation, and the reconfiguration of certain interconnections.

Segment 4b Underground Line

Date: July 5, 2007

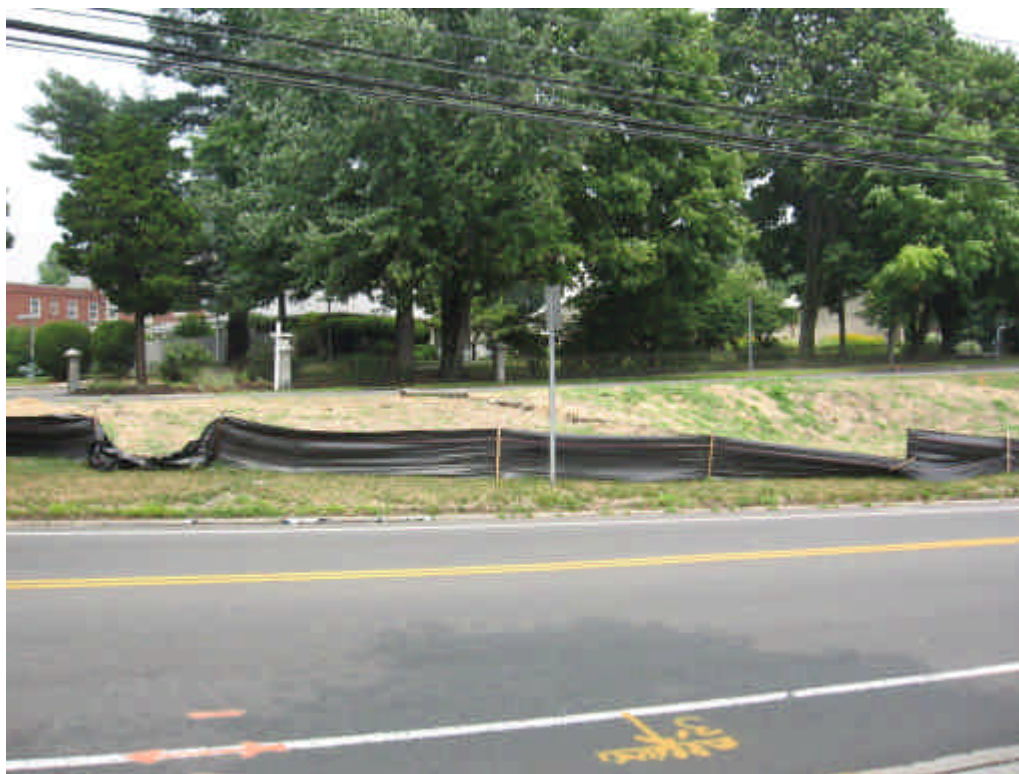
Photo of erosion controls at vault #5, a section of silt fence remains in need of repair. No evidence of additional erosion at the site and some vegetative cover was starting to establish.

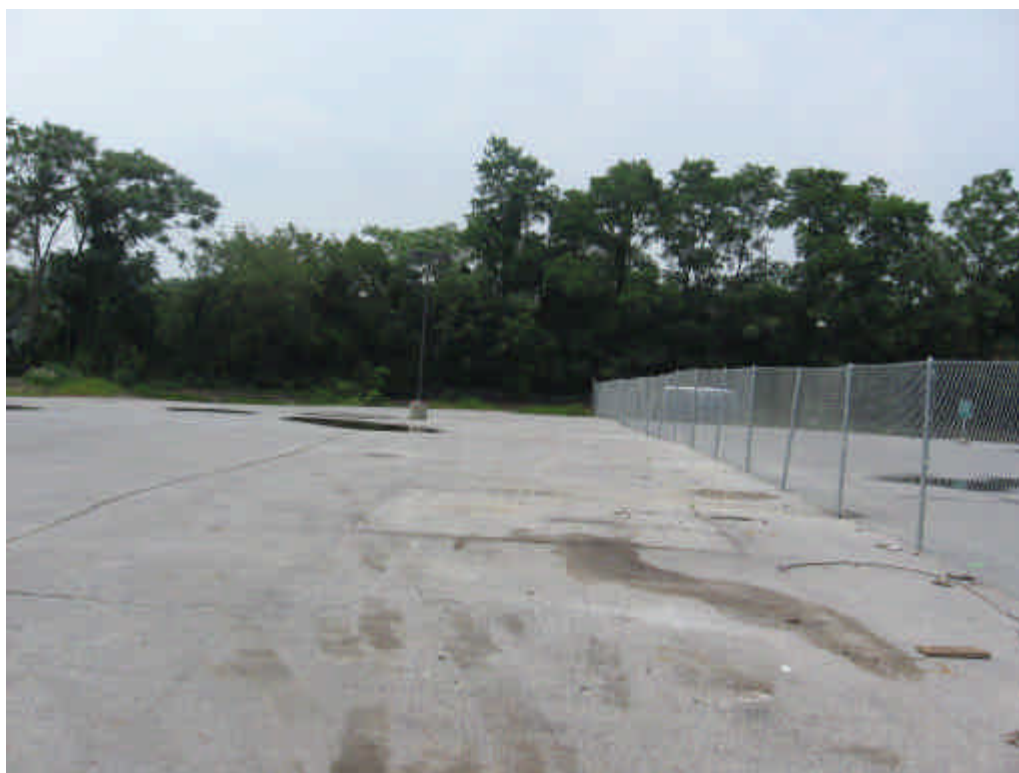
All materials have been removed from the Imperial Ave. lay-down yard in preparation for future staging/bore activities in this location.
