**Docket No. 272 – Development and Management Plan Inspection**

**Segment 1a Inspection**

**Date:** June 4, 2007

**Location:** Segment 1a – Scovill Rock Switching Station to Chestnut Junction, Oxbow Junction to Beseck Switching Station (excluding Royal Oak Bypass), and Black Pond Junction to Beseck Switching Station

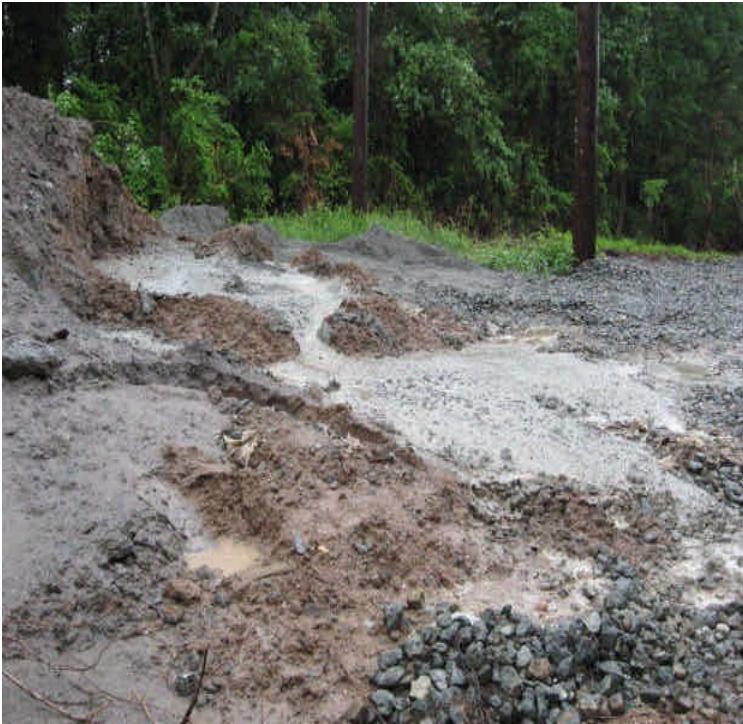
Areas of Inspection	Observation	Recommended Action	Corrected Action
<p><b>Black Pond Junction to Beseck SS</b></p>	<p>A concrete containment area located off Haddam Quarter Road, west of Oxbow, was filled past capacity or breached. Concrete material remains within the controls but adjacent to a wetland. 6/4/07</p>	<p>Remove concrete material and ensure all containment areas have adequate capacity to store washout and test concrete. Locate containment areas away from wetlands when possible. 5/29-6/4/07</p>	<p><b>Needs attention.</b></p>
	<p>Leaking equipment was stored in the vicinity of the wetland (noted 5/29). This week, the equipment was moved closer to the wetland. Repairs were attempted but it is still dripping and controls have been removed. A slight sheen of oil was noted flowing into the wetlands during the heavy rains. 6/4/07</p>	<p>Relocate the broken equipment away from wetlands and buffer zones. (Attempt to store any equipment over 100 ft away). Monitor and contain all leaks as soon as possible. Add controls and clean affected areas. 6/4/07</p>	<p><b>Needs immediate attention.</b></p> <p><i>Contractor stated equipment was relocated on 6/5/07</i></p>

**Concrete containment area overflowing onto a pad site upgradient of a wetland off Haddam Quarter Road. Provide adequate capacity and remove concrete material.**

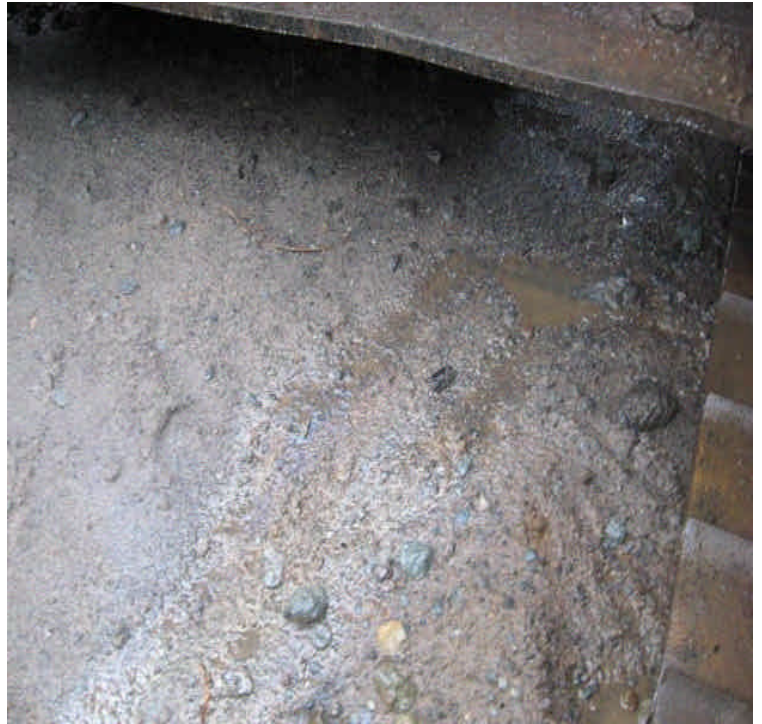
**Fluid dripping from a drill rig located off Haddam Quarter Road. Provide maintenance and containment.**

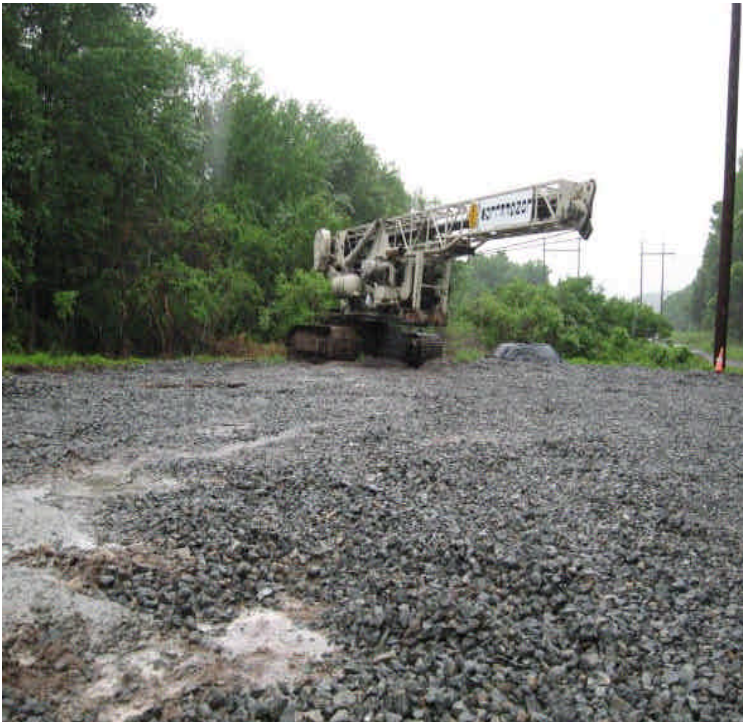
**Broken equipment was relocated closer to the adjacent wetlands. It should be removed as soon as possible; more controls are needed.**

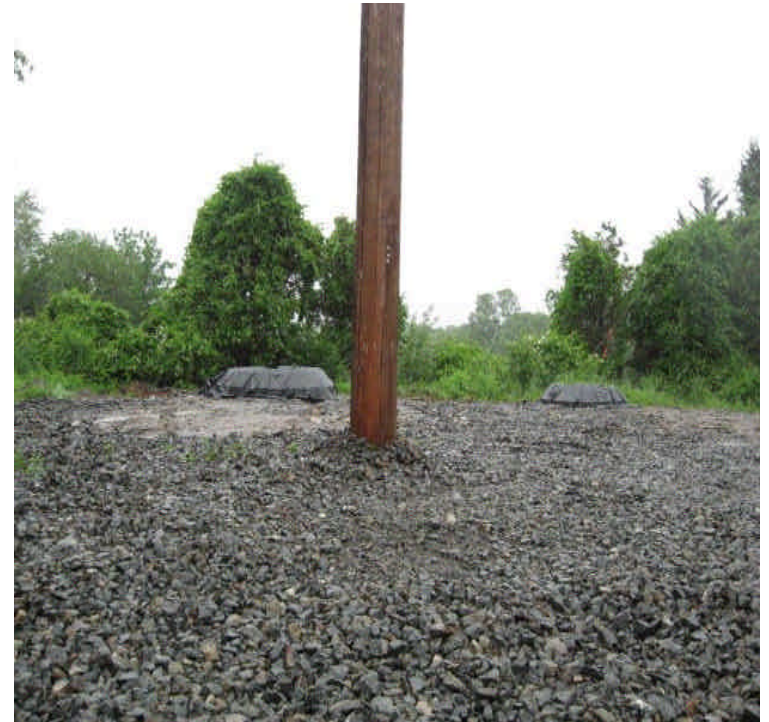
**View of new foundations in place at Oxbow Junction.**

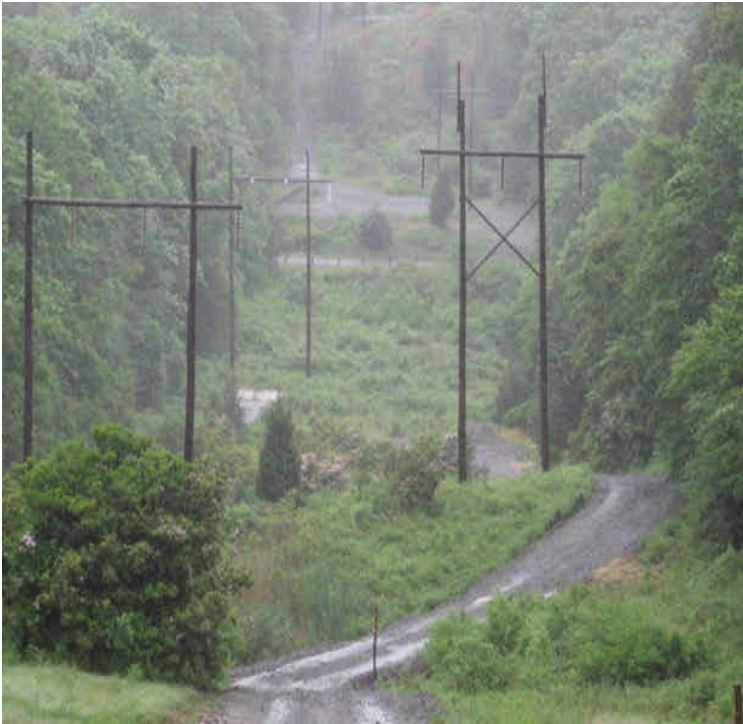
**View of the ROW looking toward Foot Hills Rd and Johnson Ln.**

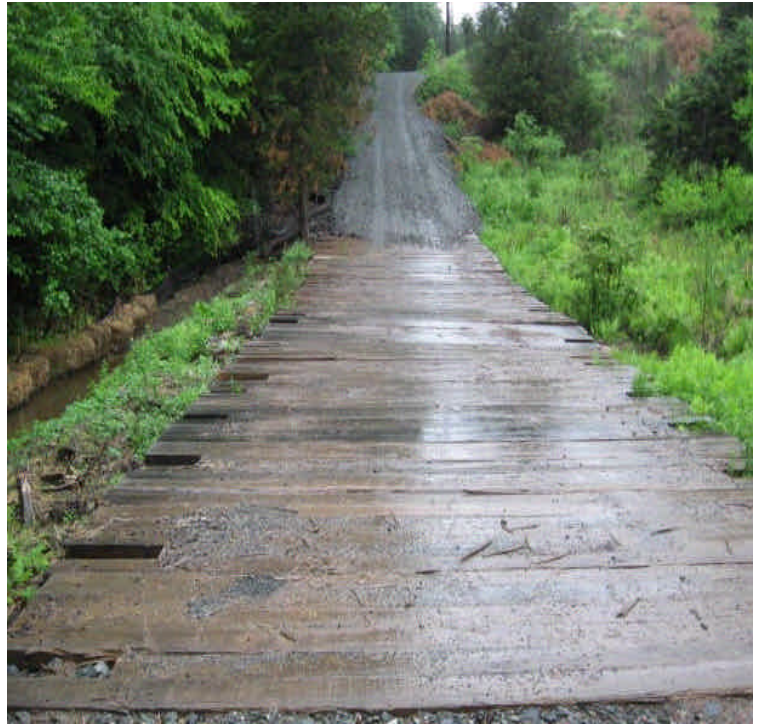
**Timber mat crossing off Johnson Ln. Monitor turbidity carefully here as the adjacent area provides amphibian breeding habitat.**

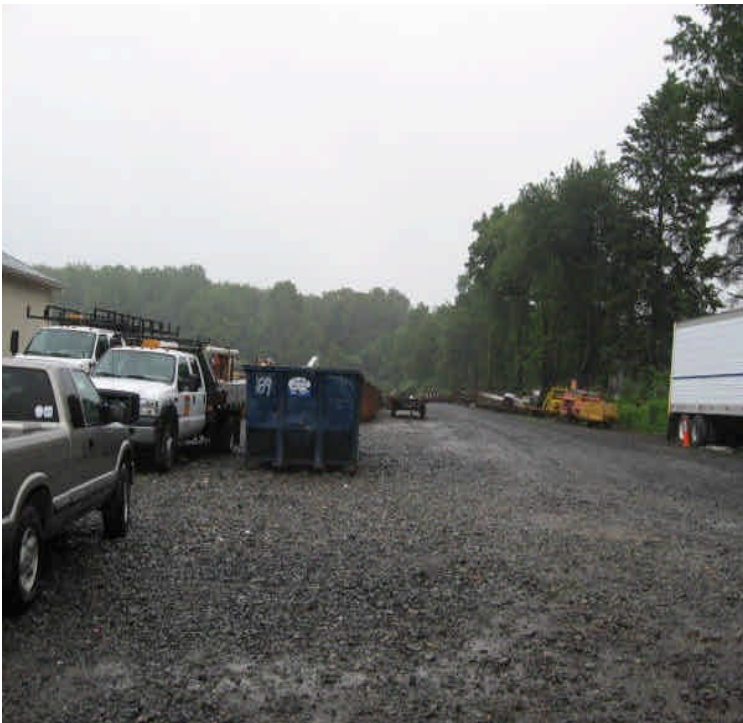
**Fuel containers are no longer located at the contractor receiving yard.**

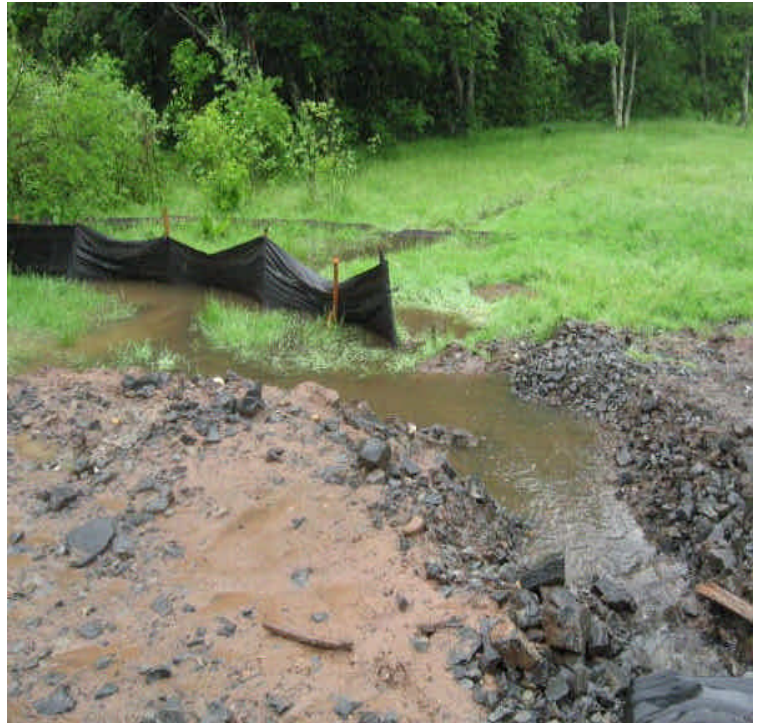
<p>Little Lane</p>	<p>Access includes timber mats and a (temporary) culvert to cross a section of wetlands and small stream. Volumes of water were flowing through the silt fence controls and off site. Most turbidity was filtered. 6/4/07</p>	<p>Monitor and adjust controls, as needed. Culverts are temporary and are will be restored at the completion of work Controls may need to be reinforced for larger storm events. 6/4/07</p>	<p>Needs to be monitored</p>
	<p>A new access road was installed off Little Ln. near a neighbor's driveway. A culvert is located near the new access. 6/4/07</p>	<p>Controls may be needed to prevent sediment from entering the culvert. Stabilize area when applicable. 6/4/07</p>	<p>Needs evaluation</p>
<p>Cherry Hill Rd.</p>	<p>A small steep access road is in place off the transfer station access road east of Cherry Hill Rd. Timber mats are in place to the west. 6/4/07</p>	<p>Some steeper slopes were noted here, continue to watch for run-off and add controls as needed. 6/4/07</p>	<p>NA</p>

**Run-off at the Little Lane wetland crossing. Silt fence check dams were filtering most before it left site.**

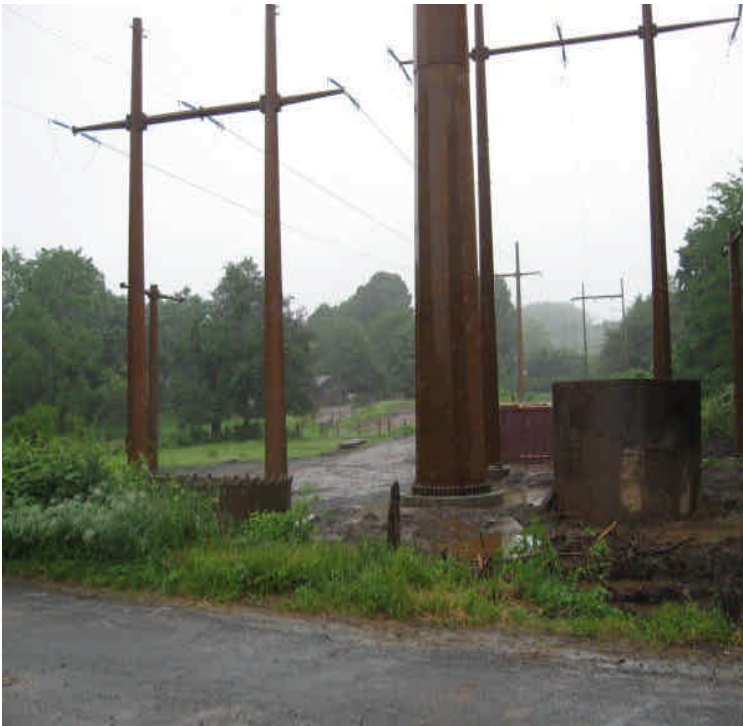
**View of structures installed off Little Lane.**

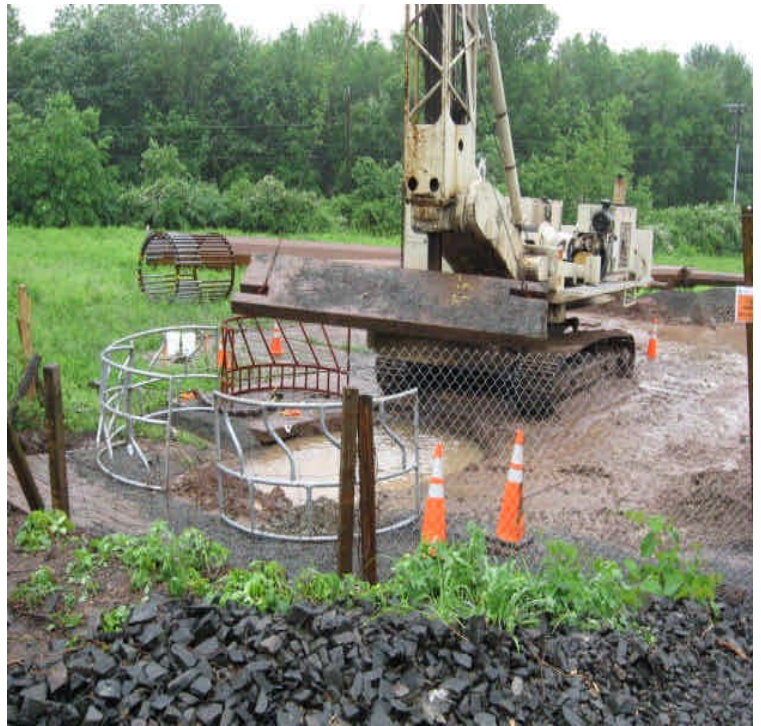
**View of a foundation drilled off Cherry Hill Road (west).**

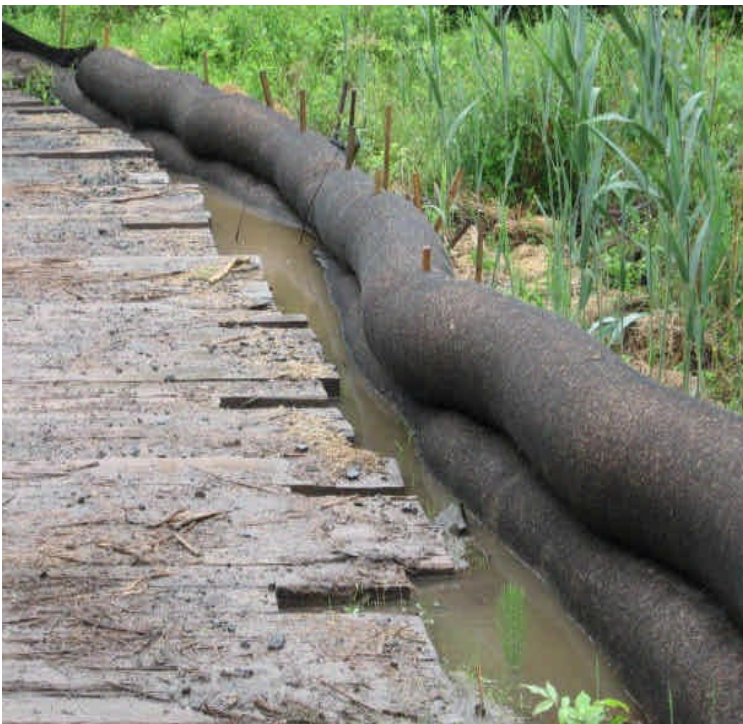
**View of well installed haybales and fiber rolls at the timber mat crossing off Powder Hill Rd. Sediment is filtered from the run-off before it flows off-site in this area. Some turbid water is retained here.**

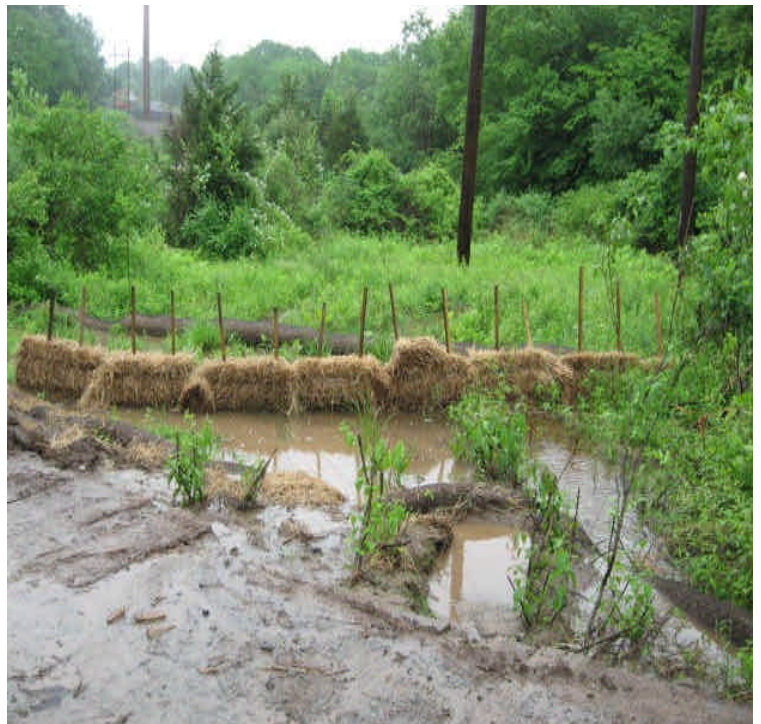
**Fiber rolls and haybales west of Powder Hill Rd are filtering turbid water before it enters the pond. Remove any accumulated sediment from wetlands when water recedes and when sediment is deeper than 2".**

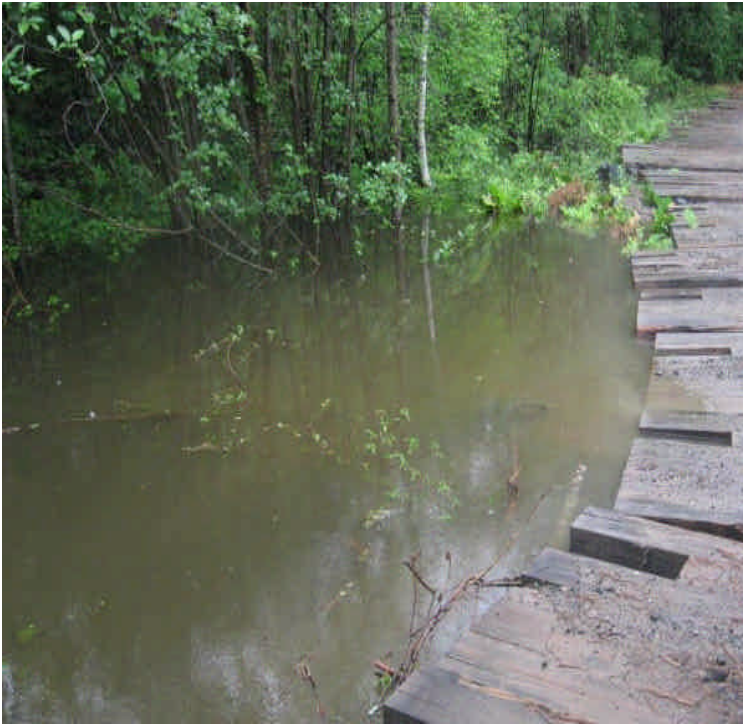
**Wetland crossing west of Powder Hill Rd.**

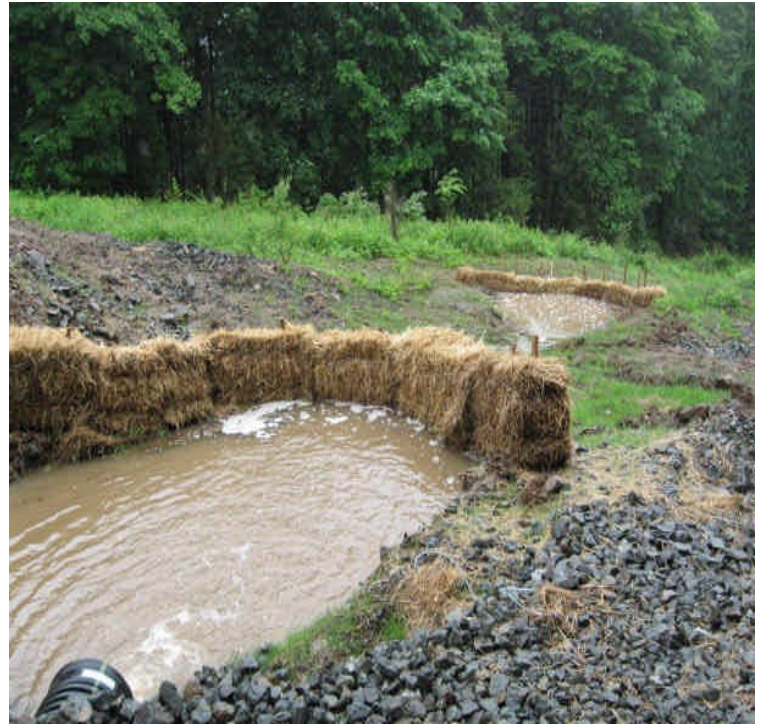
**Controls/check dams along the slope of Beseck Mt. Good efforts to control run-off were noted but stormwater volumes were high during the heavy rain.**

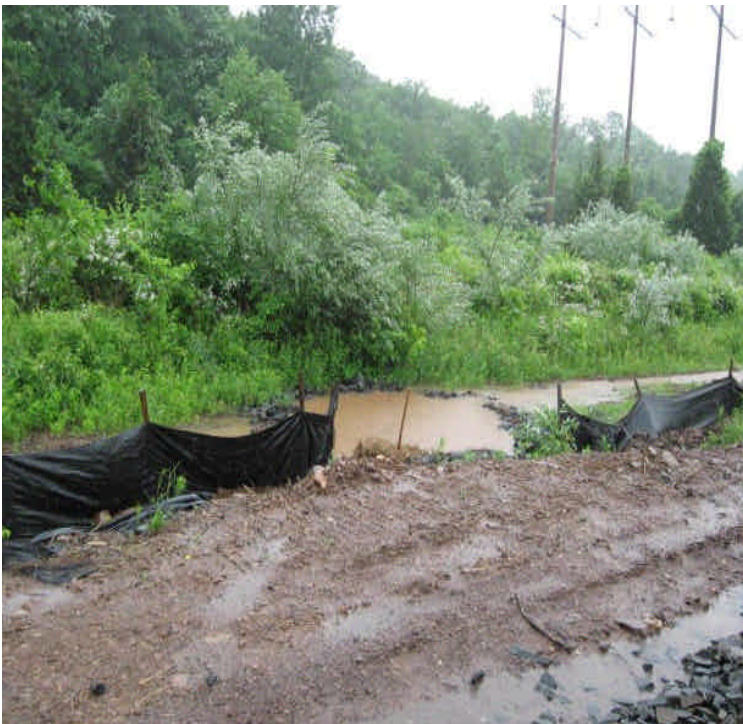
**Turbid water was overflowing the sediment trap east of Beseck SS and flowing directly into the wetlands here during a heavy rain event. Work with Beseck contractors to provide adequate capacity during larger storms.**

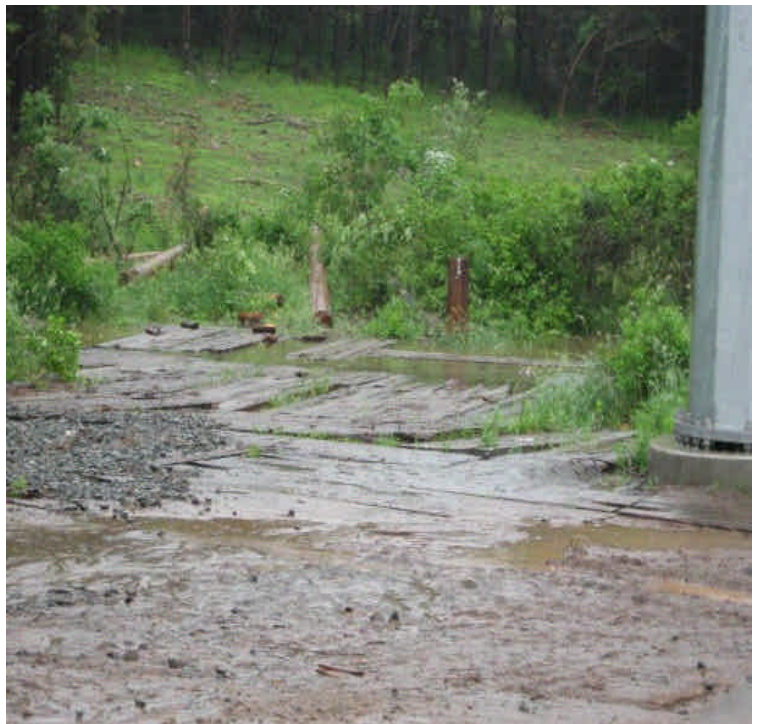
**Timber mat crossing remaining east of Beseck SS had turbid run-off. Controls need to be reinforced/extended.**

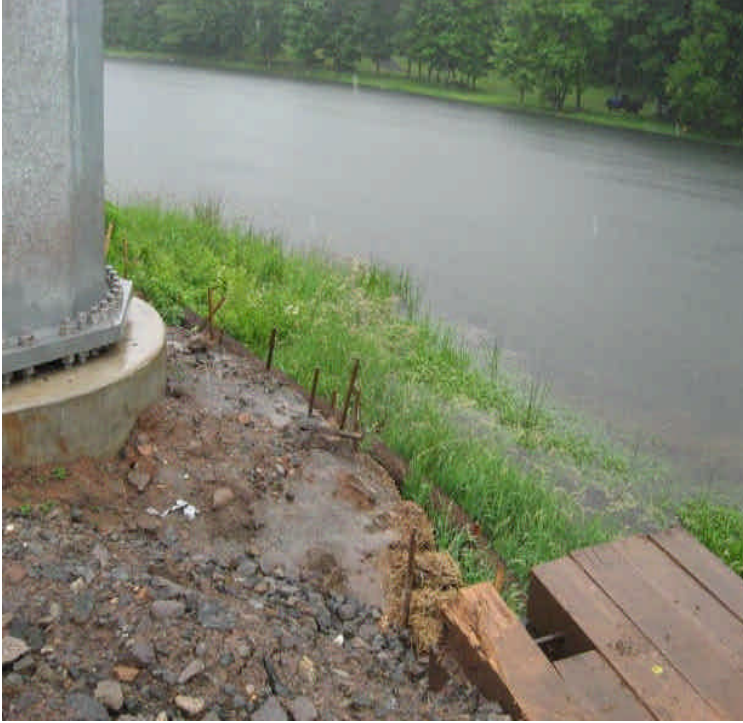
**View along the pond north of Beseck SS to E Meriden SS off Fleming Rd where pole installation is complete where sediment has filled controls to capacity immediately adjacent to the pond. A filter sock has been added as another layer of control but sediment should still be removed.**

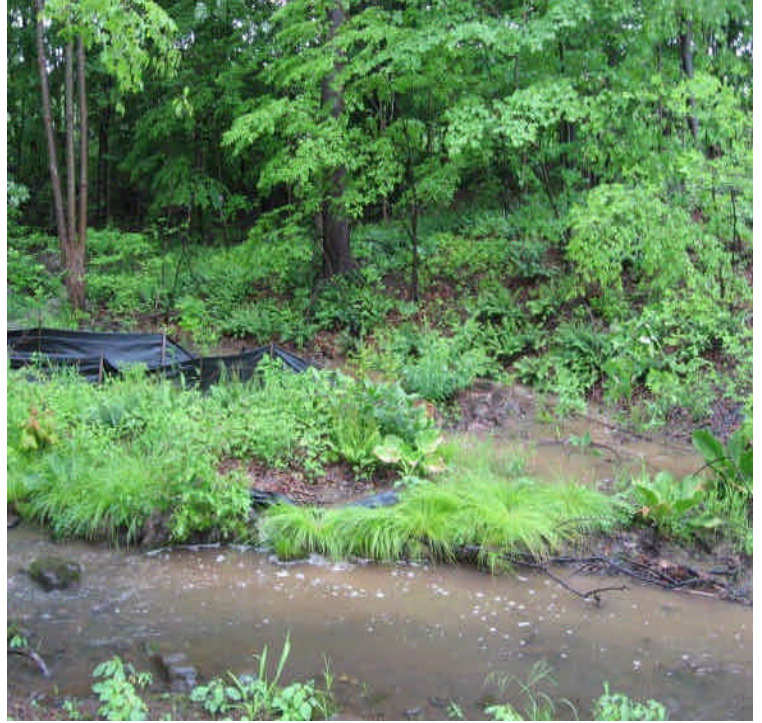
**Turbid water entering stream from off site ball fields, south of High Hill Road. Repair/extend project controls as feasible.**

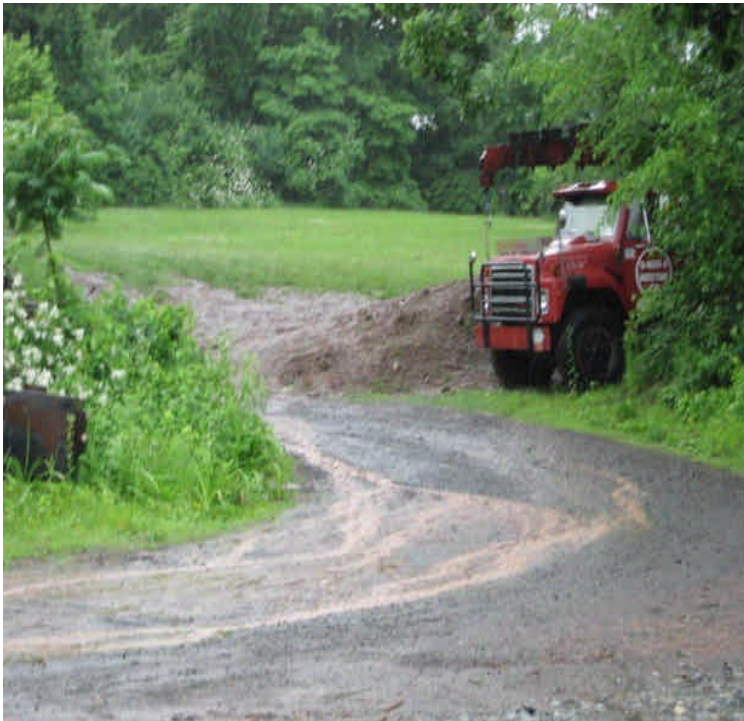
**Turbid water flowing from neighbor's driveway/activities and down the access road north of East Main Street.**

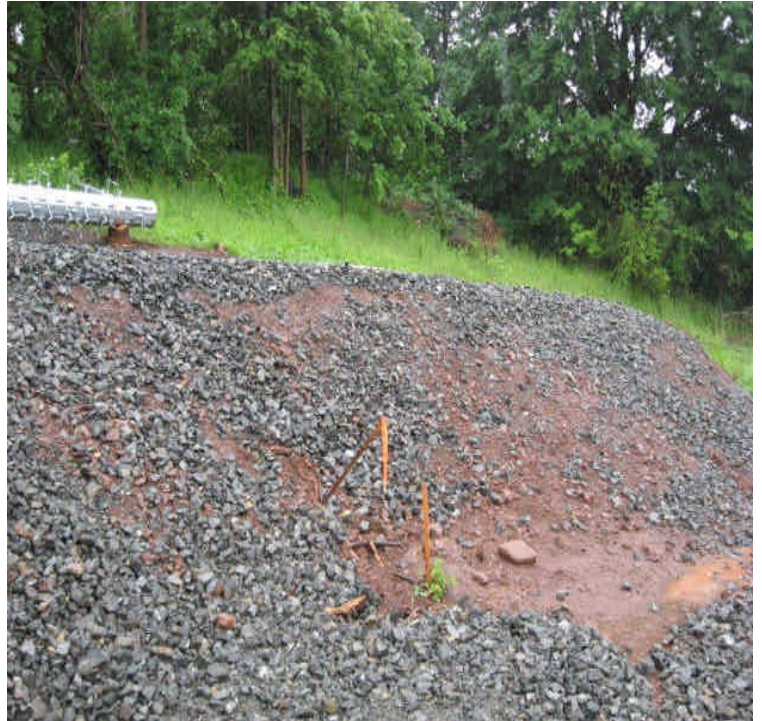
**View of the pads installed north of East Main Street. Structures were delivered for installation.**
