Docket No. 272 – Development and Management Plan Inspection

Segment 1a Inspection

Date: June 11, 2007

Location: Segment 1a – Scovill Rock Switching Station to Chestnut Junction, Oxbow Junction to Beseck Switching Station (excluding Royal Oak Bypass), and Black Pond Junction to Beseck Switching Station

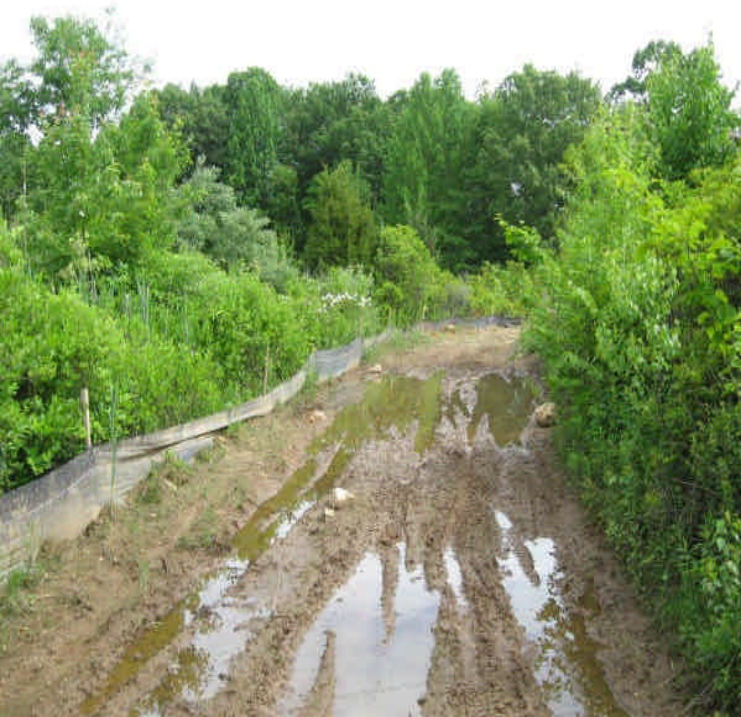
ROW access road south of Scovill SS with ponding water. Controls are in place. ATV use is prevalent here.

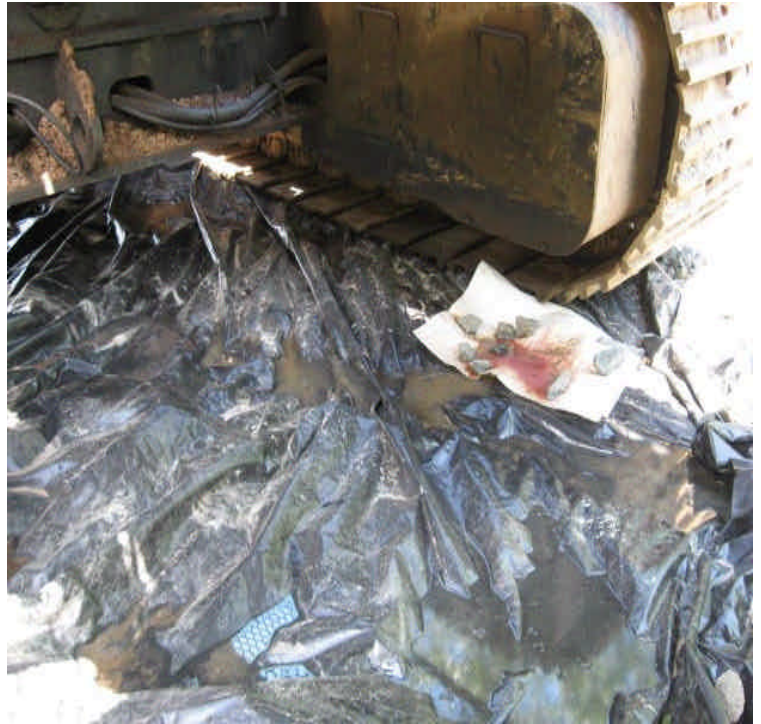
Fluid was still leaking from a drill rig off Haddam Quarter Road but increased controls have been placed here to contain the drips.

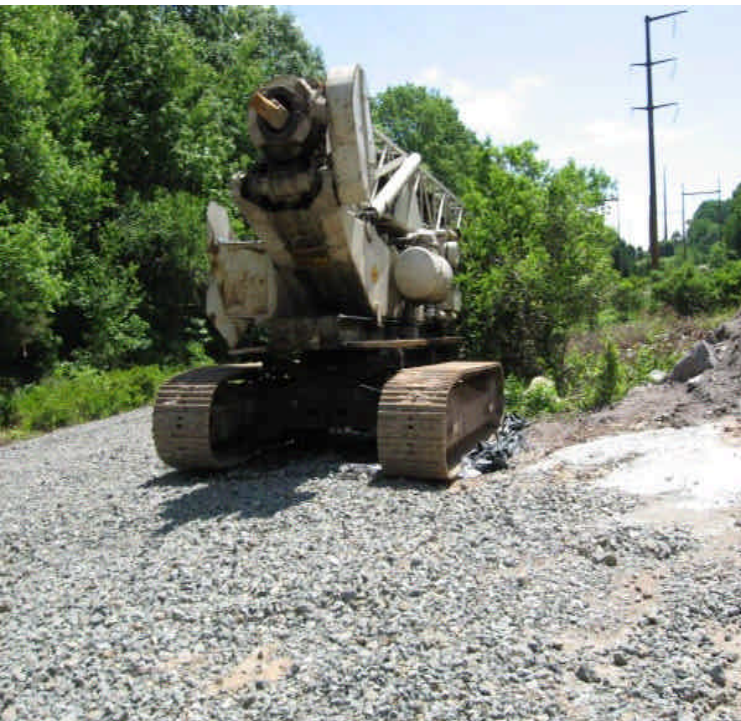
Broken equipment was relocated closer to the adjacent wetlands. It should be repaired as soon as possible. Ensure controls fully contain the leak.

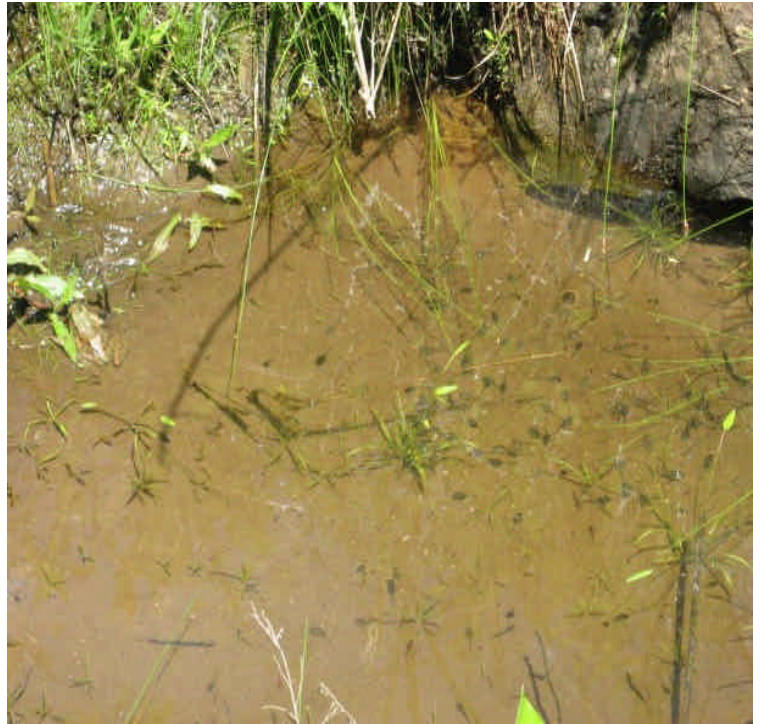
Ponded water adjacent to the timber mat crossing off Johnson Ln. Continue to prevent turbidity and sedimentation here to the extent possible as it provides good amphibian breeding habitat.

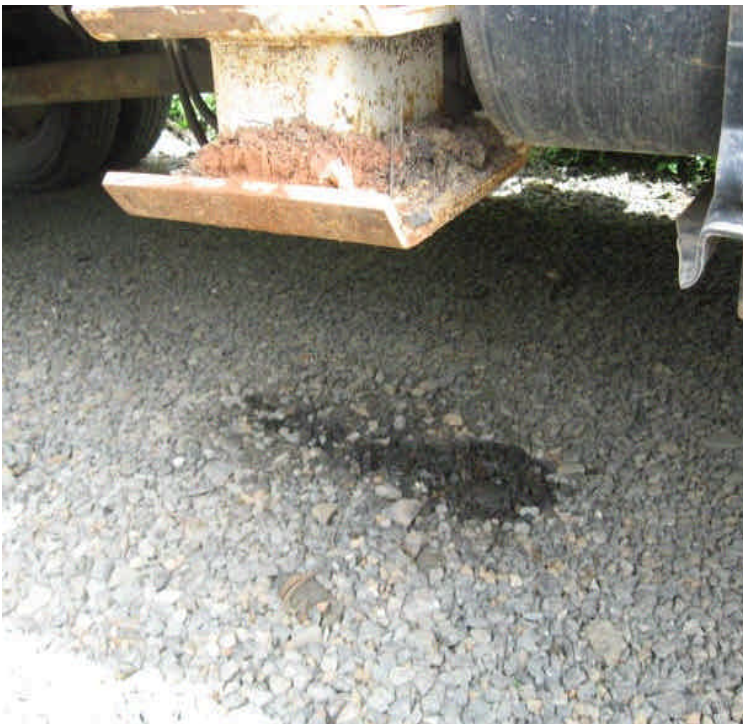
A leaking truck stored within the contractor receiving yard. Several drip spots were noted.

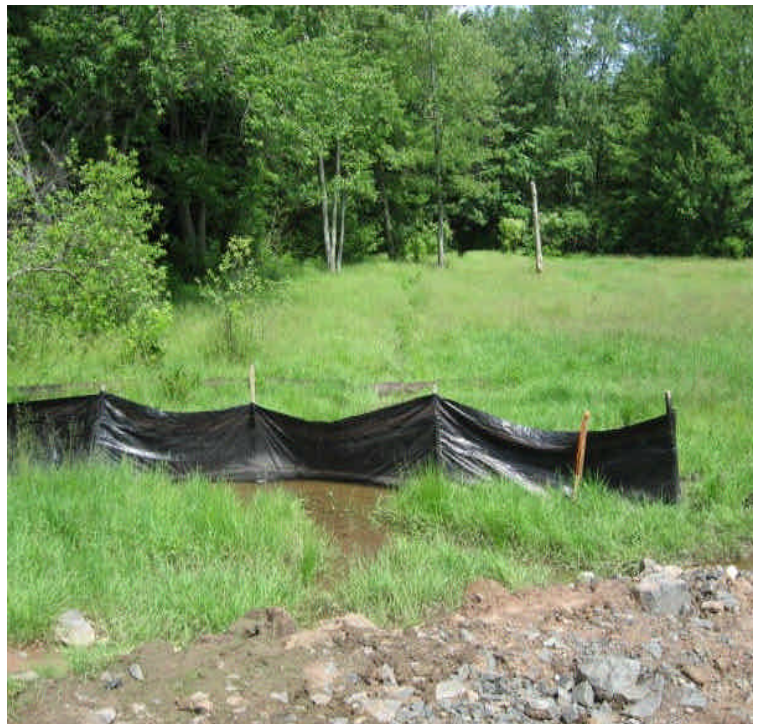
Run-off at the Little Lane wetland crossing. Silt fence check dams were filtering most before it left site.

<p>Little Lane</p>	<p>Access includes timber mats and a (temporary) culvert to cross a section of wetlands and small stream. Some run-off was flowing through the silt fence controls and off site. Most turbidity was filtered. 6/11/07</p>	<p>Monitor and adjust controls, as needed. Culverts are temporary and are will be restored at the completion of work Controls may need to be reinforced for larger storm events. 6/11/07</p>	<p>Needs to be monitored.</p>
<p>Cherry Hill Rd. (east)</p>	<p>A new access road was in place off Little Ln. near a neighbor’s driveway. A culvert is located near the new access. 6/11/07</p>	<p>Controls may be needed to prevent sediment from entering the culvert. Stabilize area when applicable. 6/11/07</p>	<p>Needs evaluation</p>
<p>Cherry Hill Rd. (east)</p>	<p>A small steep access road is in place off the transfer station access road east of Cherry Hill Rd. Some sediment was noted on the roadway here. Timber mats are in place to the west. 6/11/07</p>	<p>Some steeper slopes were noted here, continue to watch for run-off and add controls as needed. Sweep sediment from roadway as needed. 6/11/07</p>	<p>Needs regular attention.</p>

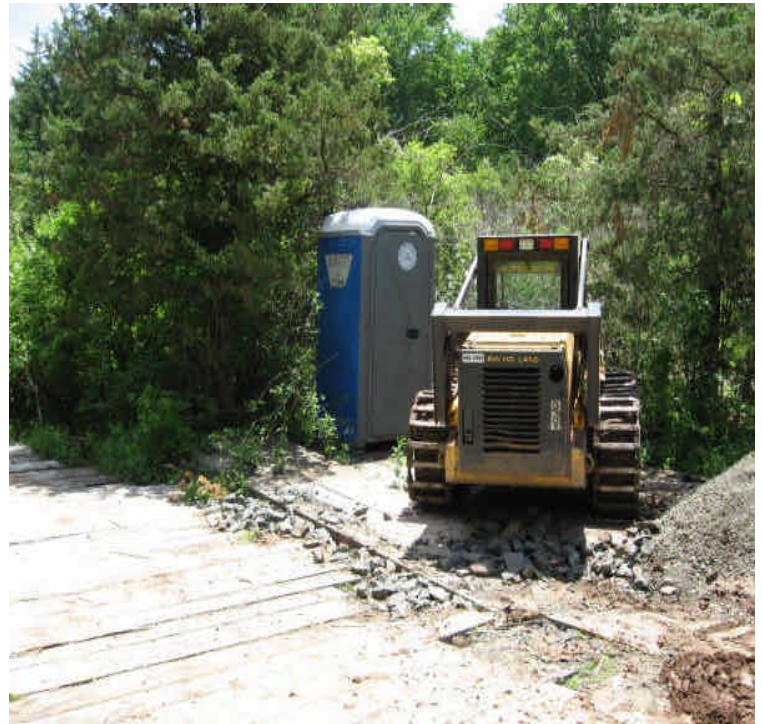
Portable sanitary facility located immediately adjacent to the wetlands off Durham Road. It should be relocated to an appropriate location in case of a spill.

Areas of Inspection	Observation	Recommended Action	Corrected Action
Durham Rd. Black Pond Junction to Beseck SS	Concrete material remains within the controls but adjacent to a wetland. 6/4-6/11/07	concrete. Locate containment areas away from wetlands when possible. 5/29-6/11/07	Additional controls were added but still needs attention. Needs attention. NA at this time
	Leaking equipment was still stored in the vicinity of the wetland (noted 5/29) but had been moved further since last week. A large plastic tarp with a spill pad was also in place directly under the leak. However, any drips that miss the pad are being washed by rain onto the ground. 6/11/07	Relocate the broken equipment away from wetlands and buffer zones or repair. (Attempt to store any equipment over 100 ft away). Monitor and contain all leaks as soon as possible. Add controls and clean affected areas. 6/11/07	
	A portable sanitary facility has been located at the edge of the wetlands. 6/11/07	Remove sanitary facility from wetland edge and attempt to keep 100 ft away in case of a tip or spill. 6/11/07

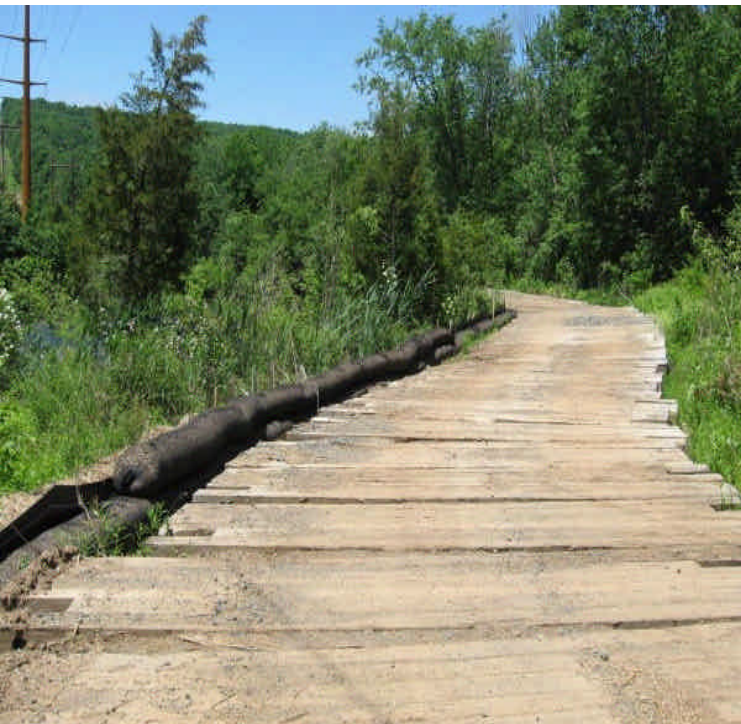
View of well installed haybales and fiber rolls at the timber mat crossing off Powder Hill Rd. Sediment is filtered from the run-off before it flows off-site in this area. Some turbid water is retained here.

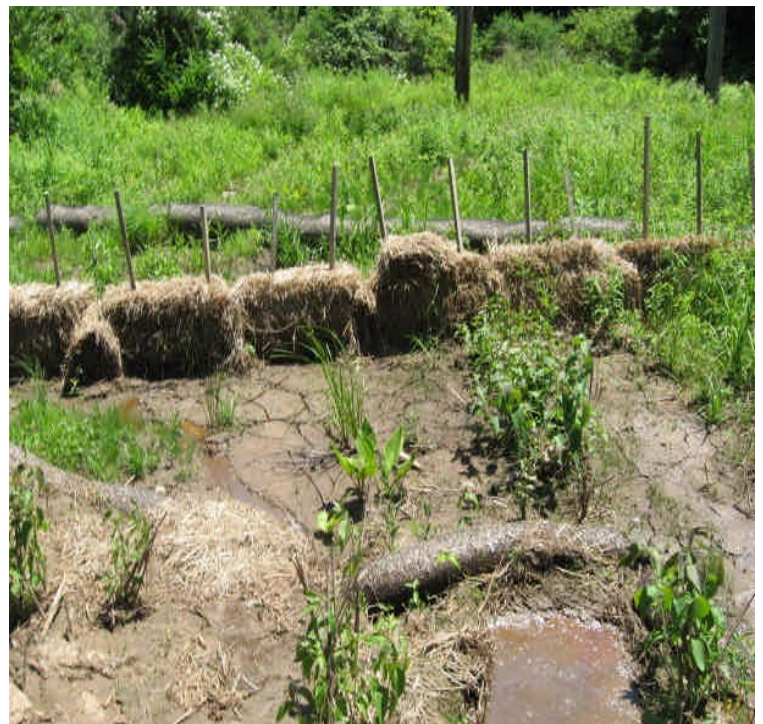
Sediment accumulation from previous heavy rains could be seen in wetlands west of Powder Hill Rd. now that standing water receded. Where accumulated sediment is more than 2" deep, it should be carefully removed from wetlands by hand.

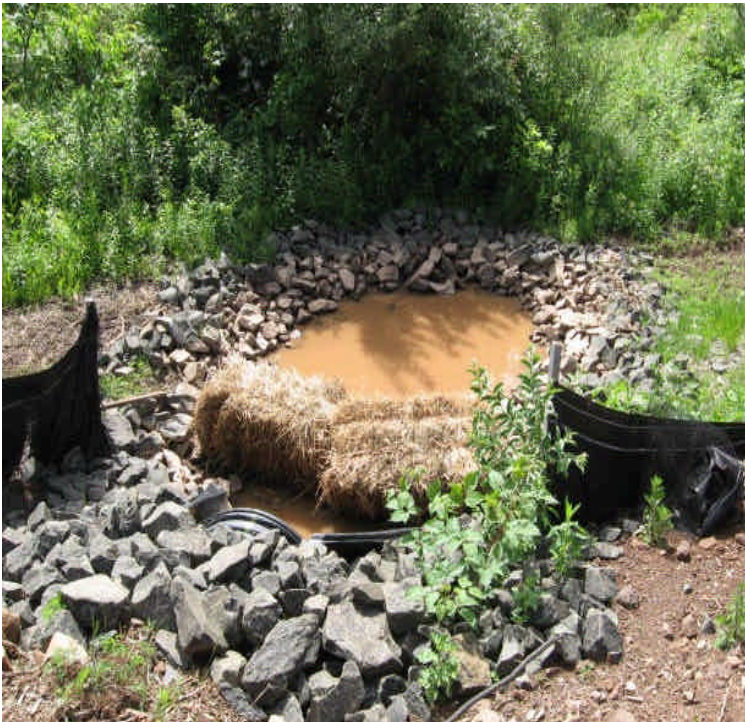
Sediment trap east of Beseck SS. Turbid water was contained within the basin but capacity is not adequate for larger storm events.

<p>The riprap sediment trap east of Beseck SS was filled with turbid water from the station yard from the recent heavy rain. 6/11/07</p>	<p>Refer to Beseck D&M plan for more information and work with Beseck contractors to improve controls for larger storm events if feasible. 6/11/07</p>	<p>NA (Not jurisdictional to this D&M)</p>
	<p>Timber mats were in place through the wetlands for pulling wire. No controls were noted. (since 6/4) Turbid run-off is an issue during heavy rain. 6/11/07</p>	<p>Add controls at crossing and monitor pond/ wetlands for turbid run-off. 6/11/07</p>	<p>Needs attention.</p>
<p>Black Pond Junction to Beseck SS ROW, North of Beseck SS to East Meriden Substation</p>	<p>Small section of silt fence was undermined and turbid water flowing off site. 6/4-6/11/07</p>	<p>Repair/reinforce silt fence as needed along wetlands 6/4-6/11/07</p>	<p>Needs attention.</p>
	<p>Several areas of exposed soil were noted along this</p>	<p>Stabilize exposed areas as soon as possible to</p>	<p>Needs attention.</p>

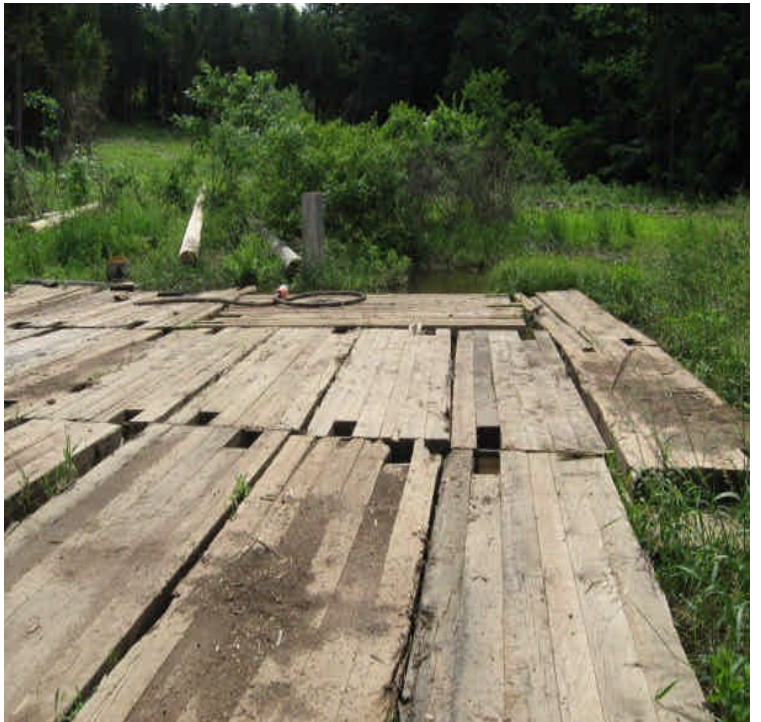
Timber mat crossing located east of Beseck SS. Controls need to be reinforced/extended.

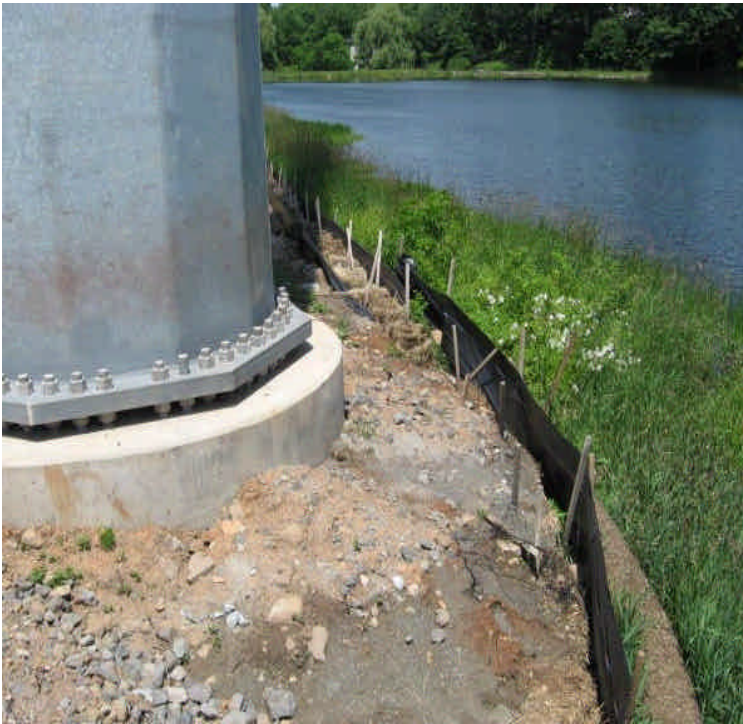
Areas of Inspection	Observation	Recommended Action	Corrected Action
Fleming Road	<p>section of ROW. 6/4-6/11/07</p> <p>Sediment accumulation is at the capacity of the controls immediately adjacent to the edge of the pond. (noted 4/30) A new filter sock was added as an additional line of control. (Noted 5/29) However, sediment still breached the controls on 6/4. A new line of silt fence was installed. 6/11/07</p>	<p>control erosion. 6/4-6/11/07</p> <p>Although the filter sock and new silt fence is in place, continue to stabilize this area. 6/11/07</p>	<p>New silt fence installed. Continue to stabilize.</p>
South of High Hill Rd. (vicinity of East Meriden Substation)	<p>The redirected stream splits, flowing partially through a culvert and partially through the center of the timber pad site. The banks and adjacent, exposed soil remain stabilized with erosion control mats. 6/11/07</p>	<p>Ensure the controls are adequate for run-off in this area. Stabilize soils as soon as possible. Controls or regular cleaning will be needed on the timber mats as well to prevent sediment from seeping through. 6/11/07</p>	<p>NA</p>

View along the pond north of Beseck SS to E Meriden SS off Fleming Rd where pole installation is complete where sediment has filled controls to capacity immediately adjacent to the pond. A filter sock has been added as another layer of control but sediment should still be removed.

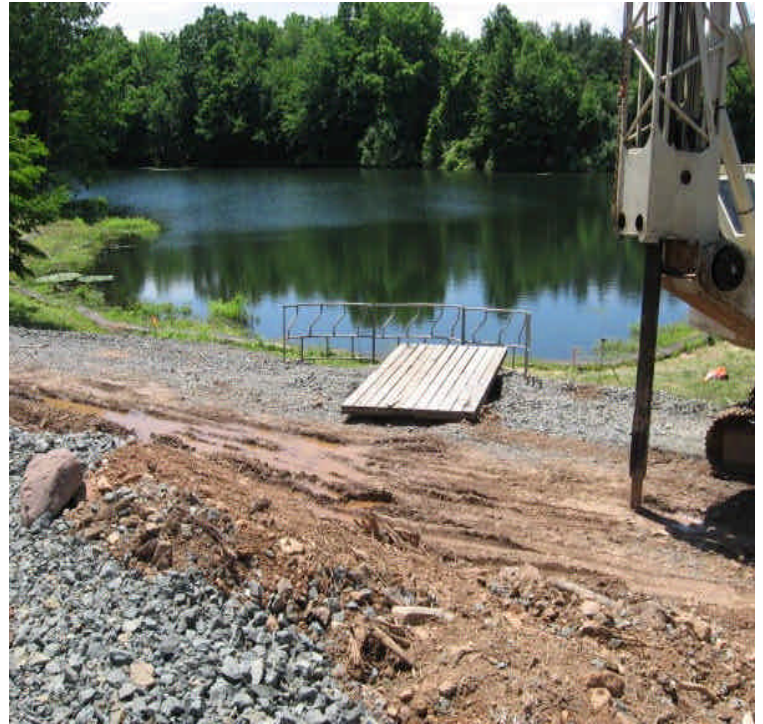
Foundation drilled north of E. Meriden SS. Controls are in place at the edge of the pond but more may be needed to control run-off.

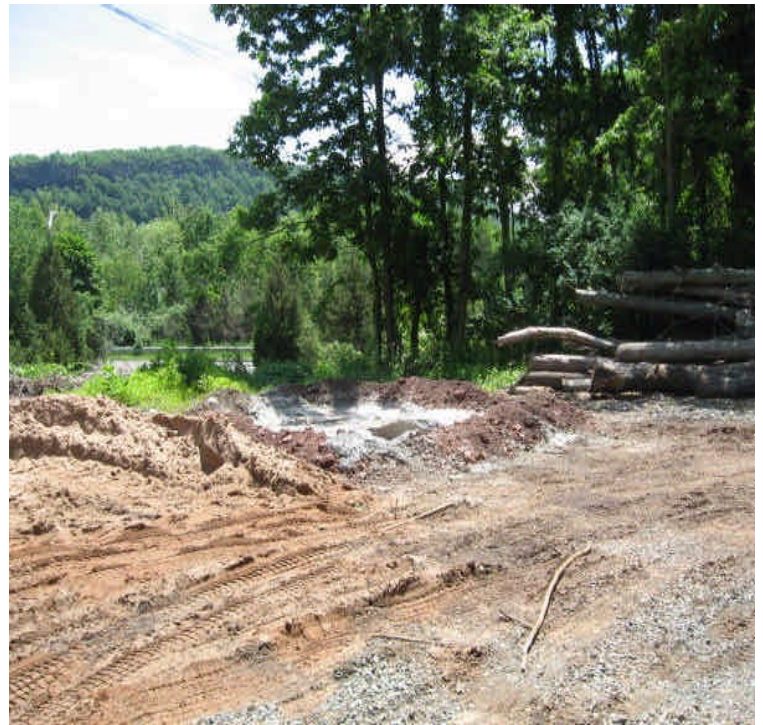
Concrete containment/dump area located north of East Main Street.
