Docket No. 272 – Development and Management Plan Inspection

Segment 1b (Royal Oaks Bypass) Inspection

Date: June 18, 2007

Location: Segment 1b (Royal Oaks Bypass)

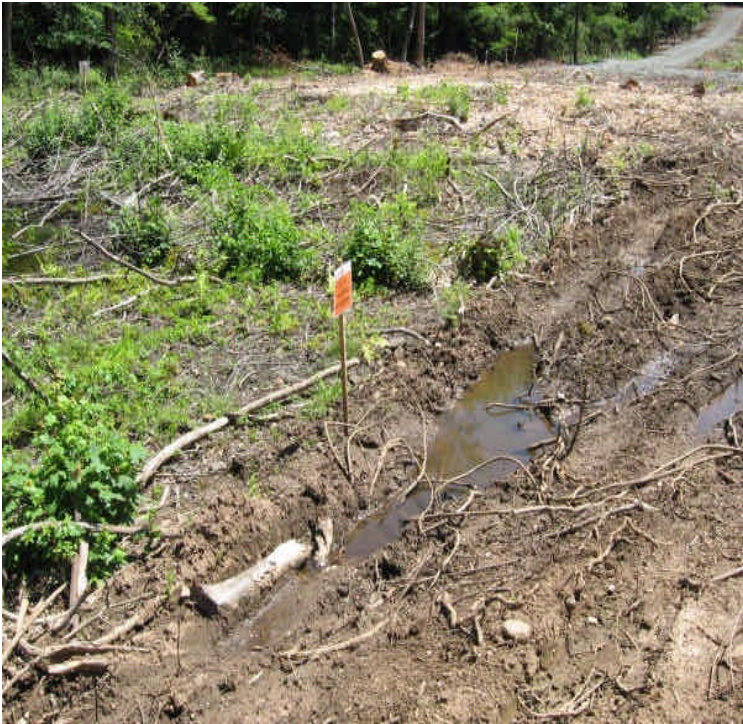
Areas of Inspection	Observation	Recommended Action	Corrected Action
	<p>watershed protection area. 6/18/07</p> <p>Equipment has driven through a channel connecting the two ponds east of Rte 17, leaving ruts (noted 5/29). This area had previously been avoided well by equipment. Controls were not in place and water was noted flowing into the pond within the ROW as a result of the ruts. 6/18/07</p>	<p>6/18/07</p> <p>Install controls where necessary. Regrade the ruts and stabilize the area. Continue to retain as much vegetation as possible in and adjacent to wetlands. 6/18/07</p>	<p>Needs attention.</p>
<p>State species of concern, threatened and endangered species.</p>	<p>According to the D&M plan, state-listed species are not located in this work area.</p> <p>Frogs, tadpoles, and <i>Ambystoma</i> (salamander) masses were noted in the small pond within the ROW. These are not state listed species but do indicate good amphibian breeding habitat. 6/18/07</p>	<p>None</p> <p>Continue using separate access points to reduce impacts to the pond. Add controls as necessary and consider construction fencing to keep equipment back. 6/18/07</p>	<p>NA</p> <p>NA</p>

Water was flowing into the pond from the equipment ruts created between Rte 17 and Black Walnut Drive. Access in this area had previously been avoided. Controls are needed. Also, confirm that the “entering wetland” sign is actually at the boundary and not within the wetland.

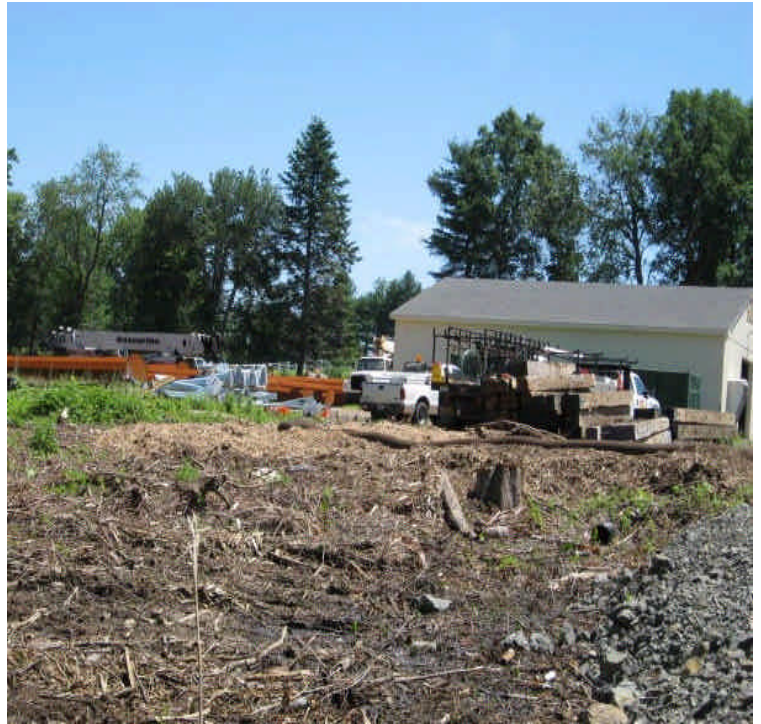
Site entrance within the receiving yard. Mulch was applied along the disturbed soils here.

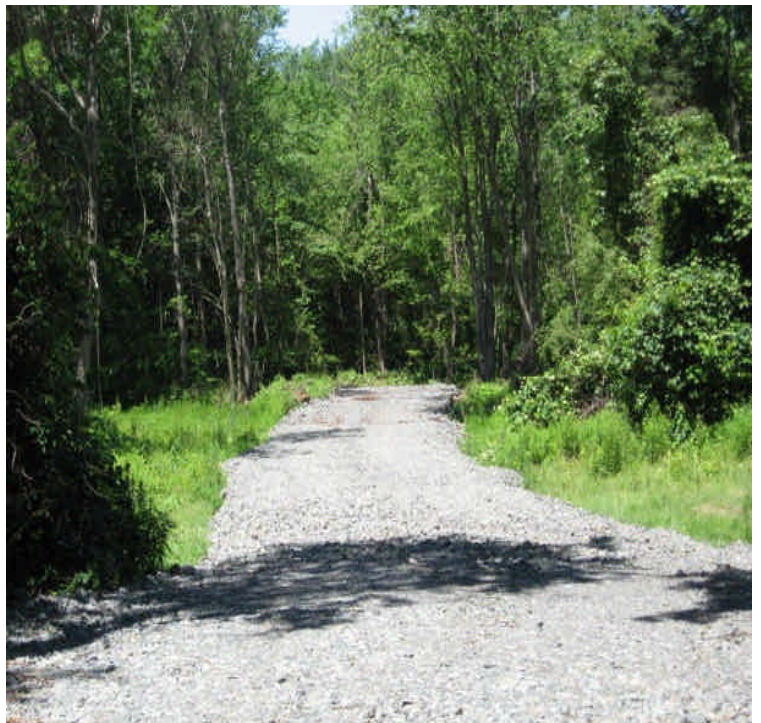
New stone base access road installed near Little Lane.
