Docket No. 272 – Development and Management Plan Inspection

Segment 1b (Royal Oaks Bypass) Inspection

Date: June 25, 2007

Location: Segment 1b (Royal Oaks Bypass)

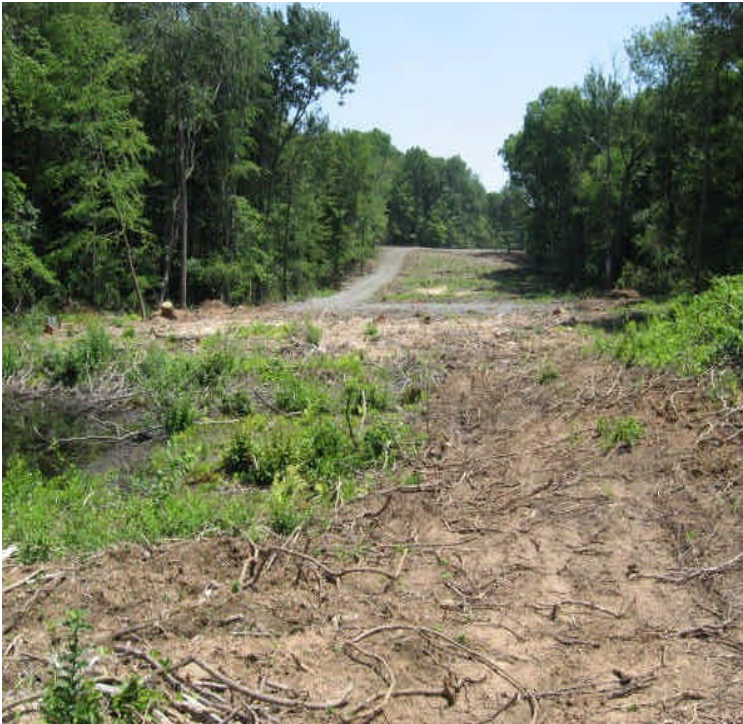
Water was no longer flowing into the pond from the equipment ruts created between Rte 17 and Black Walnut Drive. Controls are still needed. Also, confirm that the “entering wetland” sign is actually at the boundary and not within the wetland.

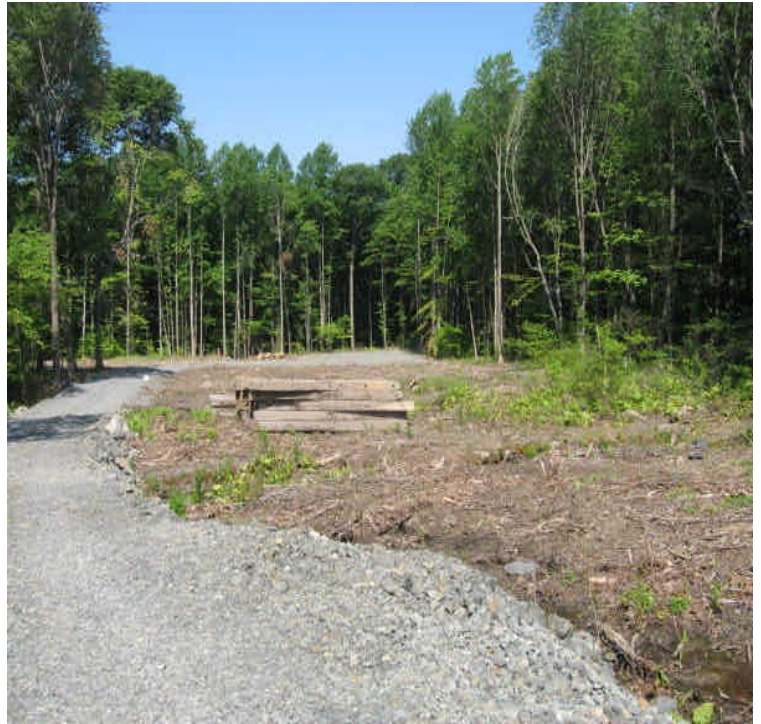
Site entrance within the receiving yard. Timber mats were stockpiled adjacent to a wetland area and should be relocated

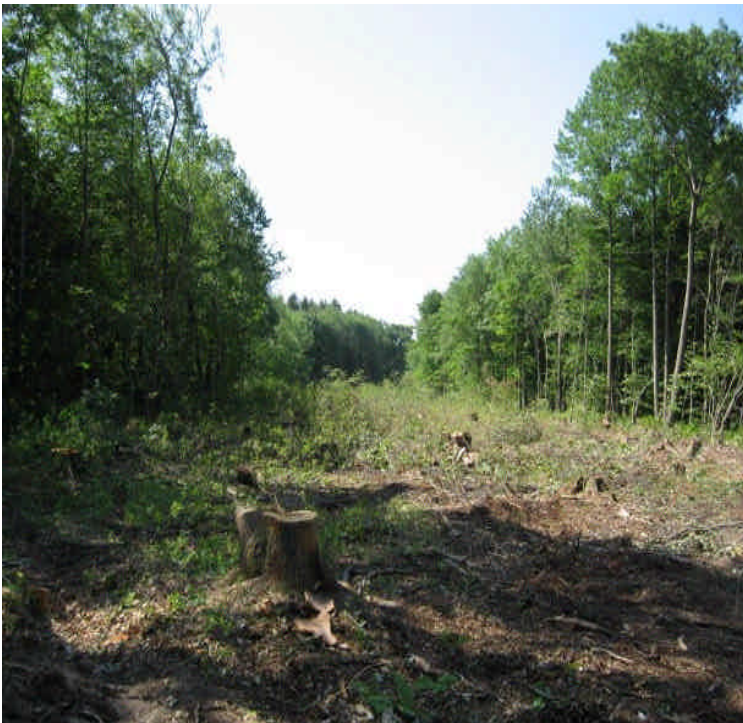
Clearing via helicopter completed within a sensitive area in the Watershed protection area. Stumps and low growing vegetation remain in place to stabilize soils.

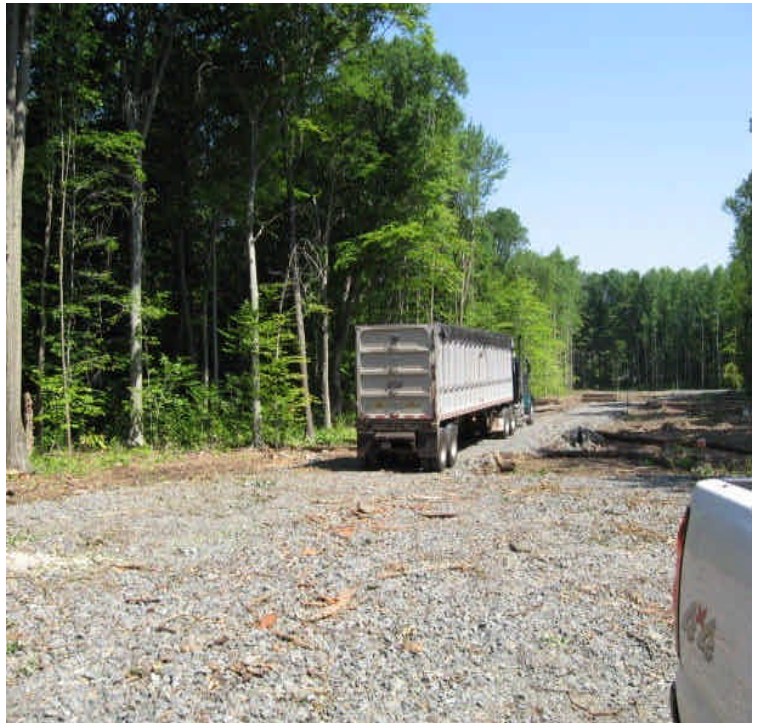
Crews were mulching stockpiled timber and removing it from site.
