**Docket No. 272 – Development and Management Plan Inspection**

**Segment 3 Underground Line**

**Date:** June 13, 2007

**Location:** East Devon Substation to the Housatonic River Crossing

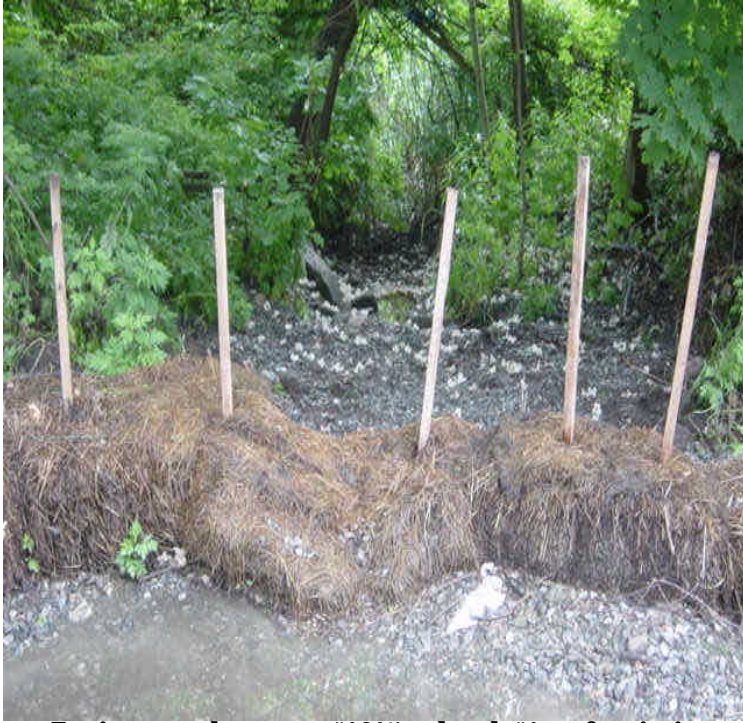
**Erosion controls near sta. #1015 and vault #1 are functioning. Continue to control sediment and run-off associated with stormwater.**

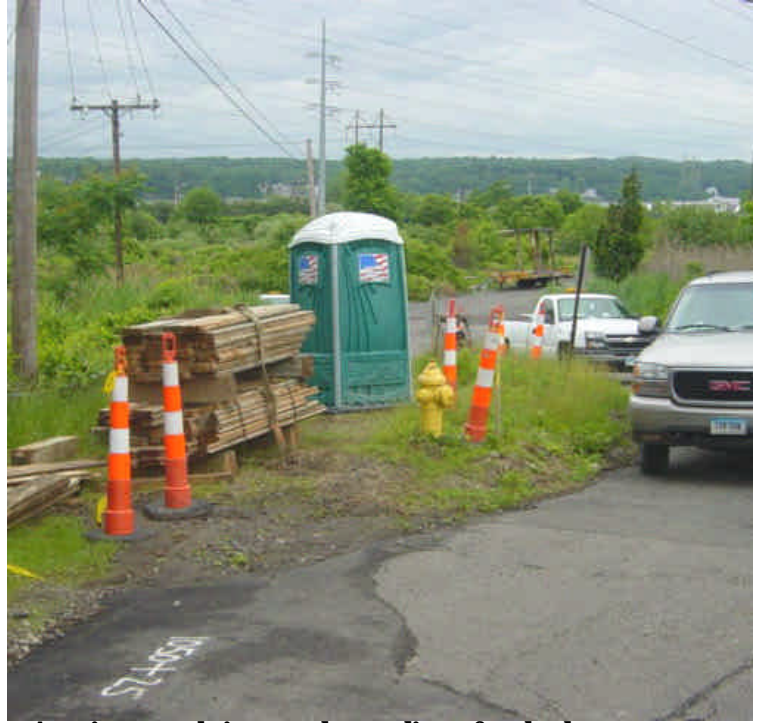
**A sani-can was being stored upgradient of wetlands near sta. #1050. These facilities should be stored greater than 100-feet from wetland areas whenever feasible.**

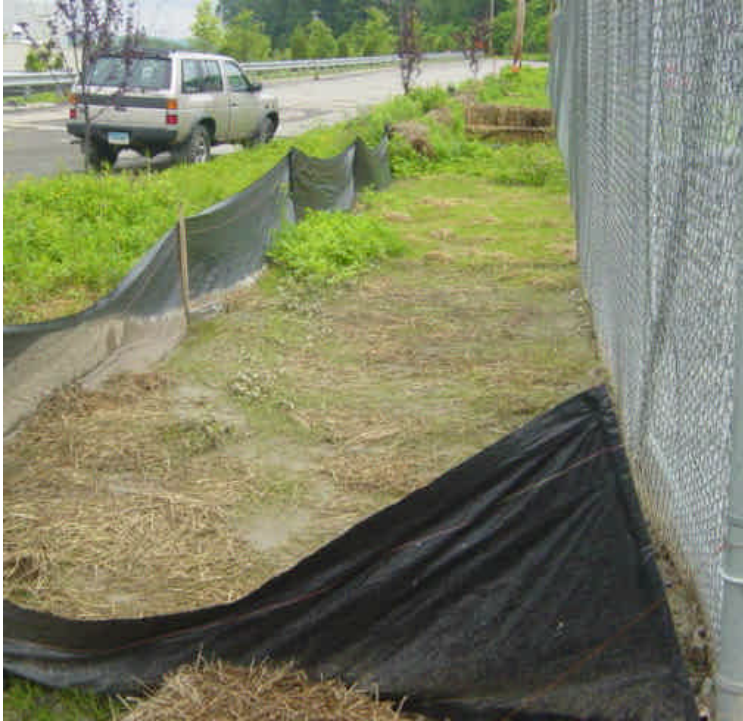
**Seed has started to germinate in the area immediately outside of the perimeter fence at the Milford lay-down yard.**

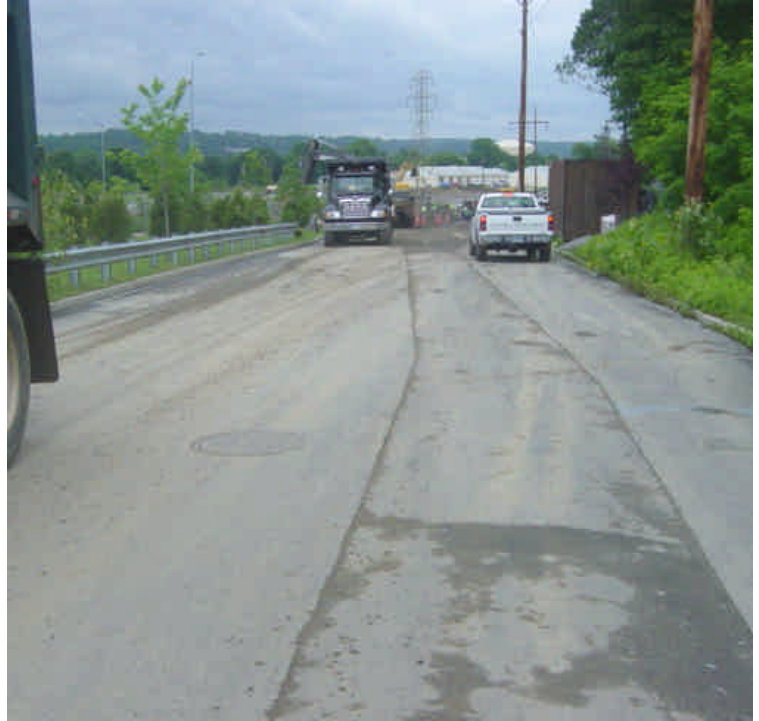
**Tracking was noted onto the paved portion of Shelland St. This appears to be largely contributed to trucks entering and exiting the East Devon substation construction site. Coordinate with other contractors to keep this roadway clean if appropriate.**
