**Docket No. 272 – Development and Management Plan Inspection**

**Segment 3 Underground Line**

**Date:** June 21, 2007

**Location:** East Devon Substation to the Housatonic River Crossing

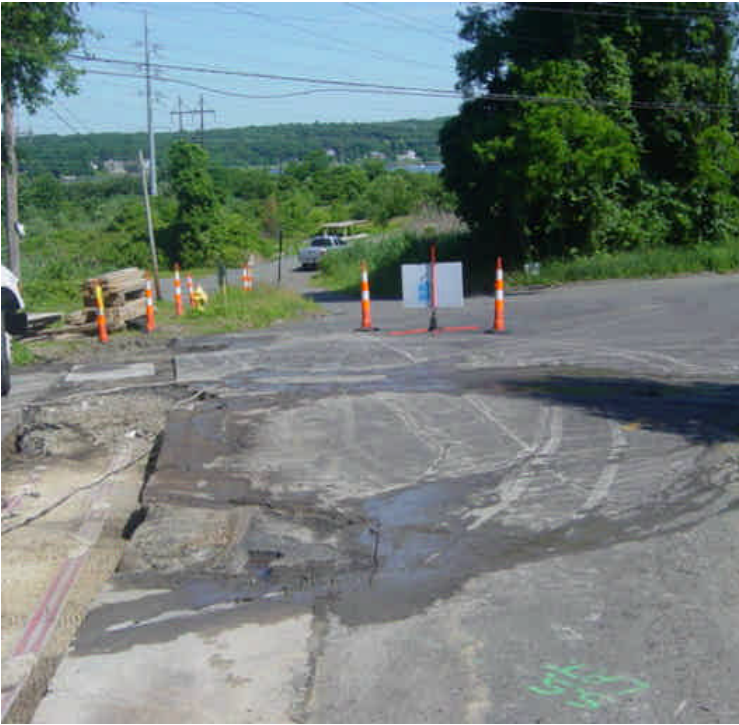
**Trenching and saw cutting work near sta. #1049 to #1050 was ongoing at the time of the inspection. A minor amount of slurry was migrating along the roadway which has the potential to enter catch basins. Continue to provide good efforts to sweep roadways.**

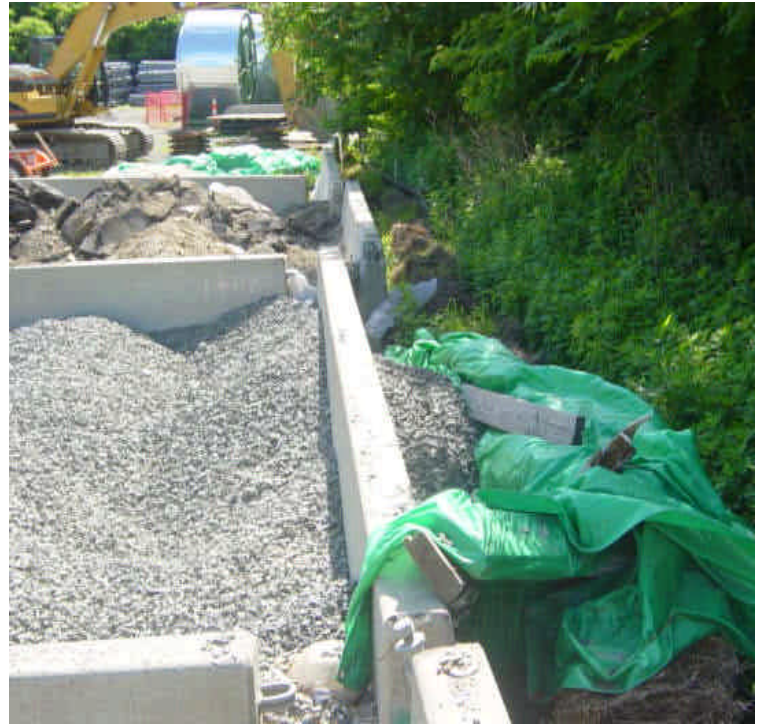
**Materials being stored in the Milford lay-down yard remain over the jersey barrier containment area. The materials are stable and remain at the boundary of the silt fence and will be addressed as part of final restoration once the yard is closed/demobilized.**

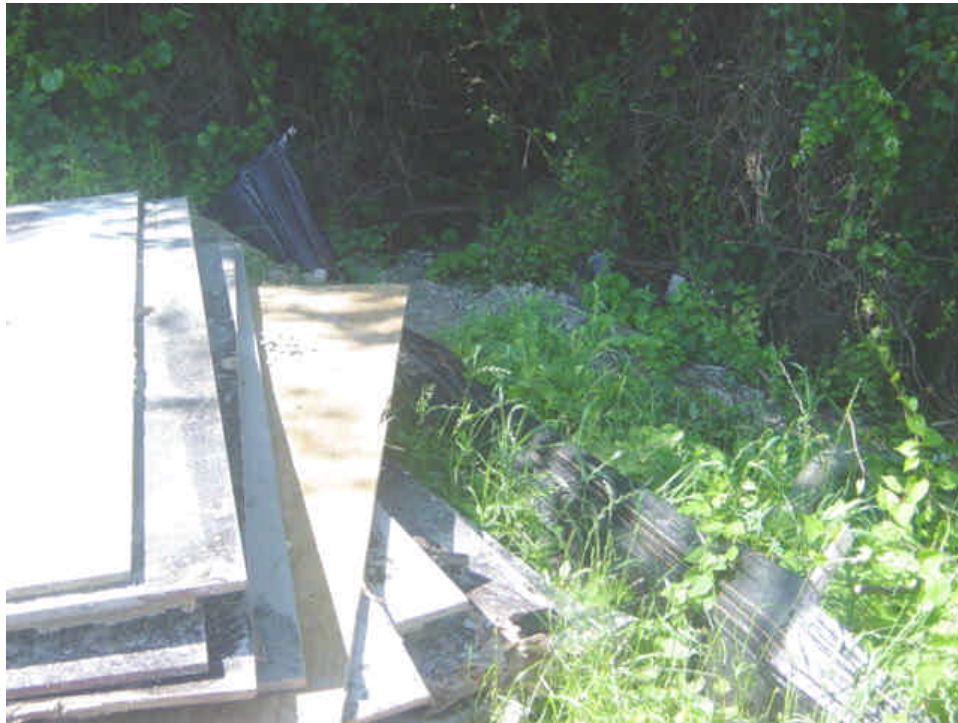
**Steel plates were stockpiled close to a section of silt fence near sta. #1050. The damaged section of silt fence should be restored and the plates should be pulled back.**
