Docket No. 272 – Development and Management Plan Inspection

Segment 4a Underground Line

Date: June 6, 2007 (evening inspection)

Location: Singer Substation to Fairfield/Westport Town Line

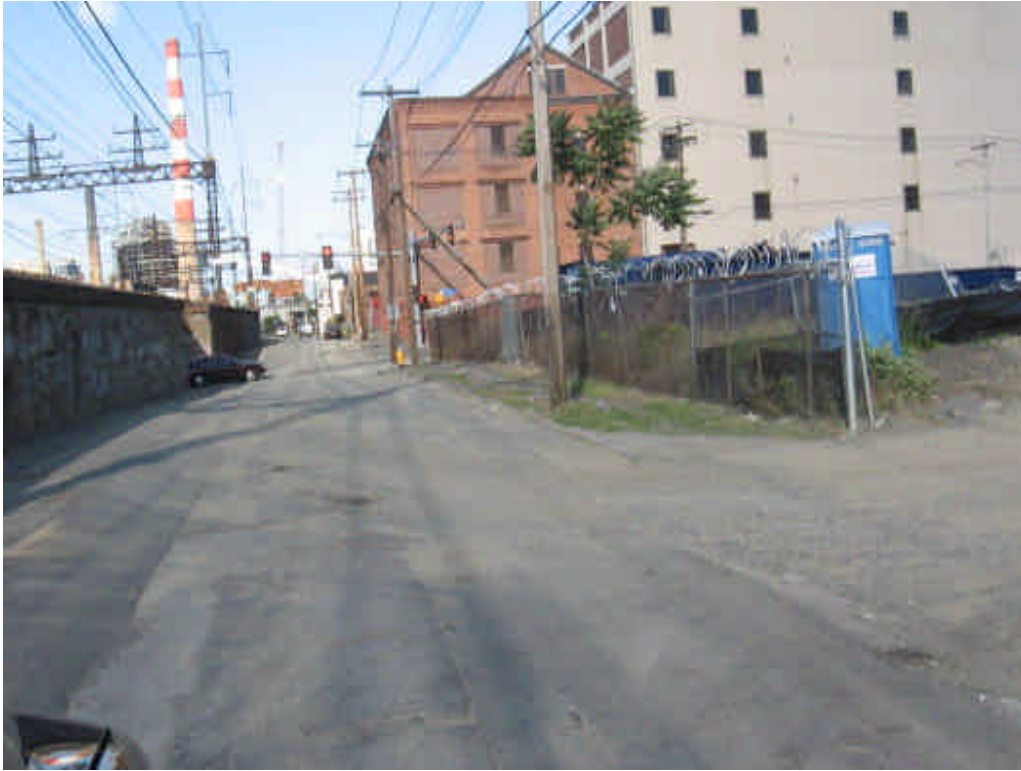
Minimal tracking was noted at Railroad Ave. near its intersection with Myrtle Ave. The tracks were originating from a stockpile yard that is not associated with this project.

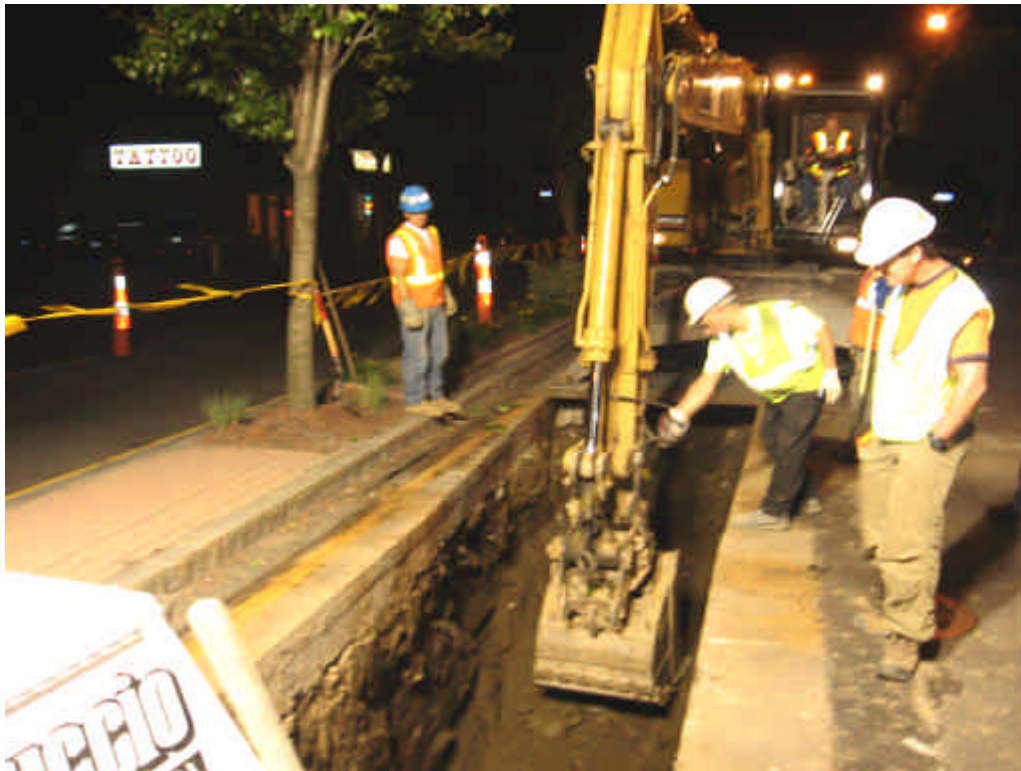
Trenching activities at sta. #698 to #700. Crews had encountered bedrock.
