Docket No. 272 – Development and Management Plan Inspection

Segment 4a Underground Line

Date: June 13, 2007

Location: Singer Substation to Fairfield/Westport Town Line

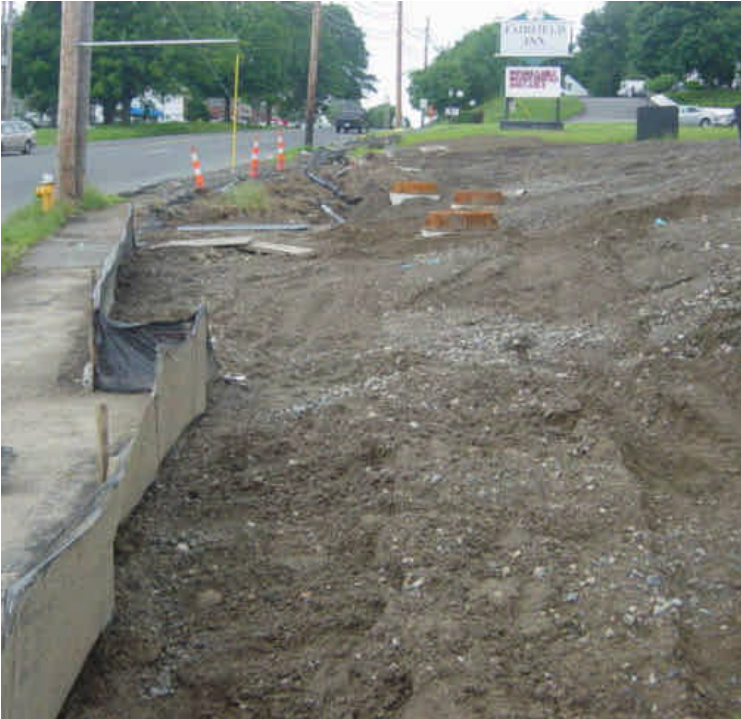
Areas of Inspection	Observation	Recommended Action	Corrected Action
Fairfield	<p>dust migration. Contractors are aware of the potential. Problems with dust were not observed this week. 6/13/07</p> <p>Slurry from saw cutting activities has the potential to enter catch basins. Problems with slurry entering catch basins were not observed this week. 6/13/07</p> <p>Erosion controls appear to have been driven over at sta. #612. Contractors stated that a motorist (non-project related) went through fencing early that morning. 6/13/07</p>	<p>exposed soils and sweeping immediately. If exposed soils are not to be worked within 30 days, they should be stabilized within 7 days of the last activity. 6/13/07</p> <p>Prevent slurry from entering catch basins and sensitive areas, by quickly attending to it as it is generated during cutting. 6/13/07</p> <p>Re-establish erosion controls as soon as feasible. 6/13/07</p>	<p>NA</p> <p>Needs attention as soon as feasible (due to a non-project related incident).</p>

Photograph of controls near sta. #612 that appear to have been driven over earlier that morning by a motorist (not project-related).

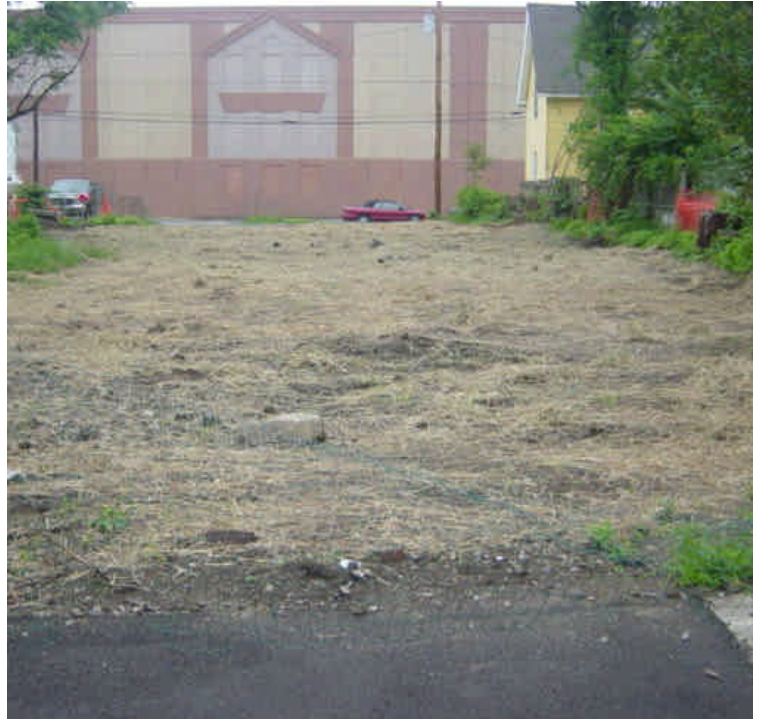
State species of concern, threatened and endangered species.	According to the D&M plan, state-listed species are not located in this work area.	None	NA
Vegetative clearing (including trees to save or danger trees noted) or stabilization	Work continues at Vault #36. Soils remain exposed. 6/13/06	Stabilize/restore lawn area when appropriate. 6/13/07	Needs attention when work is complete.
	The area near Vault #28 remains covered with a hard pack that is resistant to erosion. 3/6 – 6/13/07	Continue to monitor and provide final stabilization if necessary. 6/13/07	NA.
	Two trees were removed near sta. #462 in accordance with the D&M Plan the week of 3/27/07. 6/13/07	Vegetation should be restored as necessary upon completion of work in this area. 6/13/07	NA at this time.
	The trench formerly located between Broad	Continue to monitor for adequate vegetative	The area was seeded and mulched.

Seed and mulch have been applied to the area between Broad and Main St.

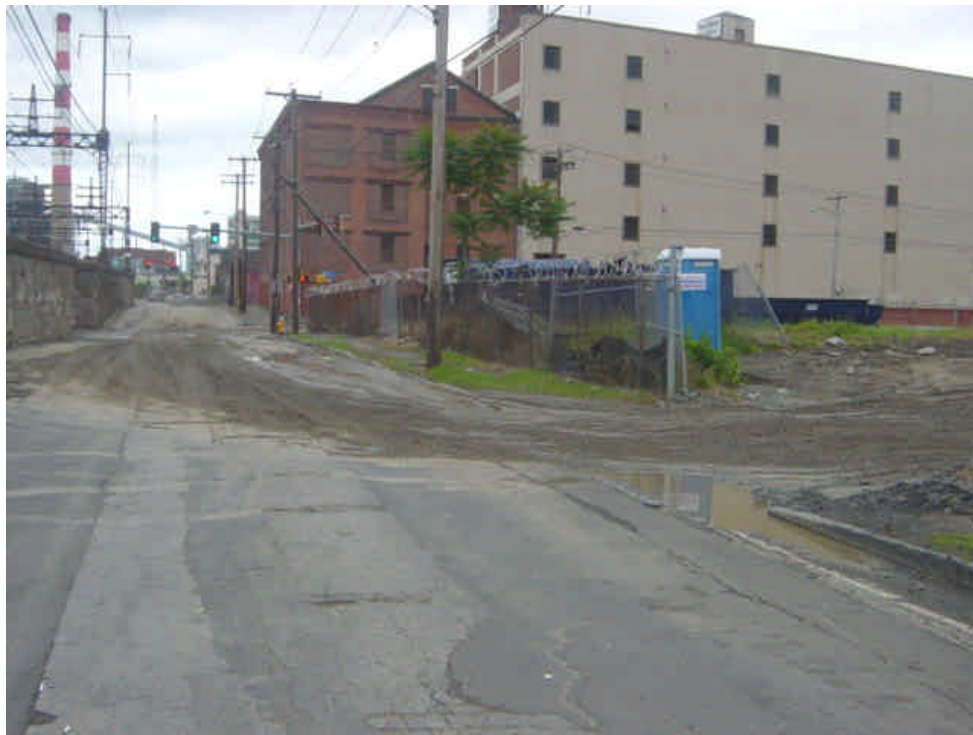
Bridgeport	<p>Sediment tracking is regularly observed at the Railroad and Myrtle Ave. intersection and catch basins in the area are overwhelmed by continued accumulation. Sediment was originating from a stockpile yard identified as being associated with the Glenbrook Cable project. This is not covered under this D&M plan. Significant tracking was noted this week; catch basins remain overwhelmed. 6/13/07</p>	<p>Noted for the record since contractors stated the sediment is not related to this project. 6/13/07</p>	<p>NA</p>
Kings Highway Lay-down Yard (Off Kings Highway, near Rt. 1 rotary)	<p>Perimeter erosion controls remain in place at the yard. 6/6/07</p>	<p>Continue to monitor and maintain the perimeter silt fence as necessary. 6/6/07</p>	<p>NA</p>
Inland Wetland and Watercourse encroachment and	<p>The Kings Highway lay-down yard is located adjacent to potential</p>	<p>See erosion control section. 6/13/07</p>	<p>NA</p>

Heavy tracking was noted this week at Railroad Ave. near its intersection with Myrtle Ave. The tracks were originating from a stockpile yard that is not associated with this project. Catch basins in this area remain overwhelmed with sediment.
