**Docket No. 272 – Development and Management Plan Inspection**

**Segment 4b Underground Line**

Date: June 13, 2007

Location: Fairfield/Westport Town Line to Westport Avenue in Norwalk

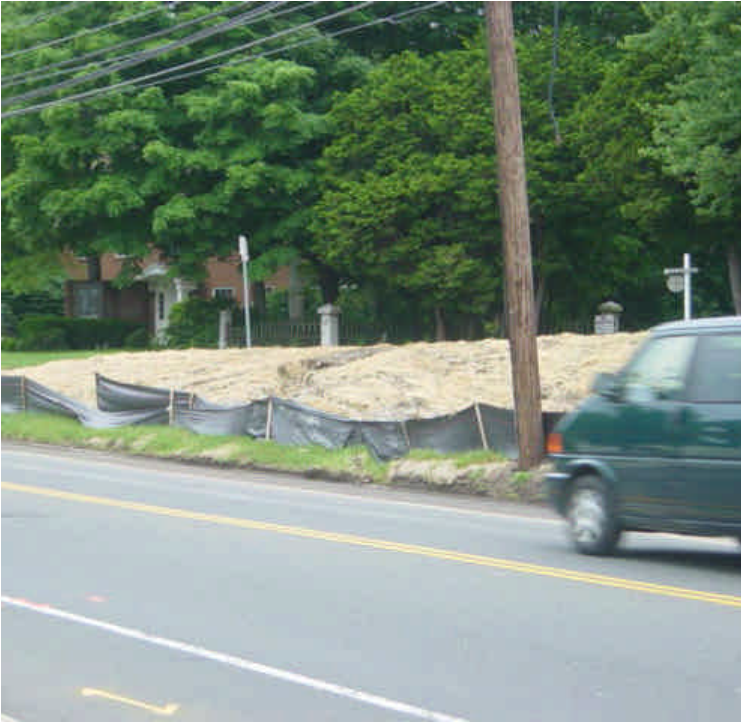
Photo of the gully/washout that has formed over vault #5. The compromised section of fence is located just to the left of the photo view.

Areas of Inspection	Observation	Recommended Action	Corrected Action
Norwalk	gradient of/adjacent to construction activities. 6/13/07	curb/gutter drop inlet to prevent sediment from entering basin. Install controls where necessary. 6/13/07	needed in some locations.
	Although active work is not occurring here, silt fence remains between the road and the brook of Imperial Ave at sta. #260 6/13/07	Ensure that silt fence is in good condition if work resumes here. 6/13/07	NA at this time.
	Although active work is not occurring here, erosion controls remain in place at Vault #13 to protect Stoney Brook. 6/13/07	Ensure that controls are in good condition when work resumes here. 6/13/07	NA at this time.
	A portion of the silt fence was observed to be slumping at vault #5 (noted since 5/31). Heavy rain has caused a small gully to form. 6/6-6/13/07	Re-establish the erosion controls and stabilize the washout area. 6/6-6/13/07	Needs attention

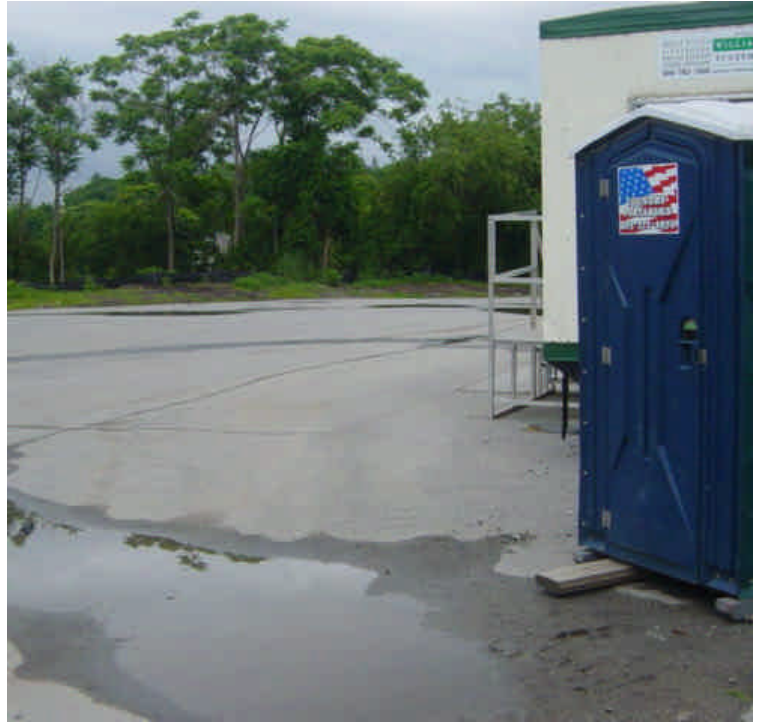
Current condition of the demobilized Imperial Ave. lay-down yard. All that remains is a Sani-can, a construction trailer, and erosion controls.

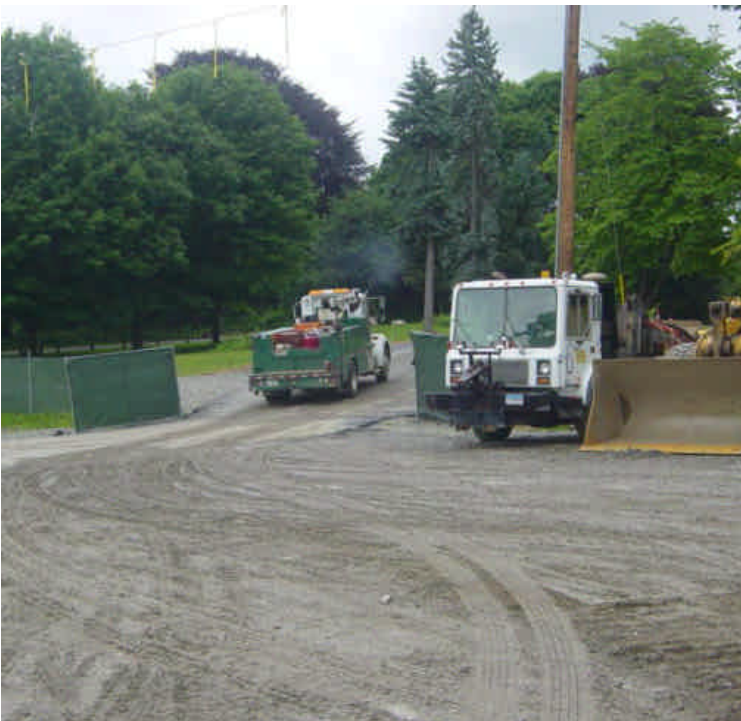
Some tracking was noted from the Sherwood Island lay-down yard. However, the entire access way has been paved, aiding in reducing tracking to the main roadway.

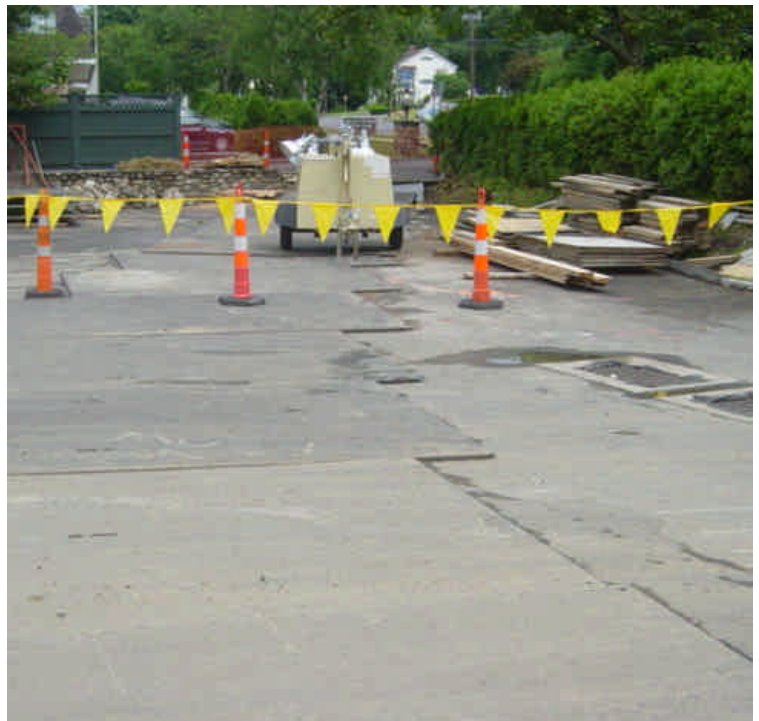
Catch basins located adjacent to sta. #334 were protected with silt sacks.
