Docket No. 272 – Development and Management Plan Inspection

Segment 4b Underground Line

Date: June 29, 2007

Location: Fairfield/Westport Town Line to Westport Avenue in Norwalk

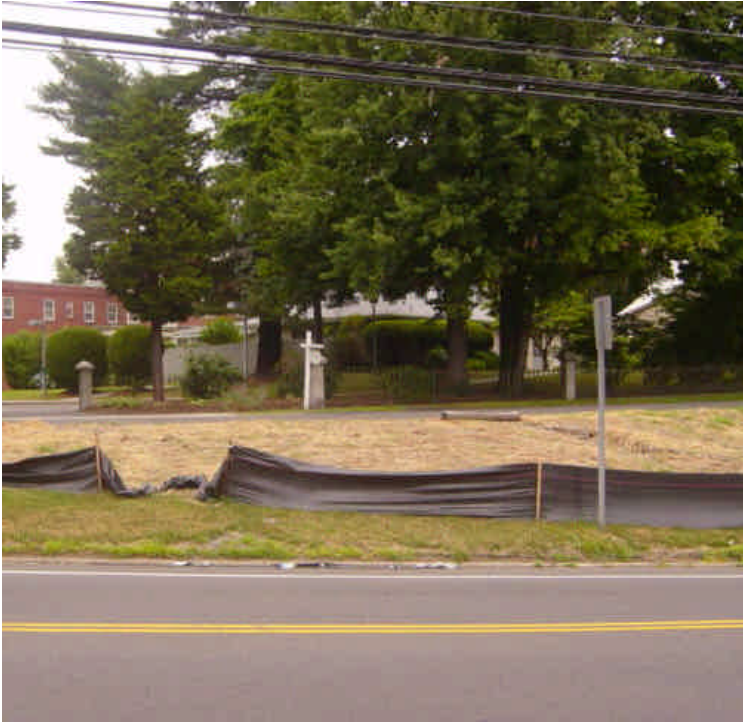
Norwalk	<p>The previous slumping section of silt fence near vault #5 was restored, but now an additional section</p>	<p>Re-establish the compromised erosion control and continue to stabilize the exposed</p>	<p>One section of fence was restored, while another is now in need of repair.</p>

A gully had previously formed near vault #5. A silt sock has been placed at the top of the slope to minimize further erosion. The silt fence was also repaired, but a new section now needs attention. Stabilize as soon as feasible.

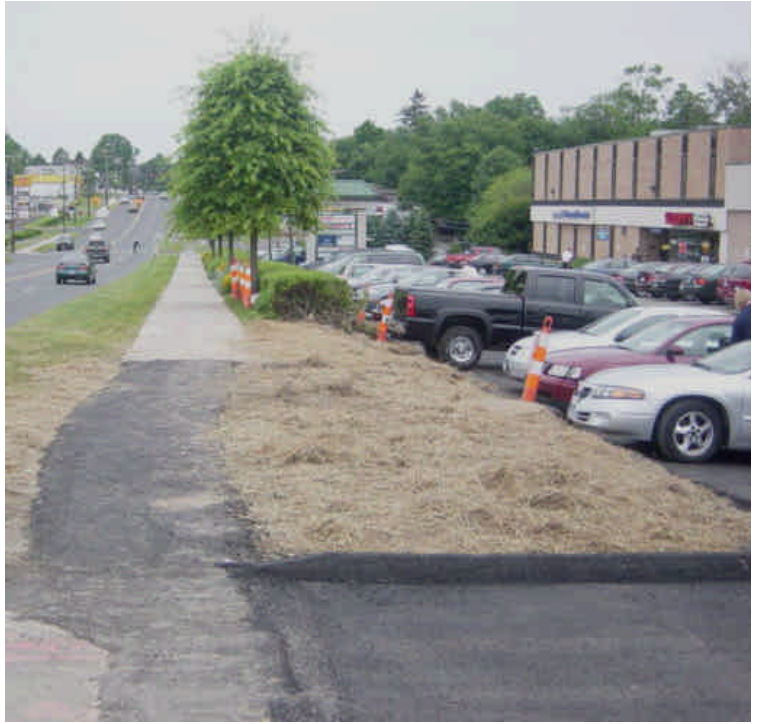
Exposed soils at vault #7 have been stabilized with hay mulch. The sidewalk was repaved and the curbing was restored.

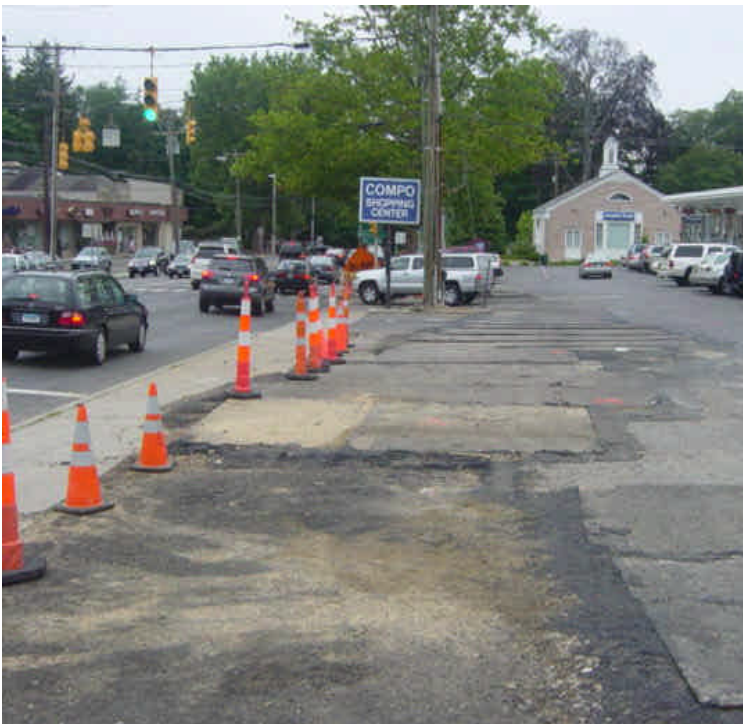
Steel plates are temporarily in place near vault #17. This area is scheduled to be paved later this week.

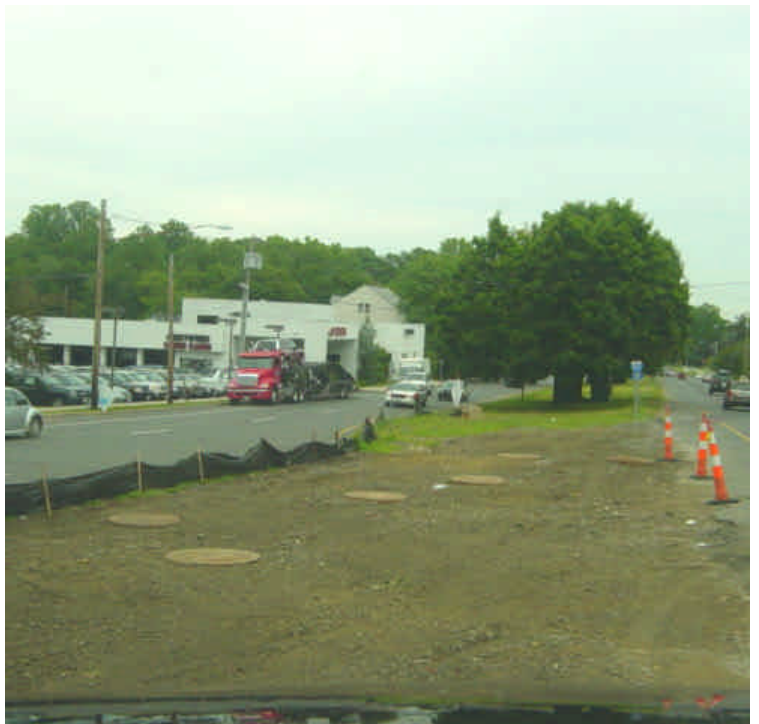
Hard-pack soil is in place near vault #19 to temporarily stabilize the exposed area. Silt fence remains along the down gradient side of slope.
