**Docket No. 272 – Development and Management Plan Inspection**

**Beseck Switching Station Inspection**

**Date:** March 13, 2007

**Location:** Beseck Switching Station

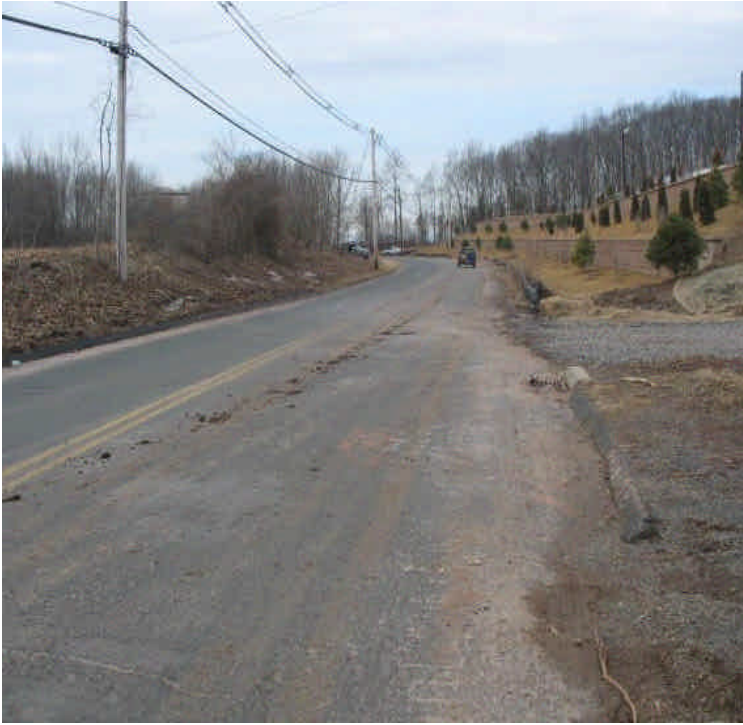
Site entrance/exit off Carpenter Lane is at final grade; haybales at the exit are degraded and should be replaced. This was going to occur shortly. No run-off was noted at the time. Tracking on the roadway was a result of Segment 2A, ROW clearing crews.

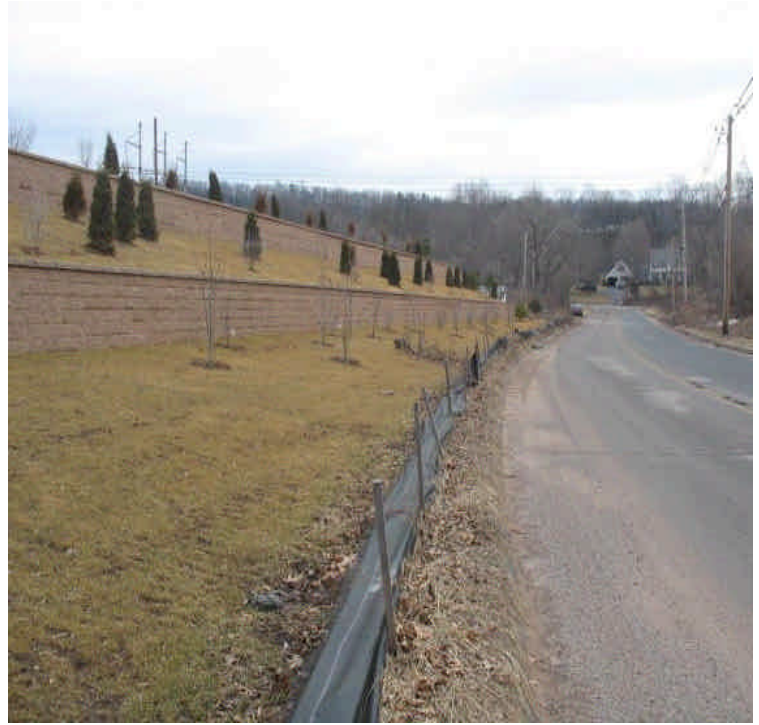
View of Carpenter Lane and retaining walls. Some slight sedimentation (as well as sand from town sanders) was noted along the gutters. Catch basins controls could use maintenance.

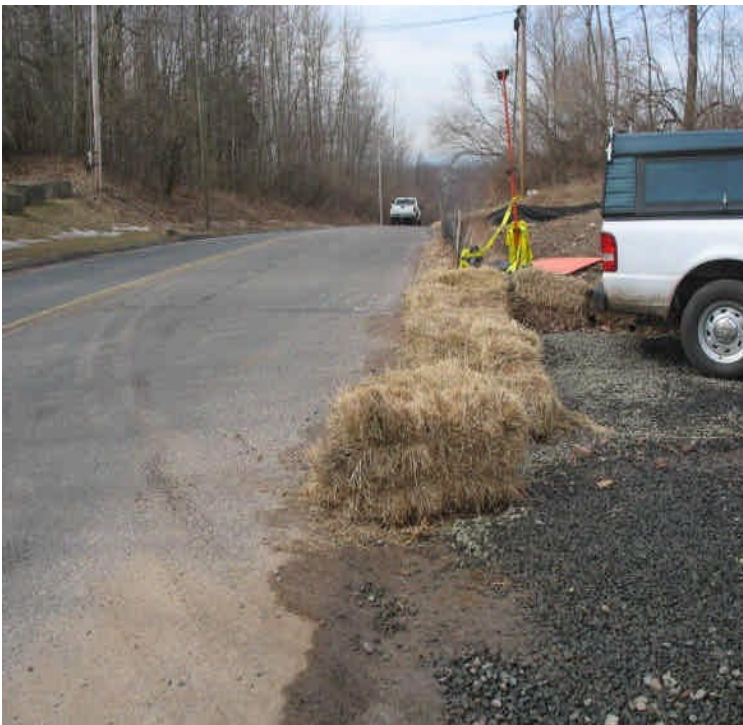
Haybales were placed across the site entrance (west side) in an effort to reduce turbid run-off from the site. Some sediment accumulation was noted at the edge of the entrance.

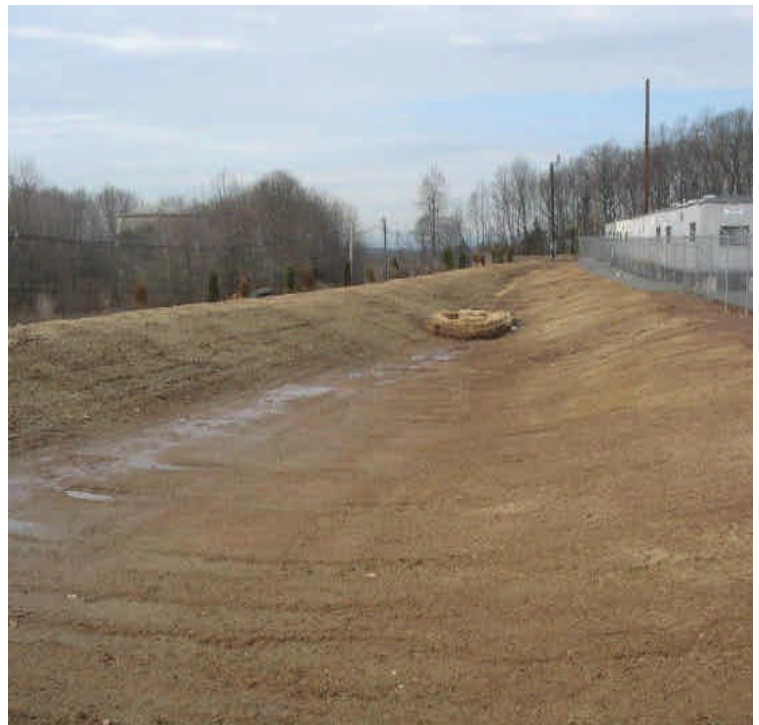
Haybales and controls remain in place at the inlet of the detention basin. Sediment from run-off appears to be contained effectively.

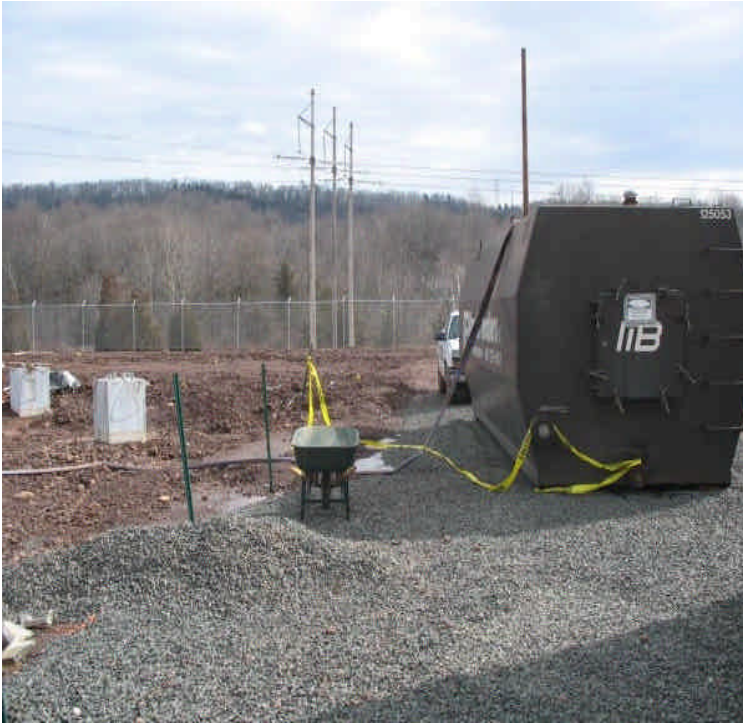
**View of dewatering into a settling tank. All water from site is well contained at this time.**

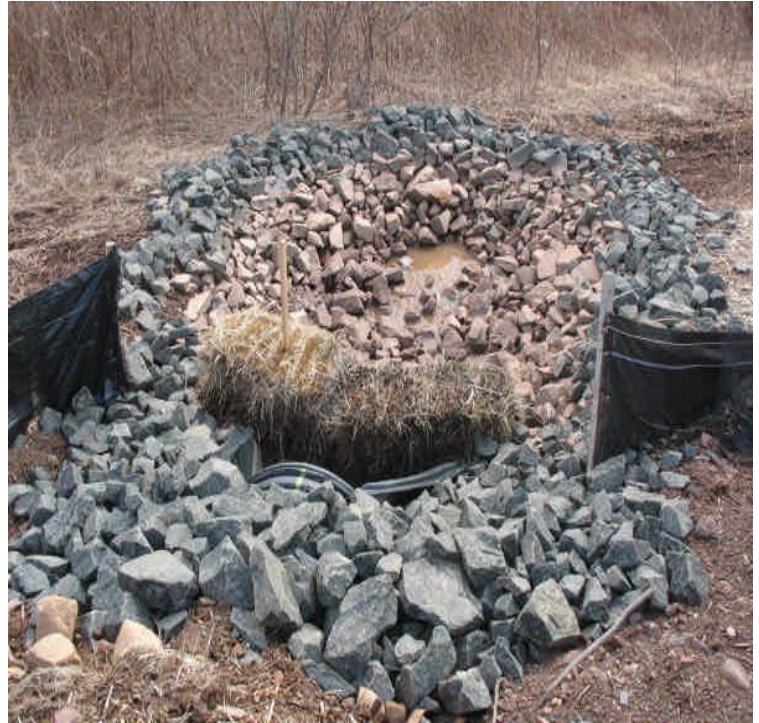
**View of the culvert under the new access road. Turbid water has mostly filtered out of the trap and sediment appears contained.**

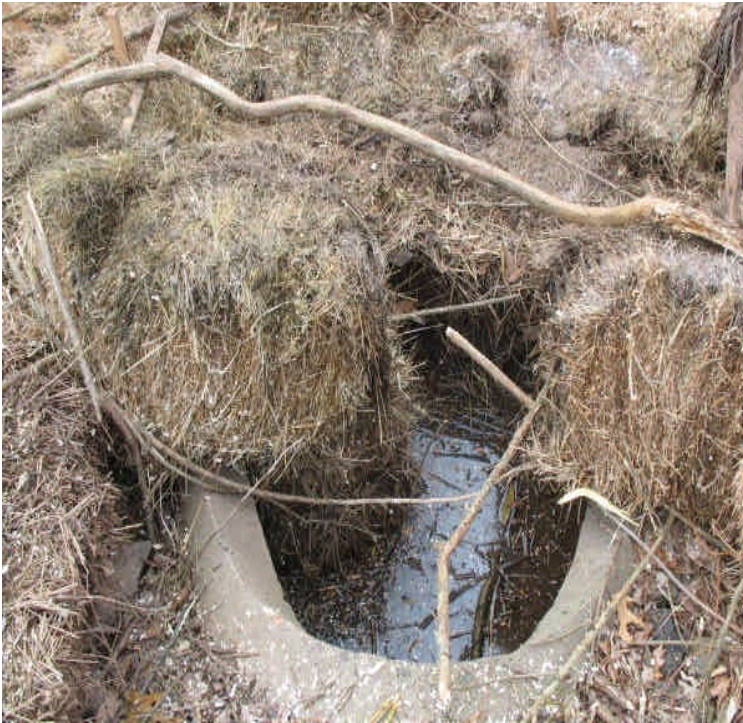
**Storm drain outlet across Carpenter Lane has clear water flowing through the haybales. The ice cover in the culvert and wetlands has melted. Efforts on site appear to have retained sediment.**

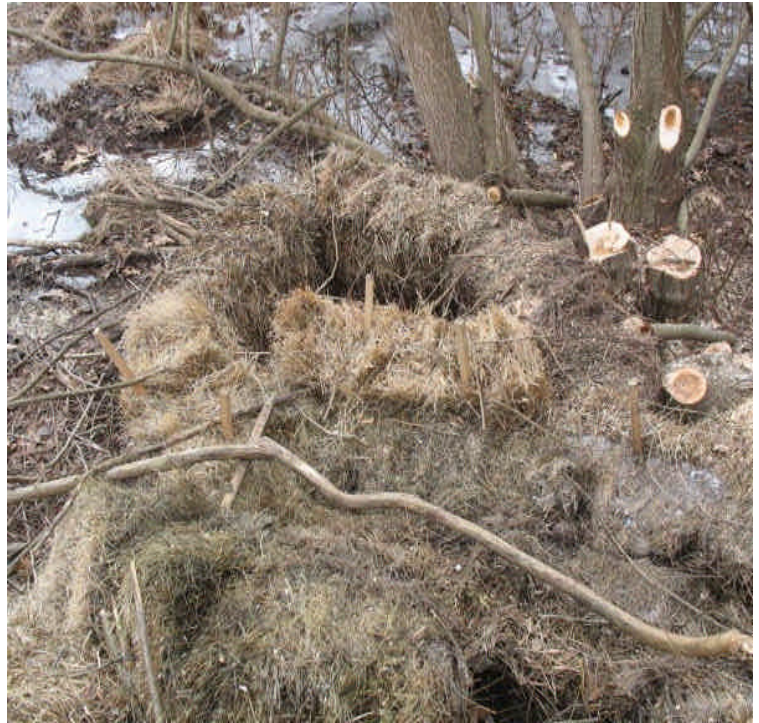
**Clear water was observed leaving the haybales and entering the wetlands. Evaluate whether the amount of sediment accumulation justifies the minor disturbance needed to remove it, once the water level subsides. Timber harvesting/clearing underway within wetlands as part of the Segment 2A overhead construction.**
