**Docket No. 272 – Development and Management Plan Inspection**

**Beseck Switching Station Inspection**

**Date:** March 27, 2007

**Location:** Beseck Switching Station

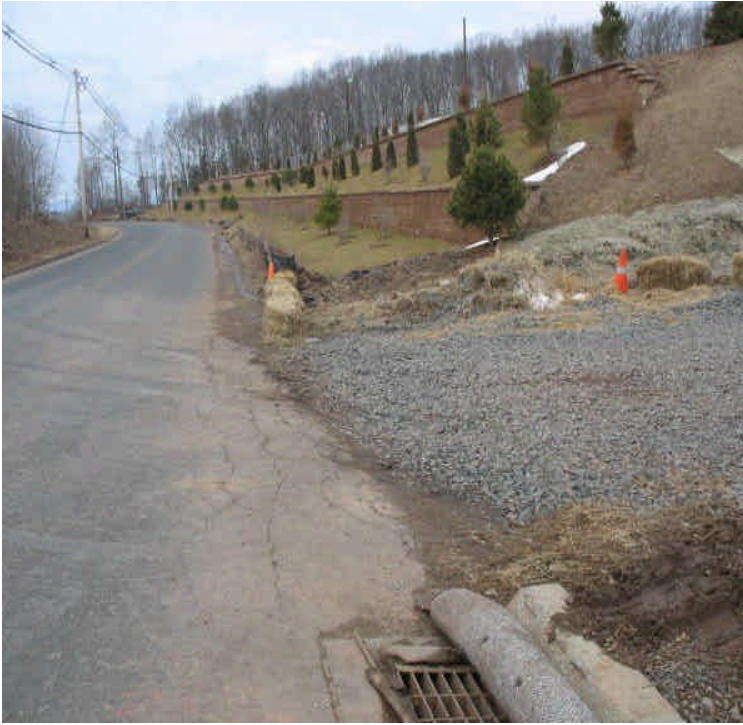
Site exit off Carpenter Lane is at final grade; haybales at the exit have been replaced. Minor amounts of fine sediment tracking are still noted but good efforts are made to keep the area controlled.

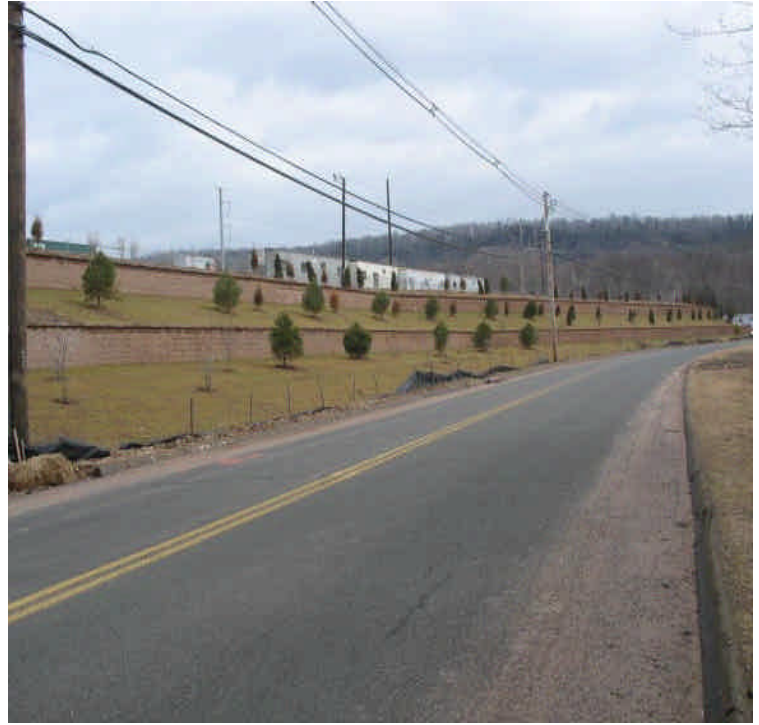
View of Carpenter Lane and retaining walls. Some slight sedimentation (as well as sand from town sanders) was noted along the gutters. Larger piles of sediment have been removed.

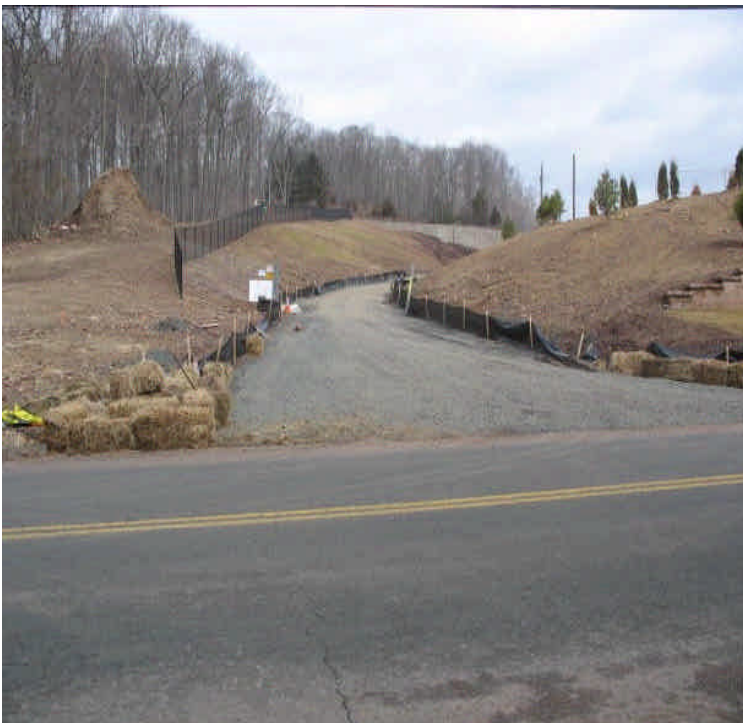
Haybales remain along the edges of the site entrance (west side) in an effort to reduce turbid run-off from the site.

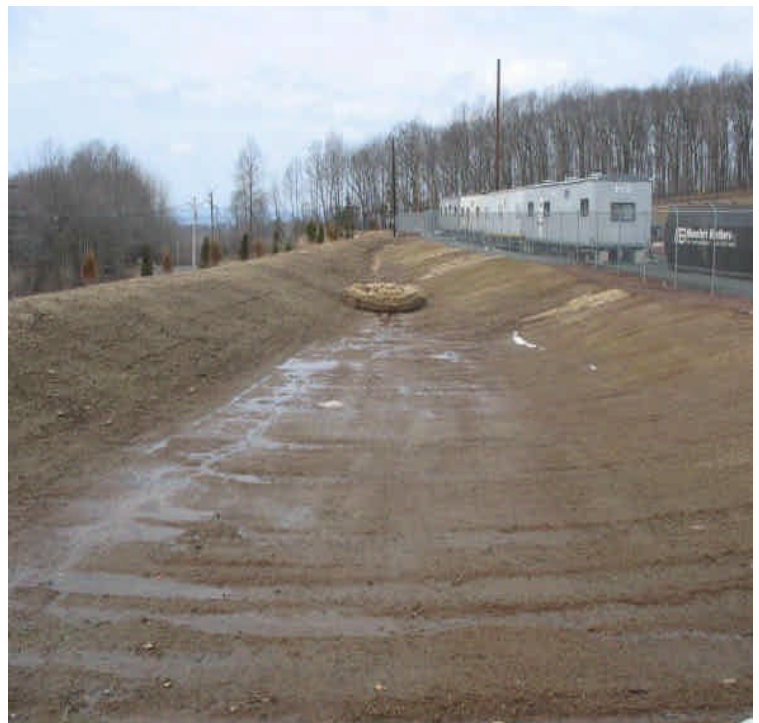
Haybales and controls remain in place at the inlet of the detention basin. Sediment from run-off was contained effectively the last few weeks.

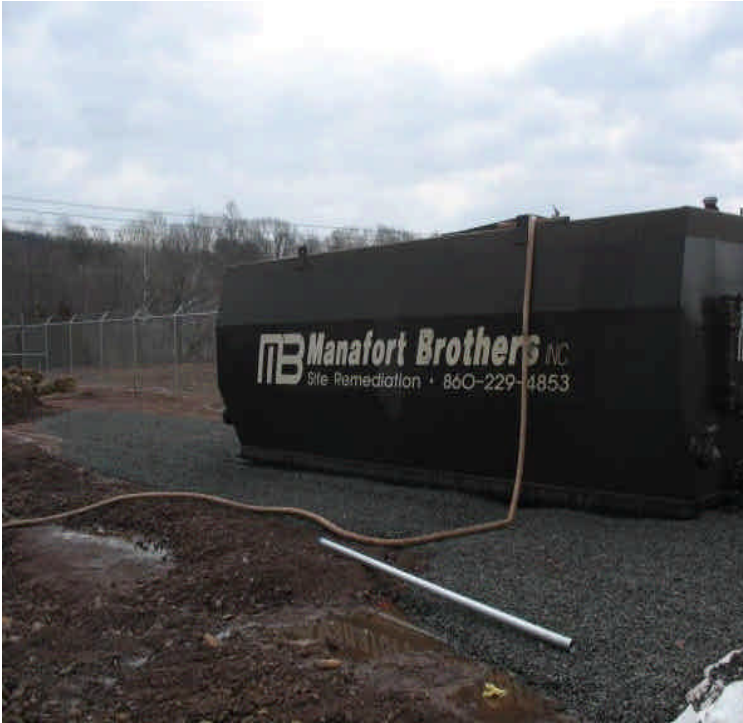
**View of settling tank. Foundation pits were filled with rainwater and were being dewatered appropriately to the tank.**

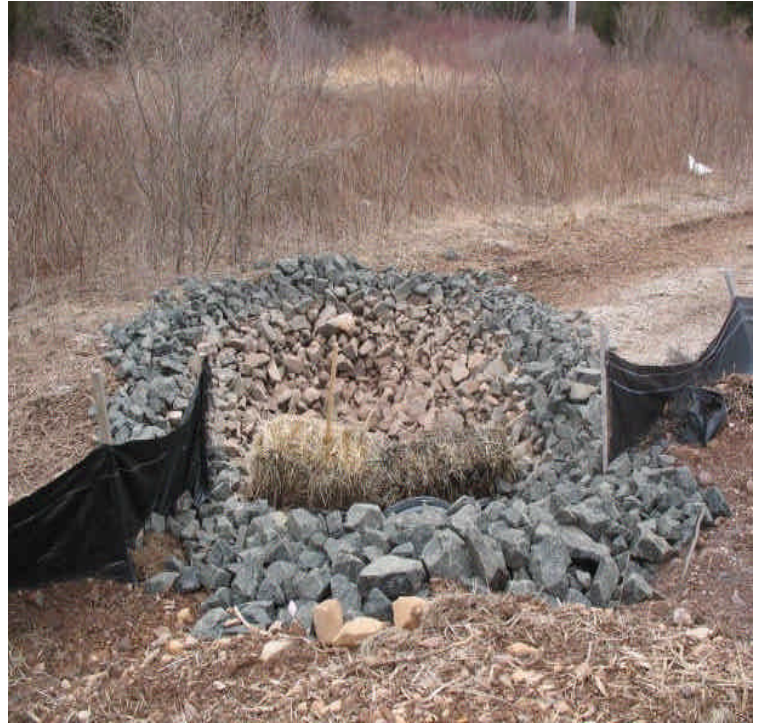
**View of the culvert and sediment trap under the access road to the ROW. Sediment appears to be contained.**

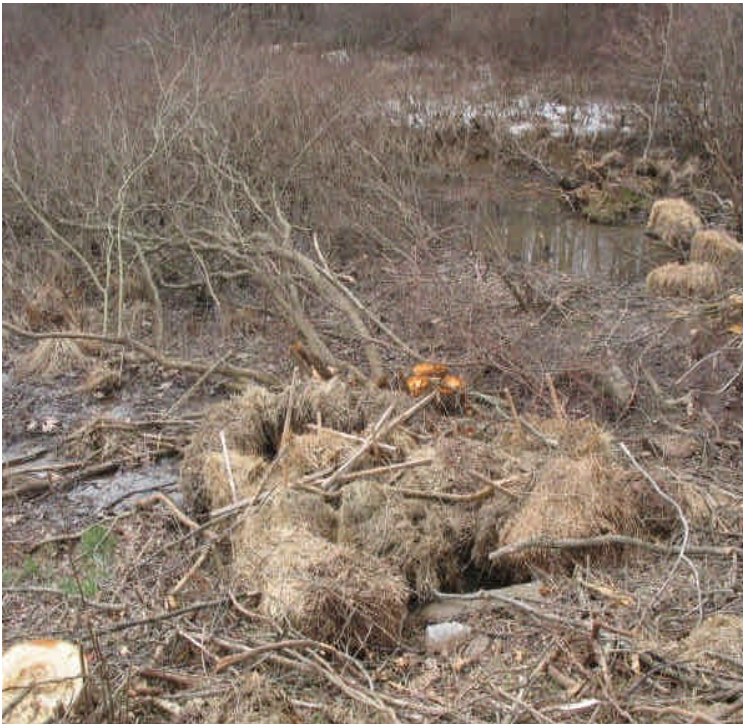
**Storm drain outlet across Carpenter Lane has clear water flowing through the haybales. Trees have been cleared in the wetland for Segment 2a work.**

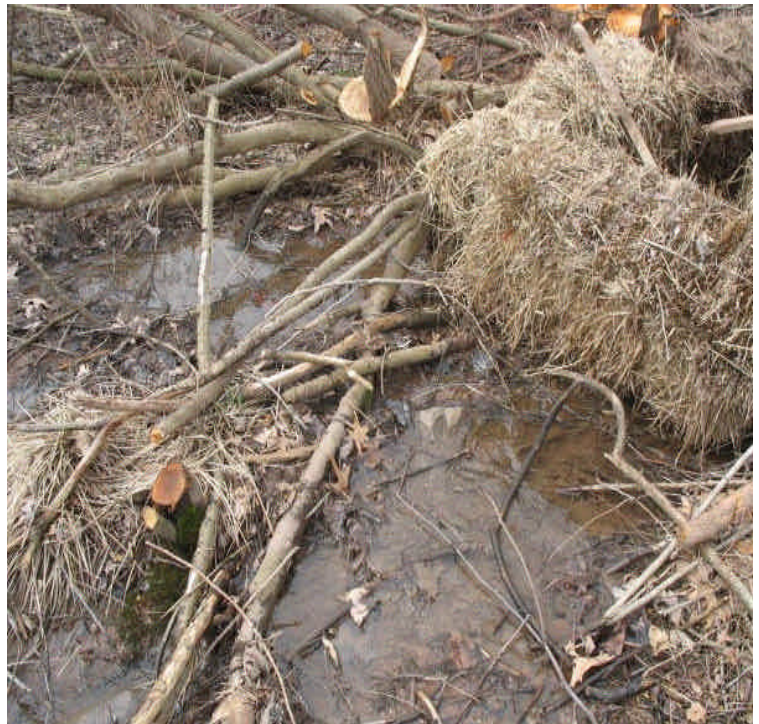
**Clear water was observed leaving the haybales and entering the wetland. Evaluate whether the amount of sediment accumulation justifies the minor disturbance needed to remove it, once the water subsides. Timber harvesting/clearing within the wetlands for 2A is complete.**
