Docket No. 272 – Development and Management Plan Inspection

Scovill Rock Switching Station Inspection

Date: March 12, 2007

Location: Scovill Rock Switching Station

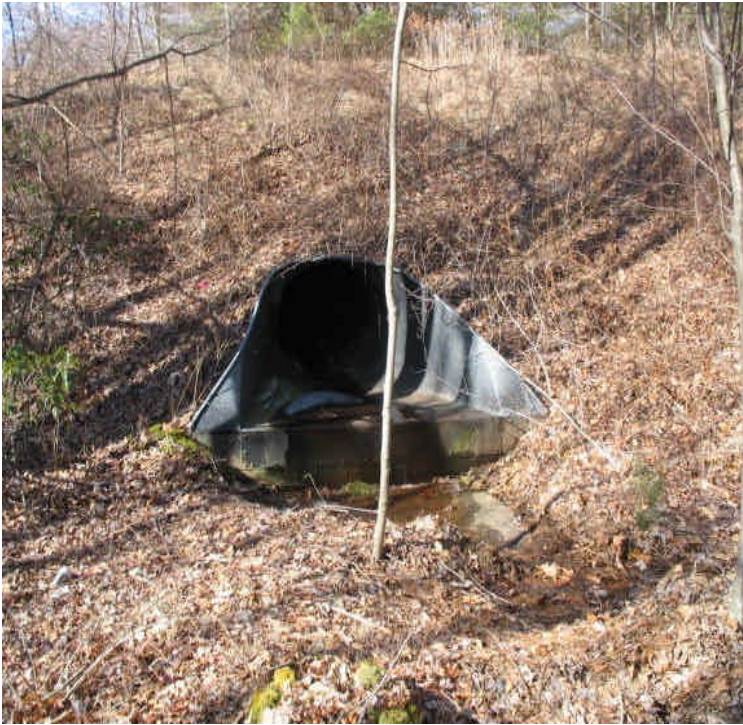
View of the culvert under the access drive. No sediment issues have been observed.

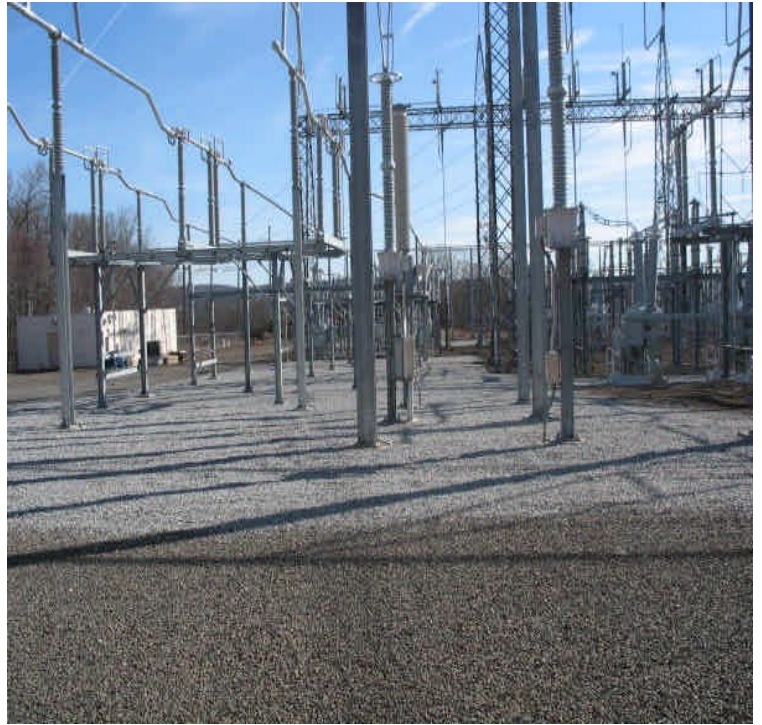
The site is stable and civil and structural work in the yard appears to be complete.

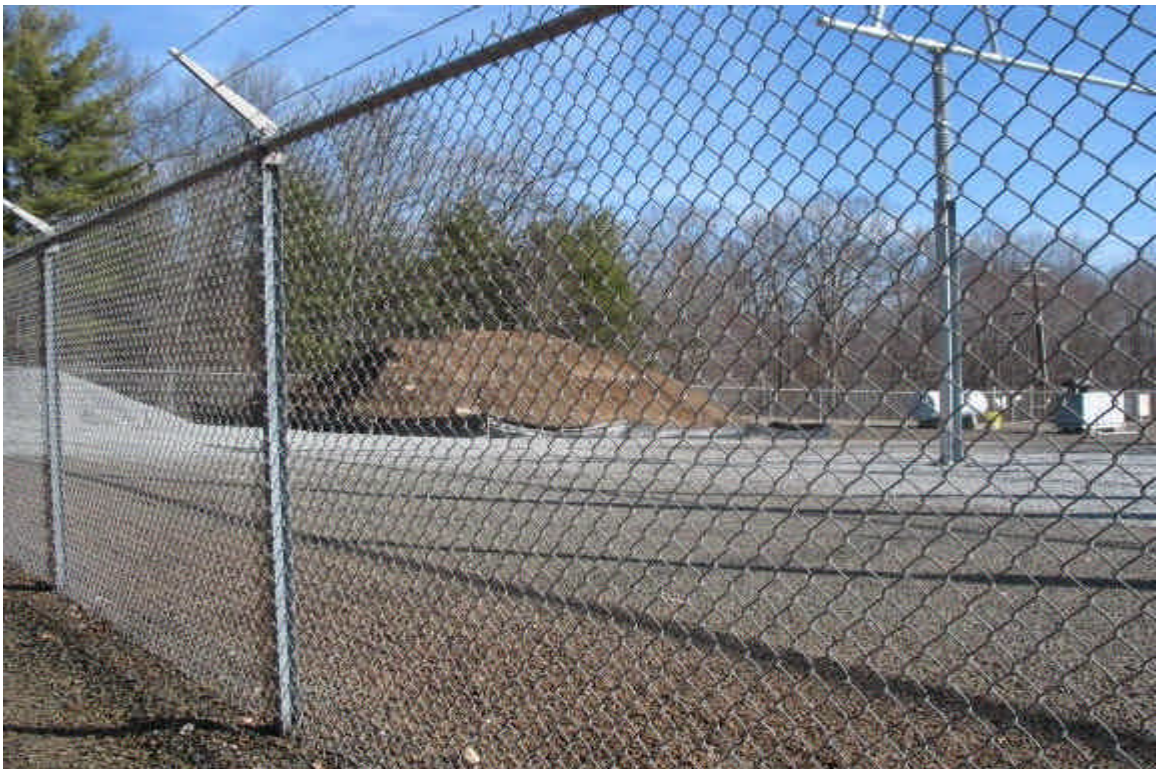
Soil stockpile to be removed. Controls are intact and sediment issues have not been observed.

One stockpile remains in the yard, surrounded by intact silt fence and a flat crushed stone surface. It	Once soil analysis is complete, remove soil and dispose of properly. Soils are contained within	NA
