Docket No. 272 – Development and Management Plan Inspection

Segment 1a Inspection

Date: March 6, 2007

Location: Segment 1a – Scovill Rock Switching Station to Chestnut Junction, Oxbow Junction to Beseck Switching Station (excluding Royal Oak Bypass), and Black Pond Junction to Beseck Switching Station

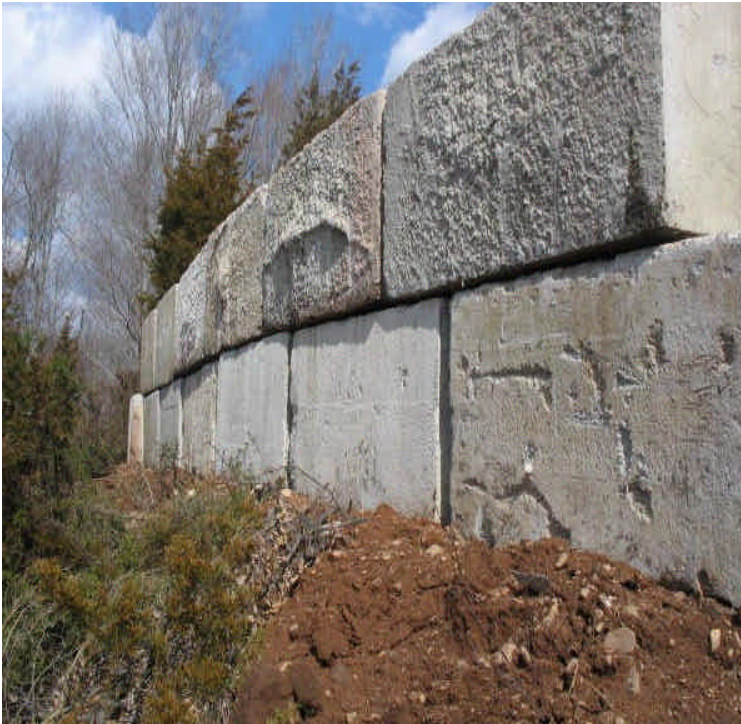
Retaining wall installed along a steep slope at a new pad site in the vicinity of the transfer station land off Cherry Hill Rd.

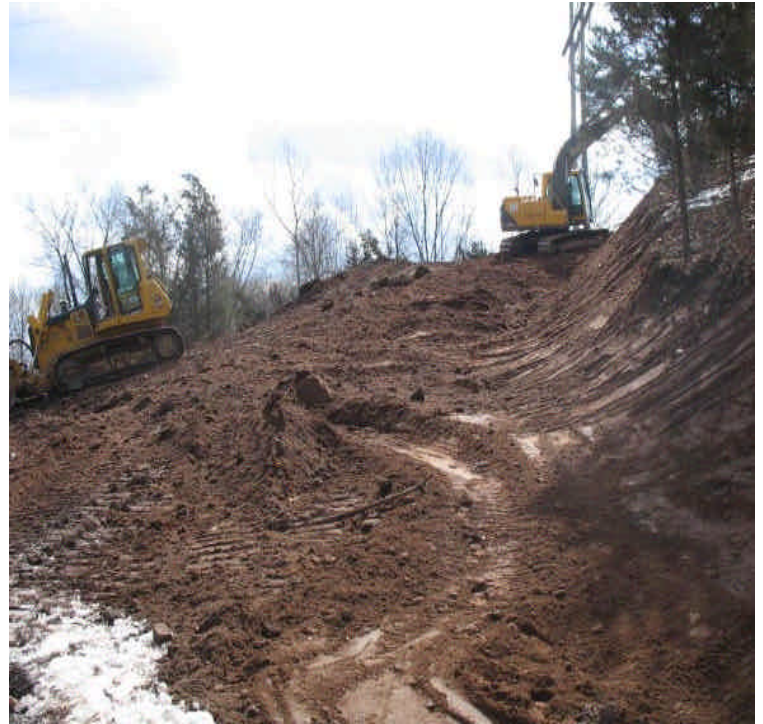
Access road and pad grading in the vicinity of the transfer station land off Cherry Hill Rd. (and vicinity of proposed structures #24523-24)

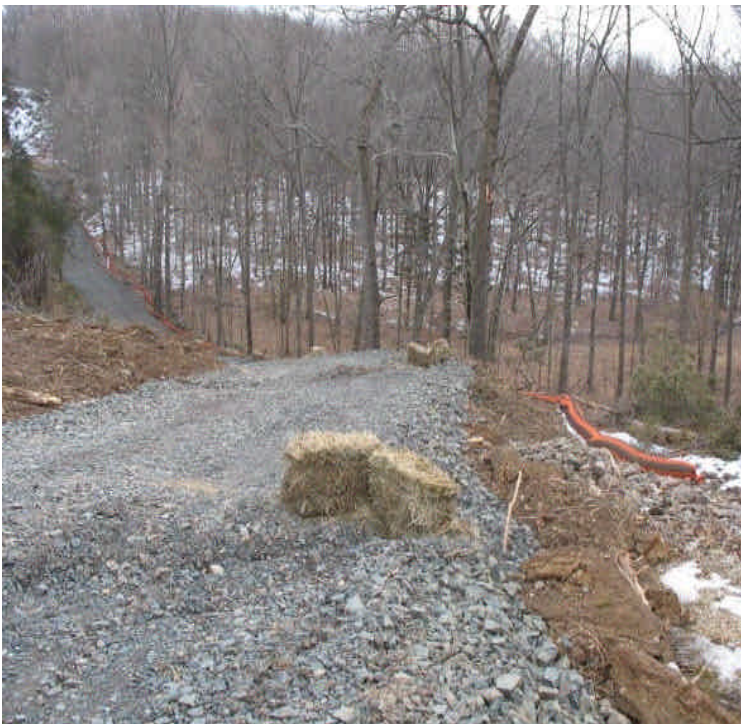
View of access road leading to the culvert area off Black Walnut Dr. Filter socks were in place along the base of slope of the access road. Drainage ditches/waterbars leading to haybales were installed to direct and filter turbid run-off along the access road.

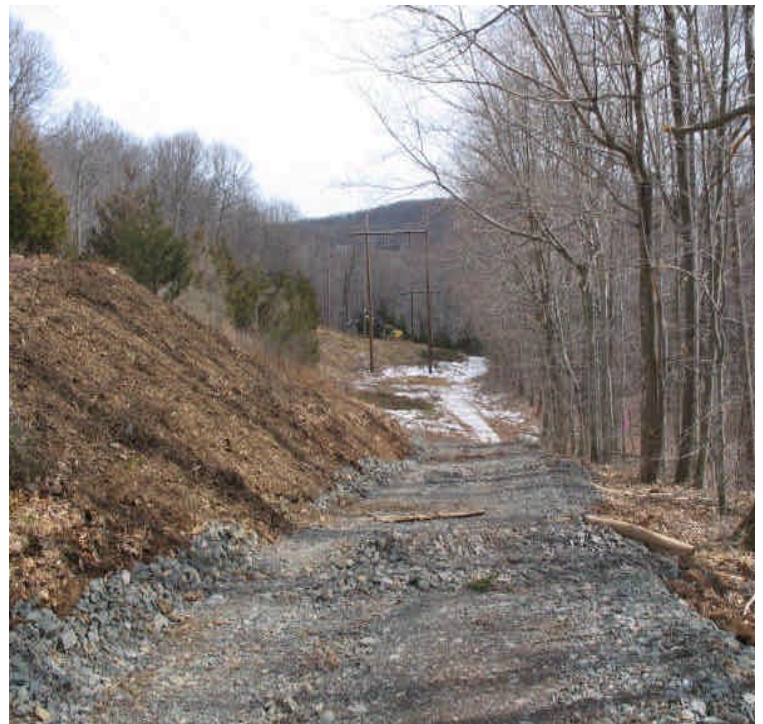
Access road and pad construction continue off Black Walnut Dr.

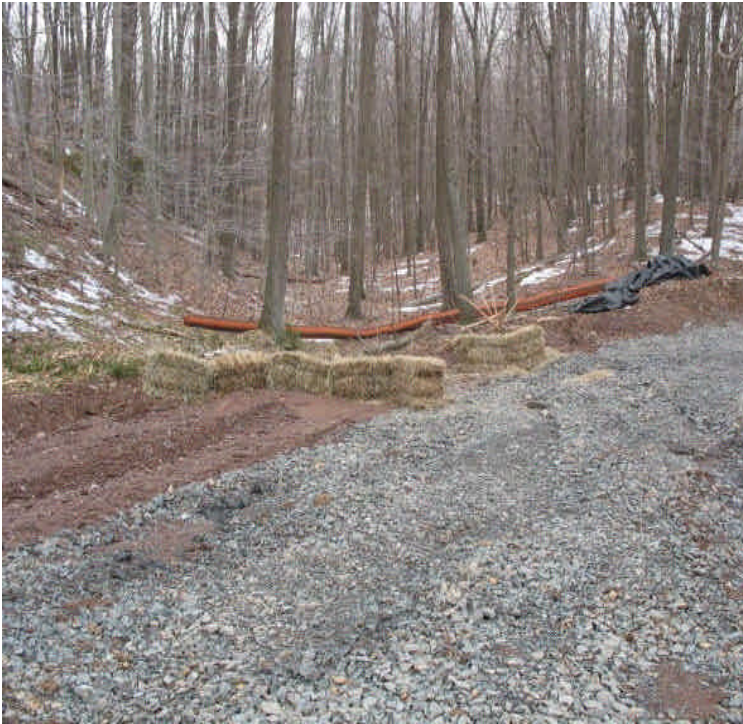
New haybales along the access road off Black Walnut Dr. Access is being installed in this section to reach structure locations to the east. This avoids crossing Ball Brook and associated habitat.

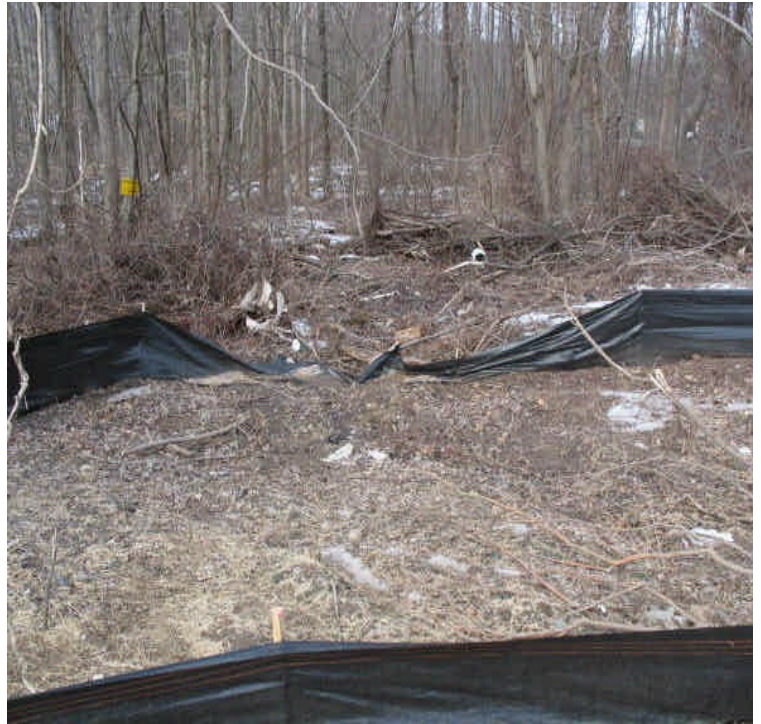
View of some of the erosion controls in place around the perimeter of the contractor receiving yard. Repair the individual sections of silt fence that require maintenance and replace the filter sock that was run over at the entrance.

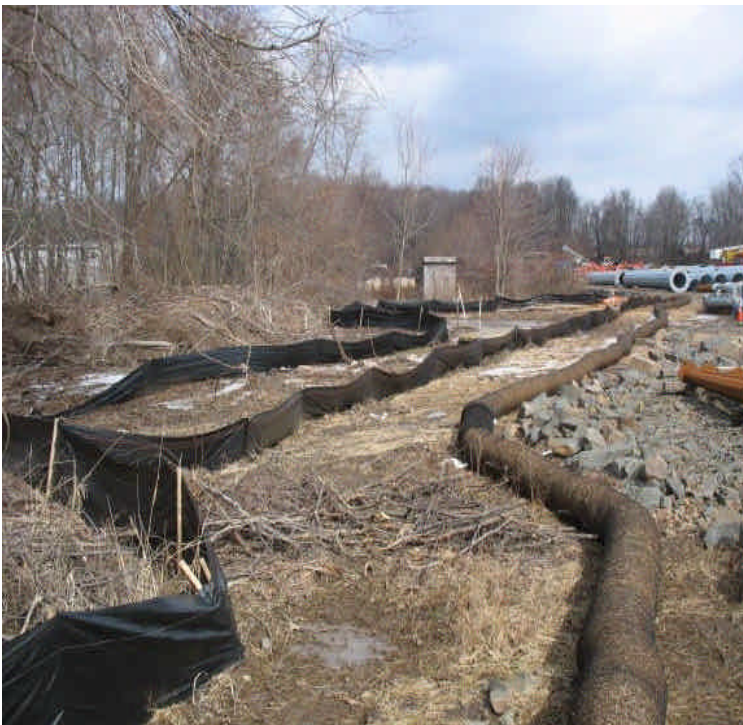
Additional controls remain in place adjacent to wetlands to filter/contain turbid run-off leaving the site.

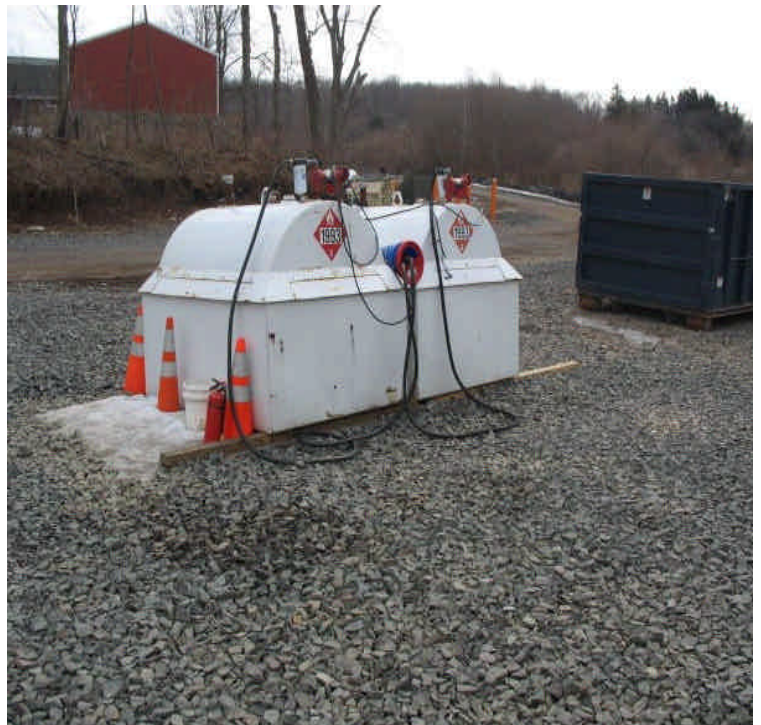
The fuel storage tanks remain in place on the stone spill pad and nozzles are contained. Small drip stains are noted and are contained to the stone.

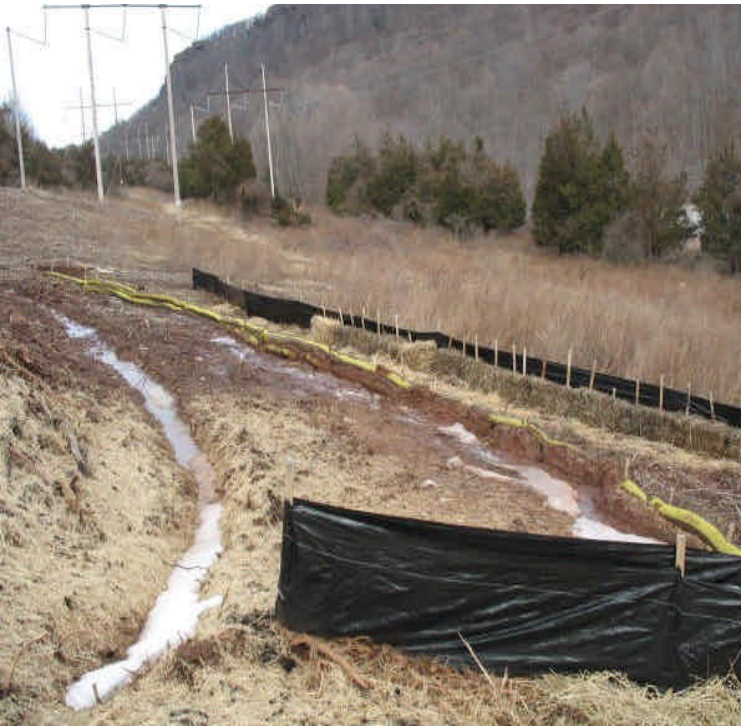
Controls are stable off Black Pond following the installation of the monopole.

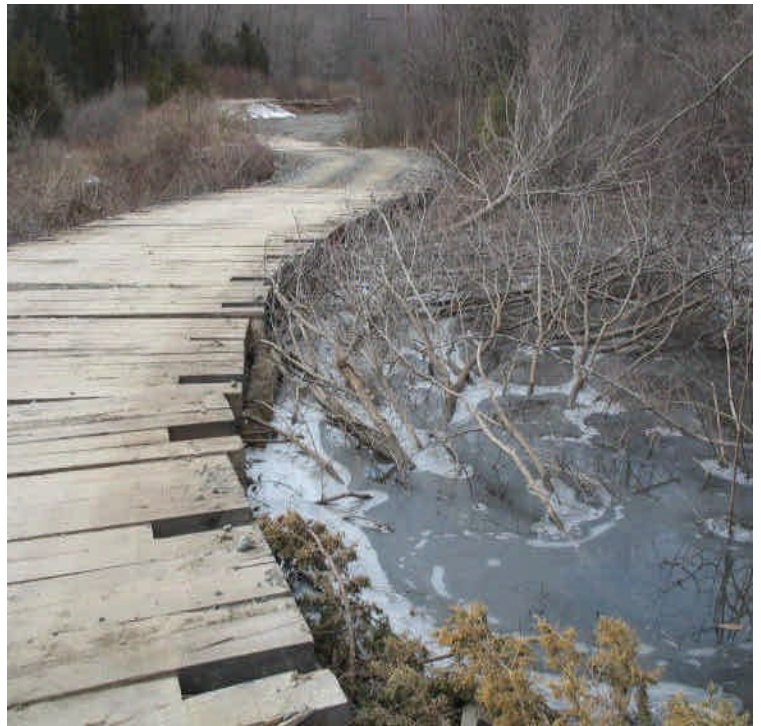
Wetland crossing off Powder Hill Road. No sediment or turbidity was observed coming from the stone crossing

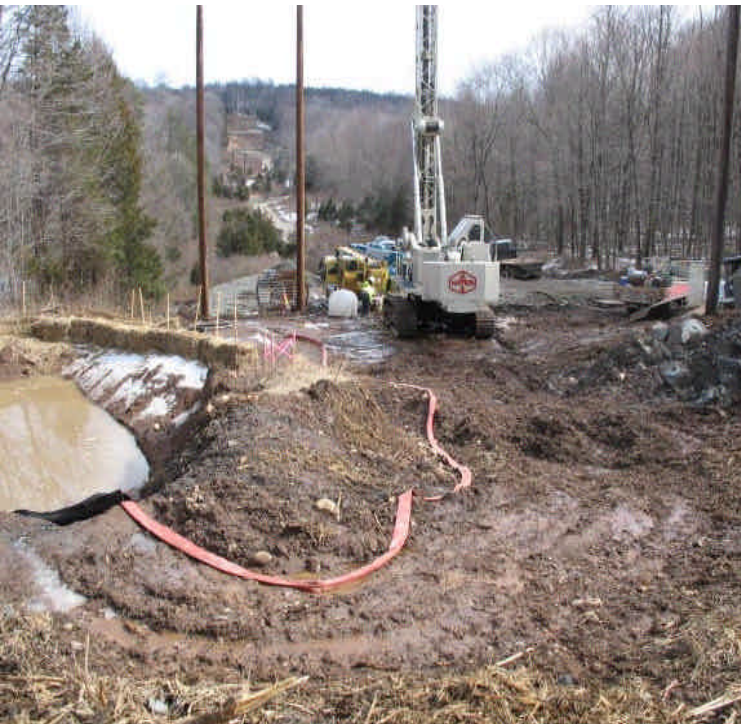
Dewatering and foundation installation off Powder Hill Rd. Water appears to be well contained in a basin at this time.

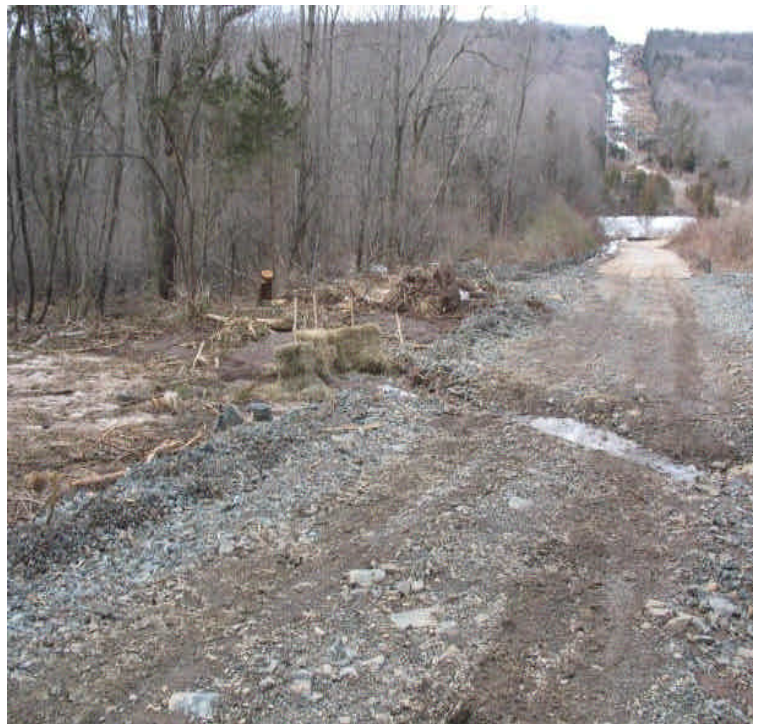
Drainage ditch/water bar and haybales installed along the slope off Powder Hill Rd. Adjust controls as necessary.

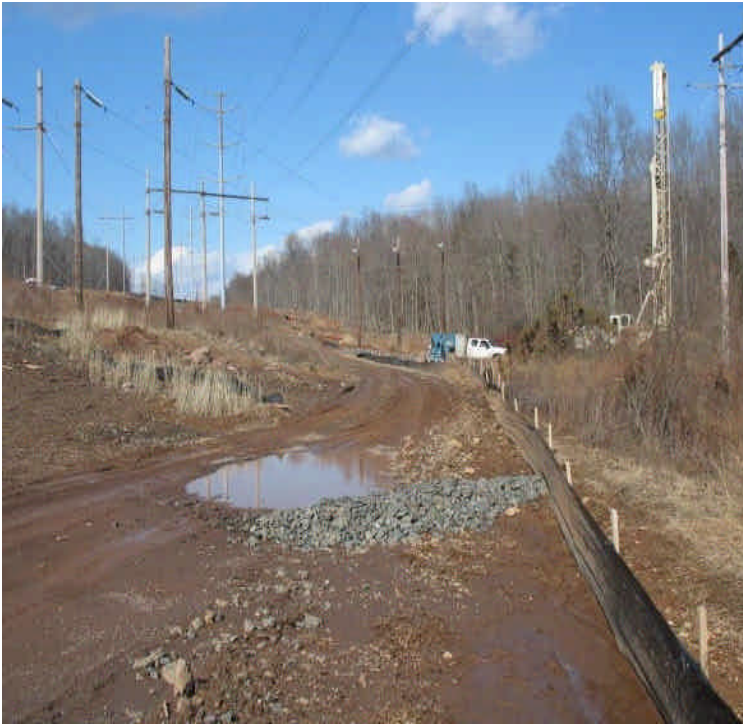
Foundation drilling along the ROW east of Beseck SS. Controls were in place to prevent sediment from entering the wetlands.

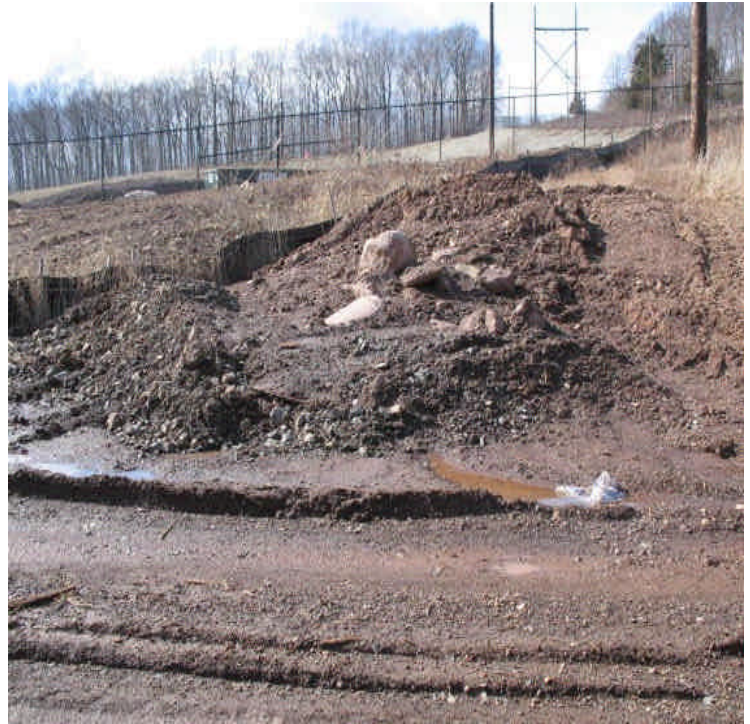
East of Beseck SS	<p>East of Beseck SS, drilling was occurring within the wetland. Slurry was being moved and spread upgradient on a slope. Controls were not in place in slurry containment area and sediment was on the access road. 2/26-3/6/07</p>	<p>It would be a better practice to place slurry into containment areas with controls. Stabilize soil or add controls at this area. 2/26-3/6/07</p>	<p>Better containment is needed.</p>
Black Pond Junction to Beseck SS North of Beseck SS to East Meriden Substation	<p>Dewatering has occurred and water was directed to a large, bermed containment basin and the several filter bags within it. The basin is surrounded by haybales and a secondary overflow basin was installed. 3/6/07</p> <p>Some dewatering slurry was observed beyond controls at the drill site near the pond north of Beseck. 3/6/07</p>	<p>Adjust controls as necessary. All slurry from dewatering and foundation installation appears to be contained at this location. Continue to provide adequate capacity and containment. 3/6/07</p> <p>See erosion control section for more details. Stabilize sediment or remove. 3/6/07</p>	<p>Needs to be monitored closely during drilling</p> <p>Needs proactive attention.</p>

Slurry from foundation drilling in the wetland was being trucked and placed on a slope upgradient. Stabilize soils or install controls as necessary to prevent sedimentation from migrating.

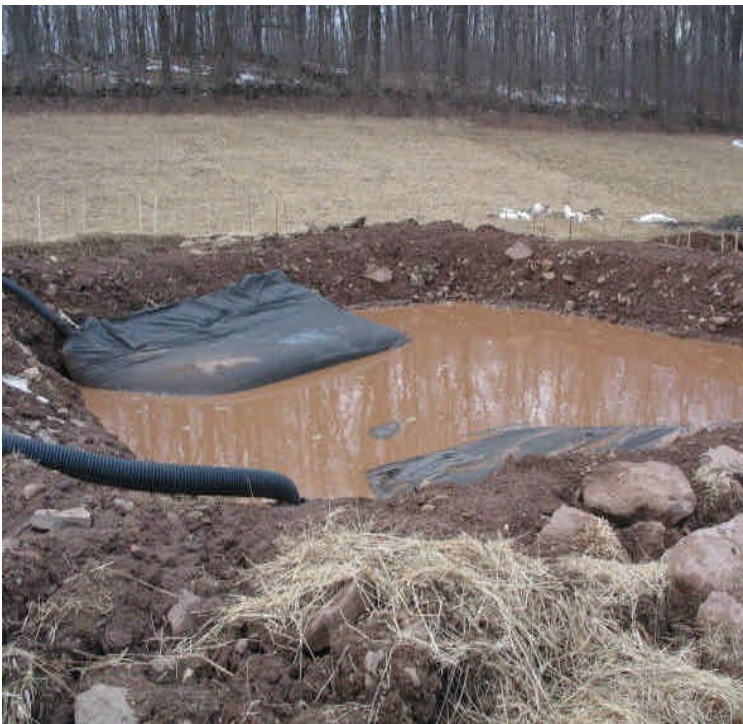
A dewatering basin with filter bags were in place north of Beseck SS.

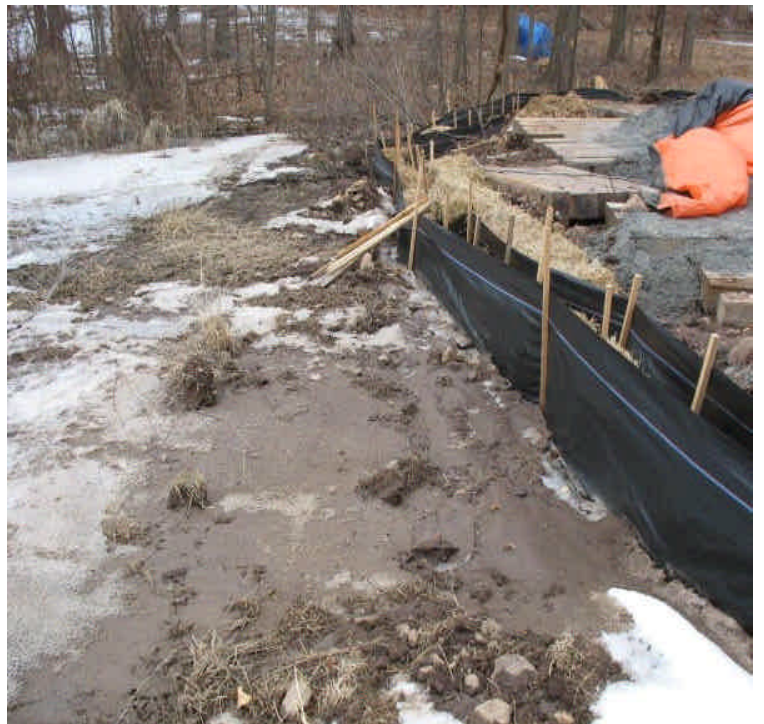
North of Beseck SS: Controls remain in place after the foundation adjacent to the pond was drilled. Ensure that sediment is adequately contained.

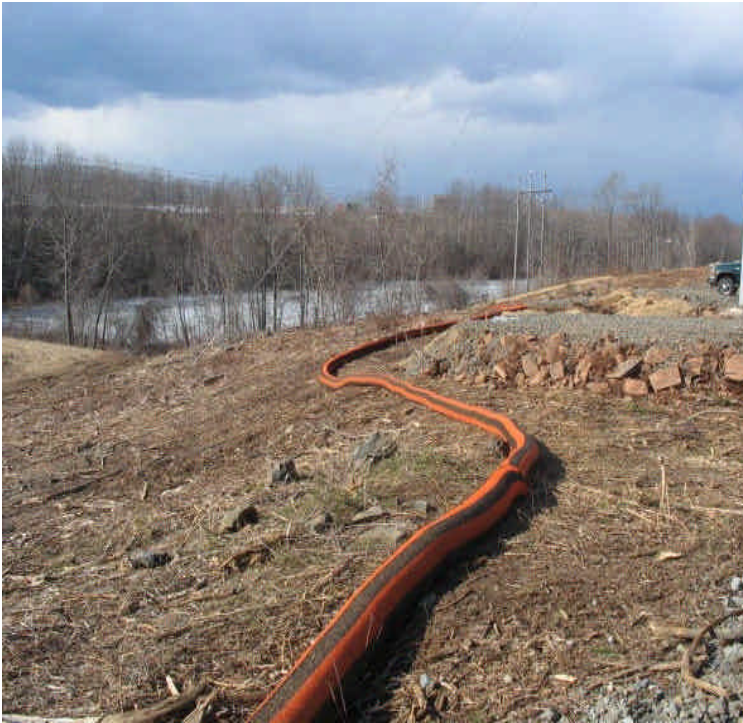
Controls installed along the access road north of Beseck SS to E. Meriden SS. Continue to monitor to confirm filter socks will filter run-off adequately.

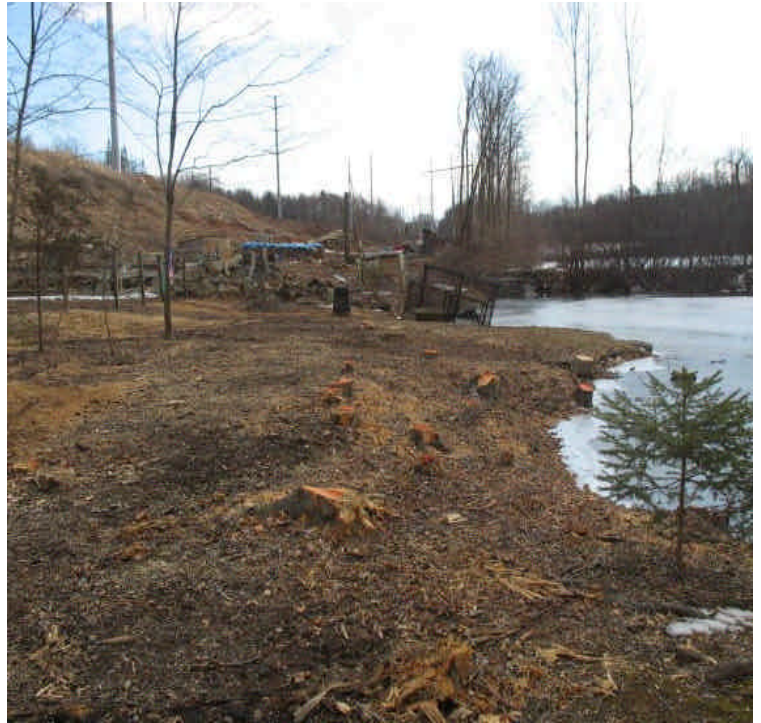
Stumps were left along the bank of a pond to maintain soil stability during clearing along the ROW from E. Meriden SS to Black Pond.

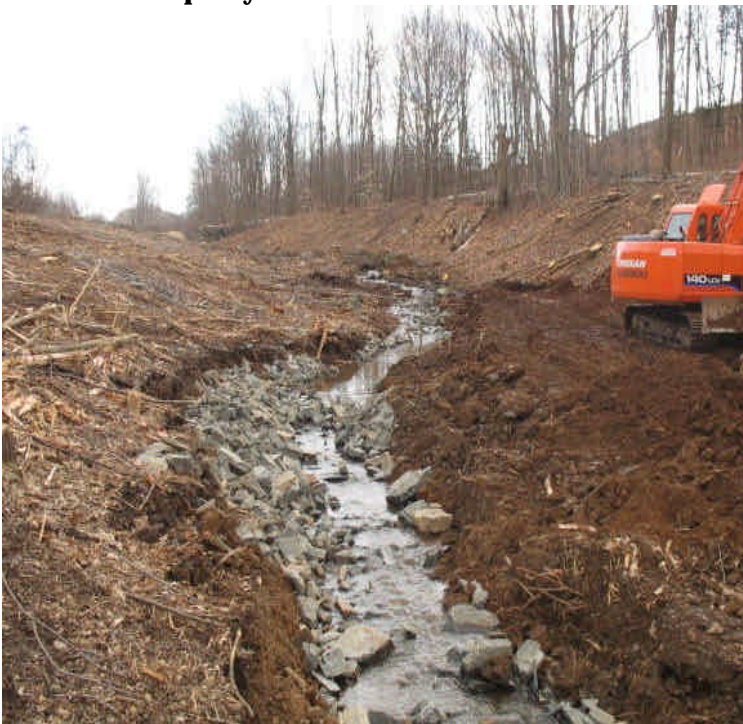
A streambed has been diverted through a riprap channel since pad workspace was necessary adjacent to the existing stream course in several locations between E. Meriden SS to Black Pond. Water in the channel was mainly clear with some suspended sediment.

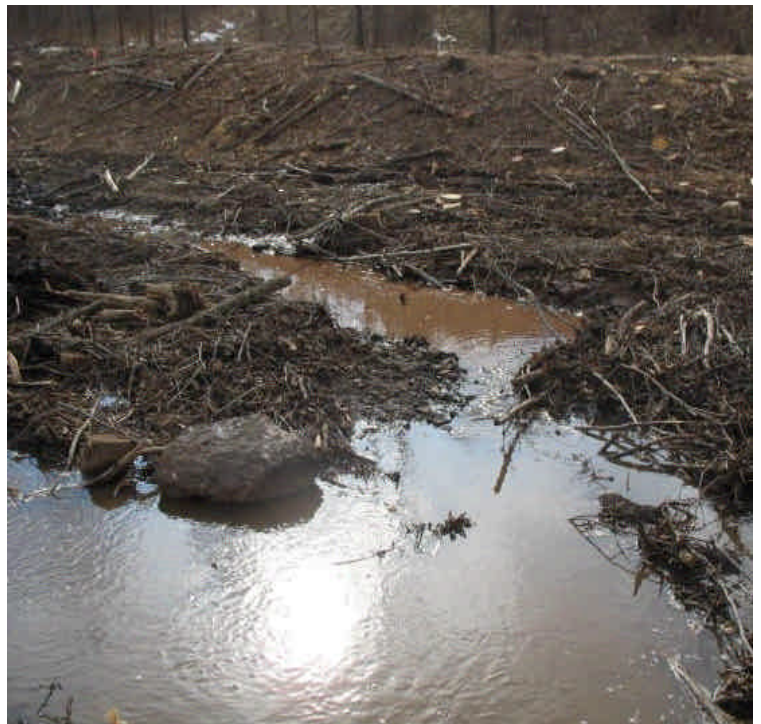
<p>Fleming Road: north past East Meriden Substation to Black Pond</p>	<p>The edge of a work area/pad was being constructed within a stream channel. The stream has been redirected around the pad site through a riprap channel during construction. However, the site is generating turbid run-off from the</p>	<p>Provide temporary stabilization for the adjacent area. Divert runoff to haybales for filtration and consider placing filter socks in the stream channel if feasible. Add and maintain controls until the area is stabilized. 3/6/07</p>	<p>Needs attention.</p>

Areas of Inspection	Observation	Recommended Action	Corrected Action
	<p>fill activities which is reaching the re-routed stream downgradient. Turbidity was diluted by the time the flow reaches Black Pond. 3/6/07</p> <p>The banks and adjacent soil to the re-routed stream were exposed as well. 3/6/07</p> <p>Some stumps have been left along the banks of a pond in this section of ROW so the root system would help stabilize soils. 3/6/07</p>	<p>Provide temporary stabilization measures for adjacent soil in an effort to reduce turbidity. 3/6/07</p> <p>Continue to monitor and install additional stabilization measures as necessary. 3/6/07</p>	<p>Needs attention.</p> <p>Vegetation and stumps were retained to stabilize soil.</p>
<p>Inland Wetland and Watercourse encroachment and mitigation</p> <p>Most access areas (including ROW North of Beseck SS; Arbutus St.; Little Lane; Durham Rd.; Powder Hill Rd. Black Walnut Dr.)</p> <p>Oxbow Junction to Beseck SS Haddam Quarter Rd. To Foot Hills Rd.</p> <p>Contractor Storage Yard</p> <p>Durham Rd.</p>	<p>ACOE permit is in hand. 1/22/07</p> <p>A number of wetland crossings (via timber mats) were noted. Adjacent controls were installed. 3/6/07</p> <p>Sedimentation issues were not noted but additional controls may be needed to protect offsite and isolated wetlands when work resumes. 3/6/07</p> <p>Previous sedimentation has been noted within the wetlands and pond but ice and snow cover make observation difficult. The controls appear to be filtering turbid water flowing from the site. 3/6/07</p> <p>Access at Durham Rd reached a deeper area in</p>	<p>Perform work in wetlands under the permitted guidelines. 3/6/07</p> <p>Monitor closely for sedimentation and add controls as needed. All crossings are temporary and will require restoration at the end of the work. 3/6/07</p> <p>Caution should be taken not to fuel or store equipment near any wetlands. 3/6/07</p> <p>Continue to monitor. Adjust controls as needed around the site. 3/6/07</p> <p>Ensure that construction windows and access</p>	<p>NA</p> <p>NA</p> <p>NA</p> <p>NA</p> <p>NA at this time</p>

The stream flow was picking up sediment and becoming turbid down-gradient of the diversion. Additional controls are needed (i.e. filter sock across the channel and temporary soil stabilization measures on the adjacent exposed soil and banks).
