**Docket No. 272 – Development and Management Plan Inspection**

**Segment 1a Inspection**

**Date:** March 19, 2007

**Location:** Segment 1a – Scovill Rock Switching Station to Chestnut Junction, Oxbow Junction to Beseck Switching Station (excluding Royal Oak Bypass), and Black Pond Junction to Beseck Switching Station

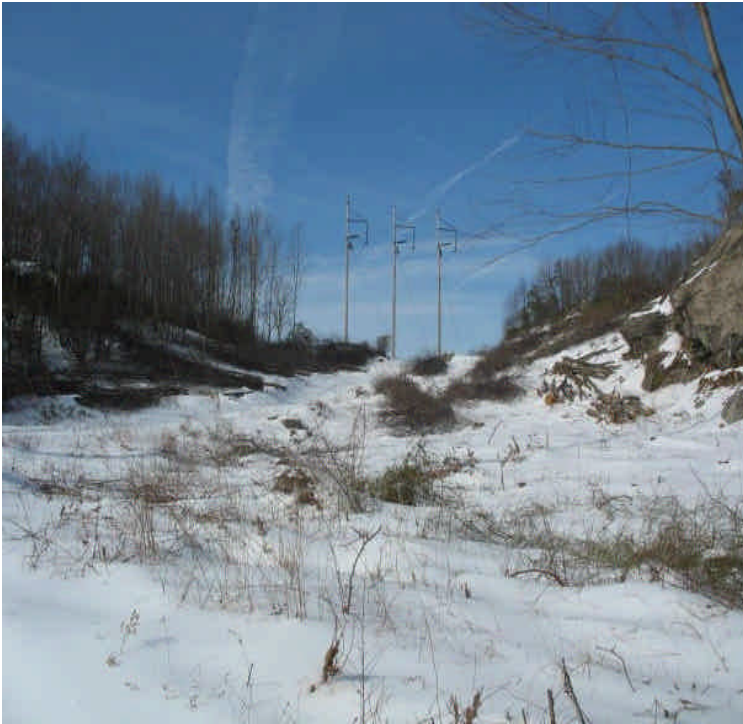
**View of minor clearing west of Scovill Rock SS within the existing ROW.**

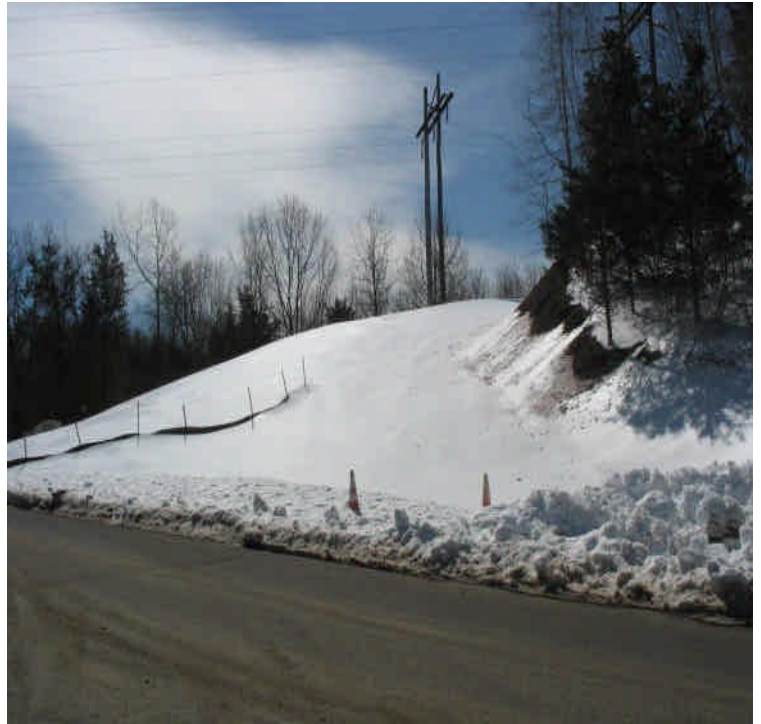
**Filter socks were added along the pad and access road slope in the vicinity of the transfer station off Cherry Hill Rd. Ensure that controls are adequate to slow erosion.**

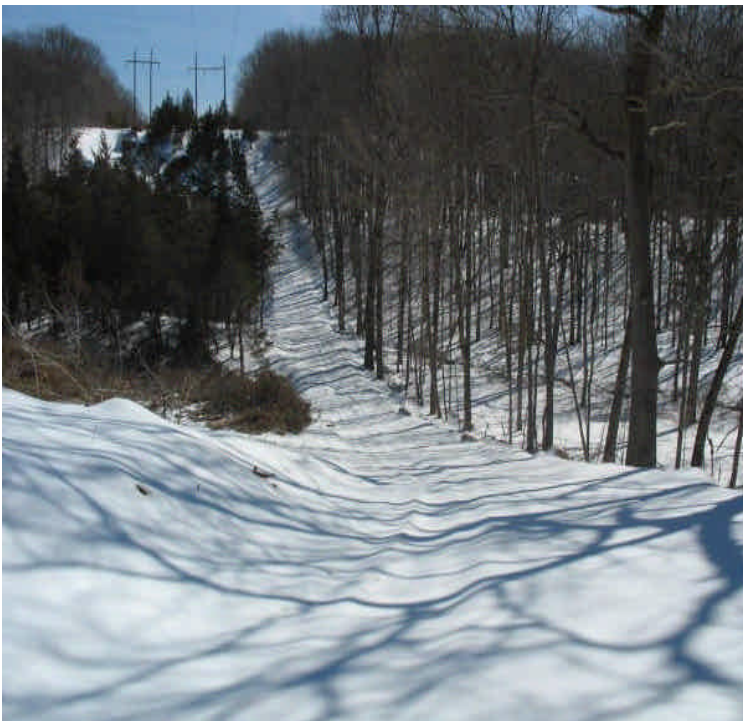
**View of access road leading to the culvert area off Black Walnut Dr. Check dams (haybales and stone) were in place along the access road. Drainage ditches/waterbars leading to haybales were installed to direct and filter turbid run-off along the access road.**

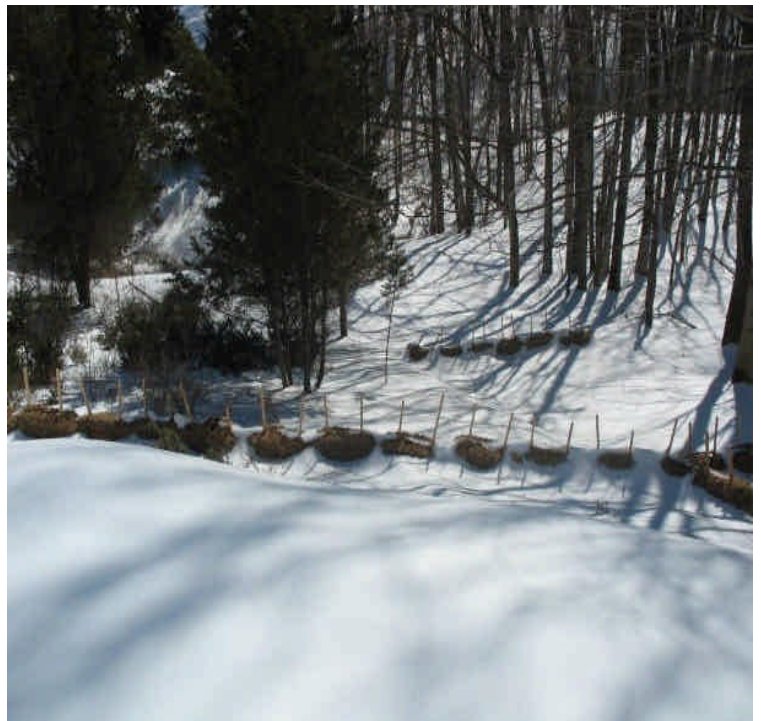
**Pad site installed off Black Walnut Dr. upgradient of Ball Brook. Additional mulch, haybales, and a filter sock were placed along the slope in an effort to reduce erosion prior to snow cover.**

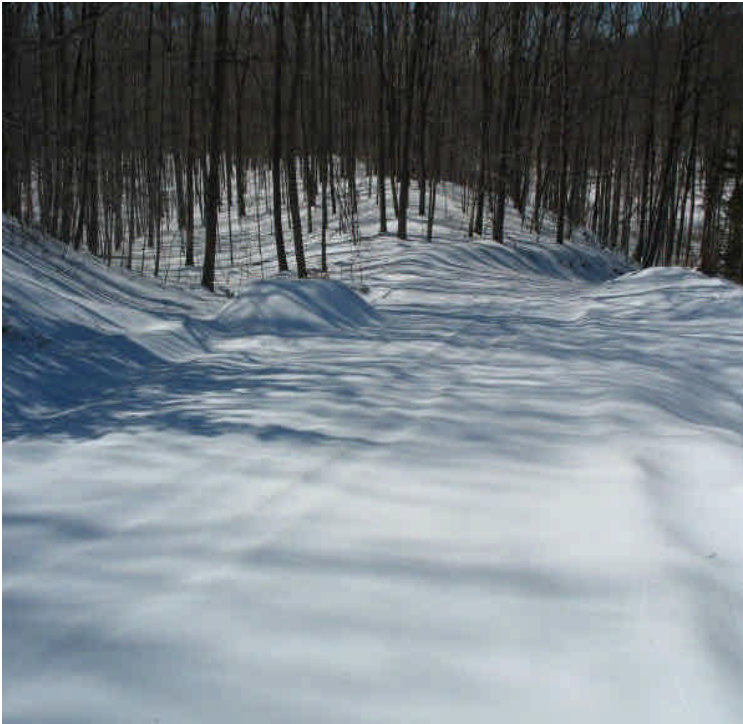
**Haybales and water bars are in place along the access road off Black Walnut Dr., currently under snow cover. Continue to monitor the area as snow melts and ground thaws.**

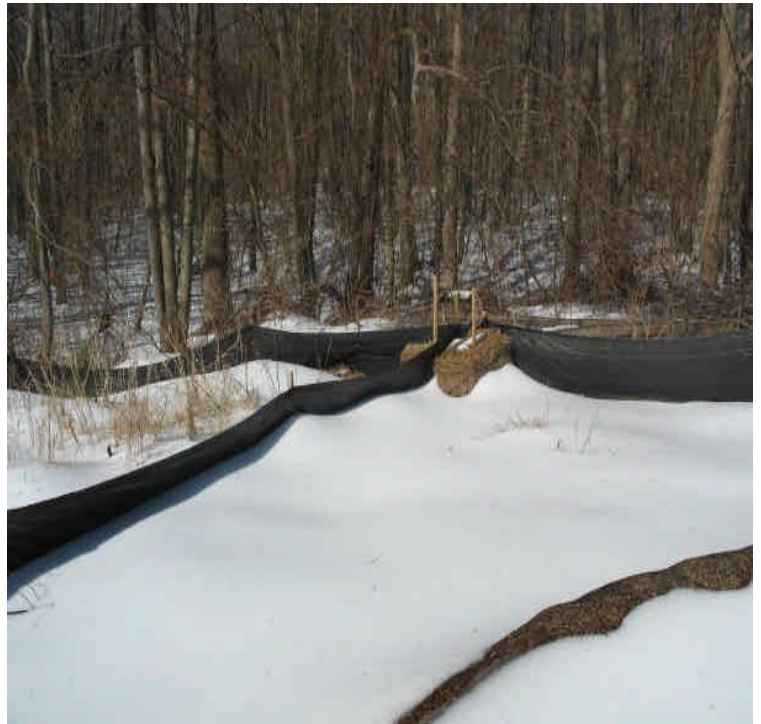
**Silt fence, fiber rolls, and hay mulch are in place as a buffer for wetlands around the perimeter of the contractor receiving yard. Fallen sections of silt fence were supported with haybales.**

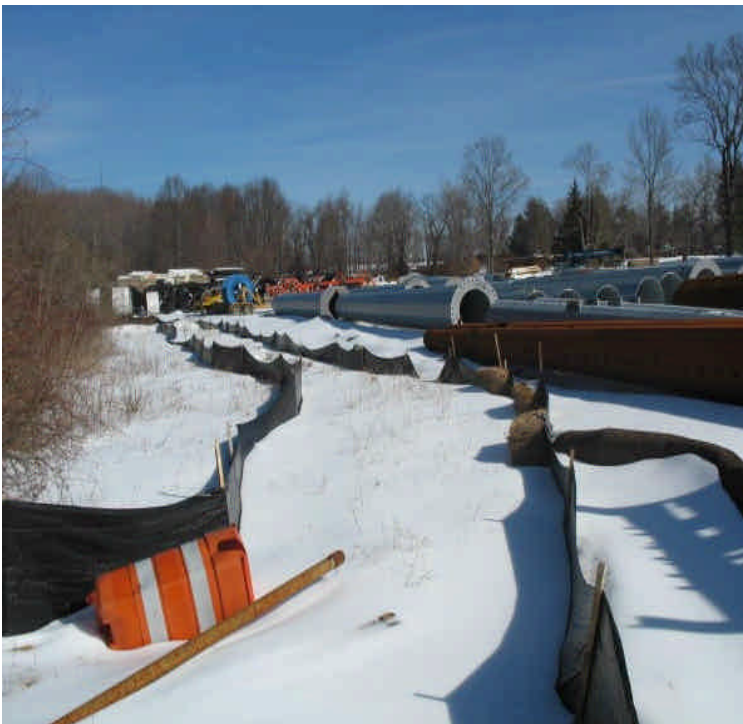
**Additional controls remain in place adjacent to wetlands to filter/contain turbid run-off leaving the site.**

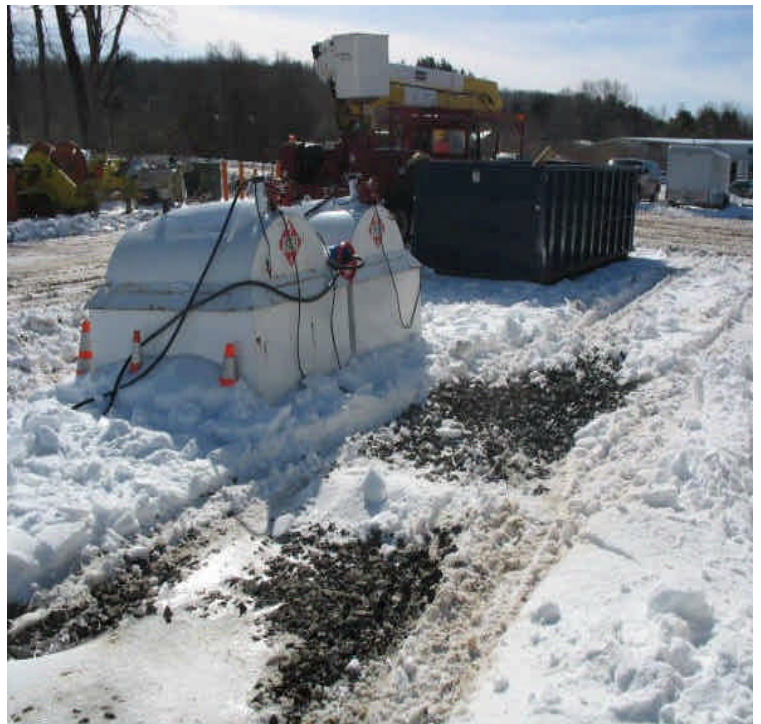
**The fuel storage tanks remain in place on the stone spill pad and nozzles are contained. Larger drip stains were noted; spills contained to the stone.**

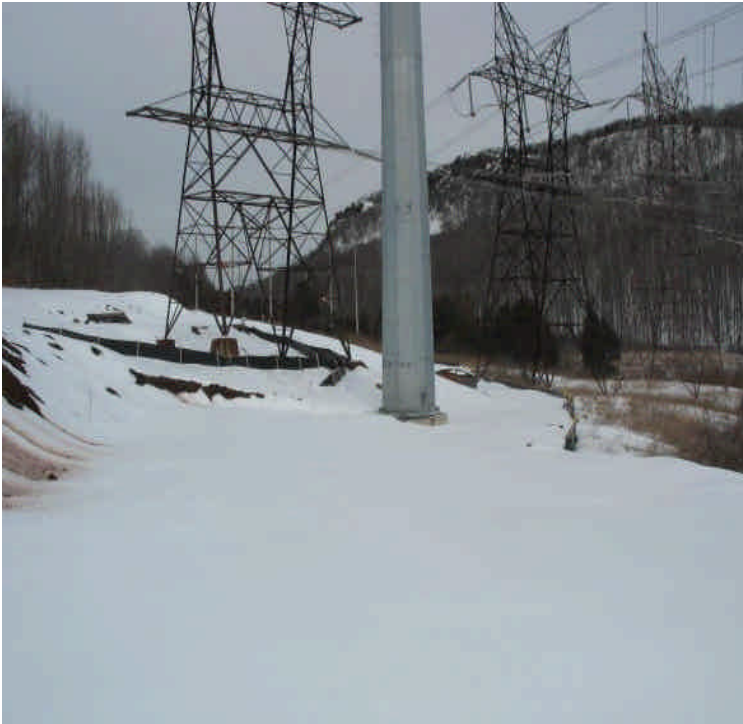
**Controls remain stable off Black Pond following installation of the monopole. No active work in this area.**

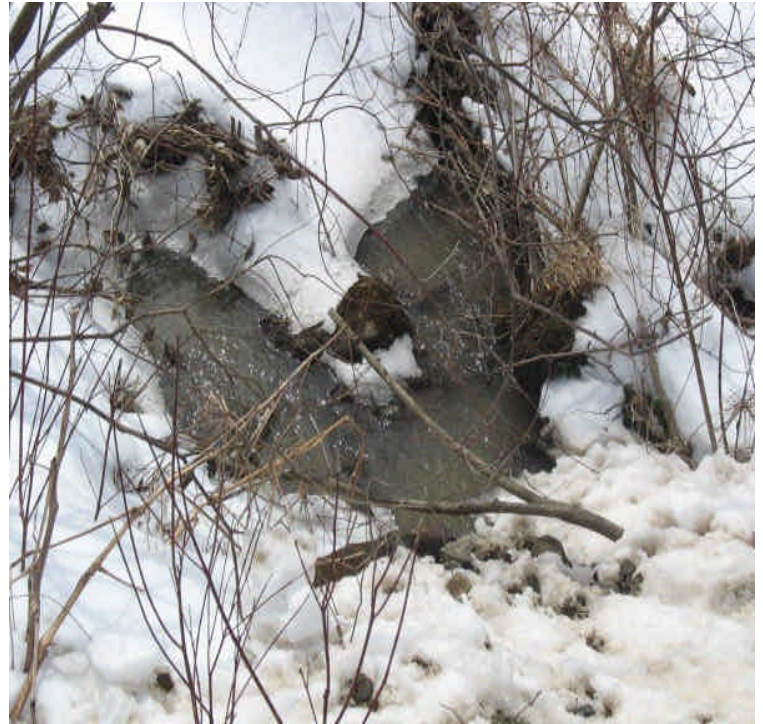
**Wetland crossing off Powder Hill Road. Slightly turbid water was observed flowing from the stone crossing despite controls.**

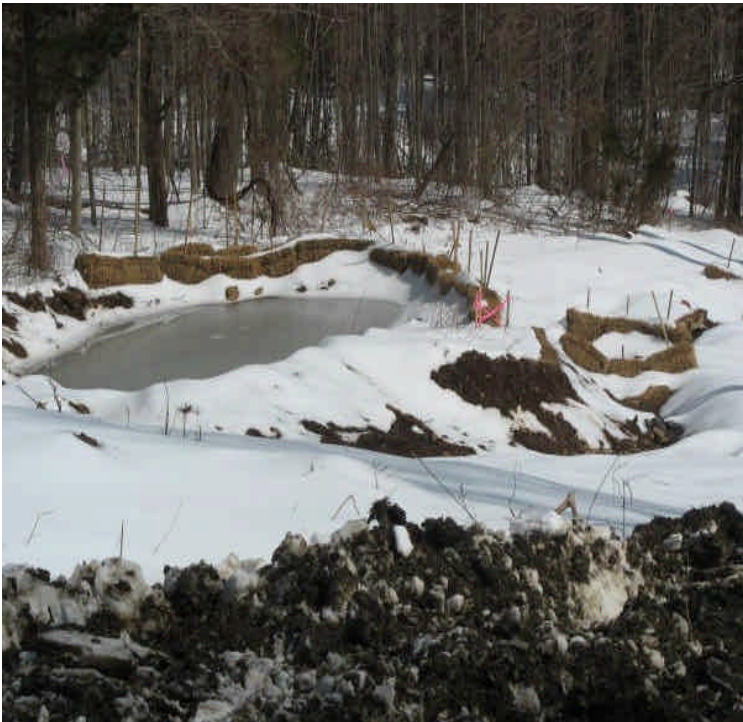
**View of water and slurry from dewatering the foundation excavations off Powder Hill Rd. This appears contained to the basin.**

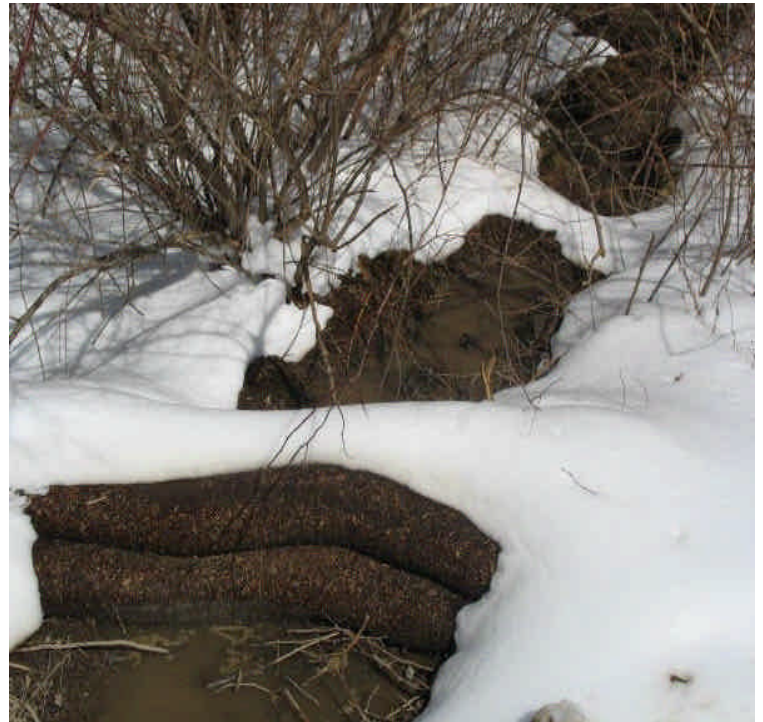
**Turbid water and sediment is seeping through some of the controls in some areas located off Powder Hill Rd. Contractors were actively working to repair the problems during the inspection.**

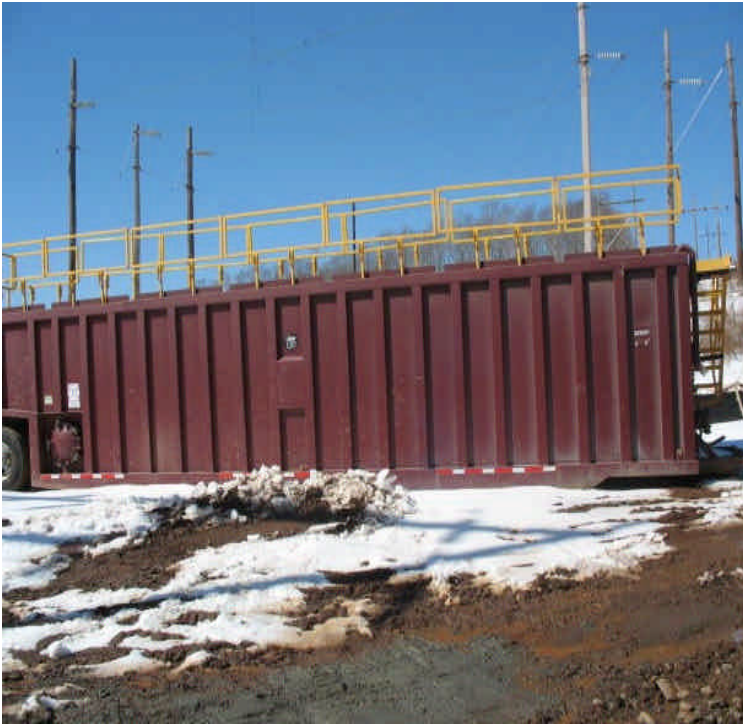
**Dewatering tank along the ROW east of Beseck SS. Slurry was removed from the foundation and transported to a containment basin. Controls were in place along the wetland edge.**

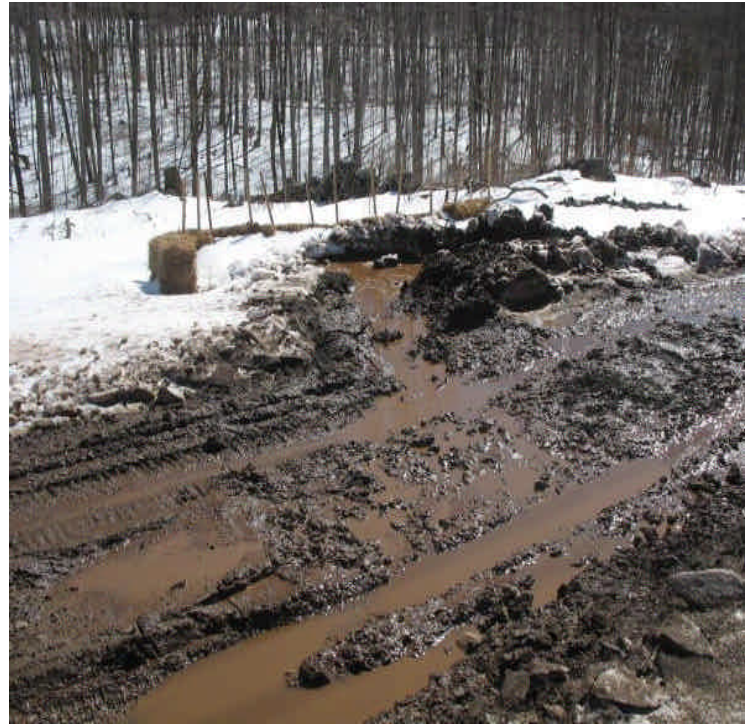
**Turbid run-off and mud cover the surface of the access road north of Beseck SS. Consider stabilizing the access road with stone. Remove sediment accumulation from controls as needed.**

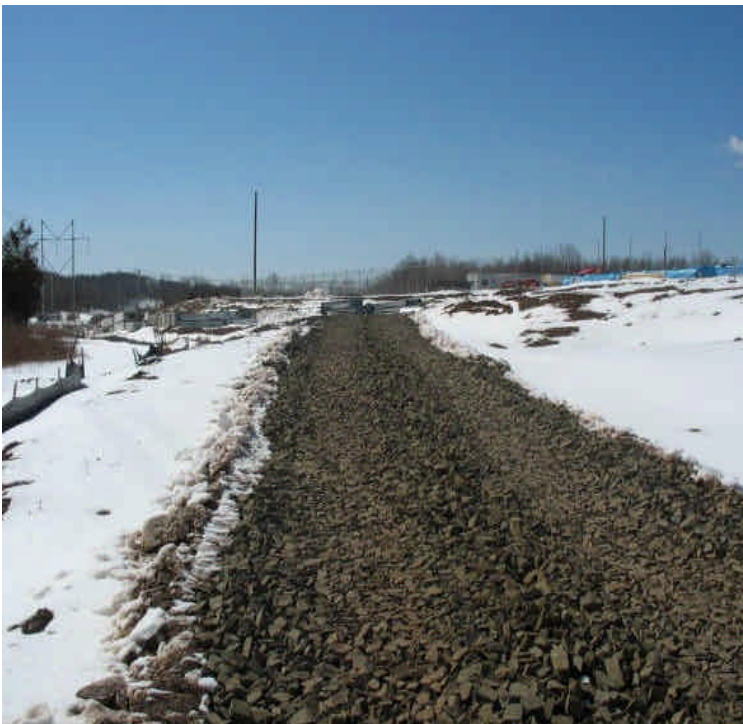
**Tracking pad installed along the ROW and connecting to the Beseck SS stone entrance pad to reduce sediment tracking from the ROW.**

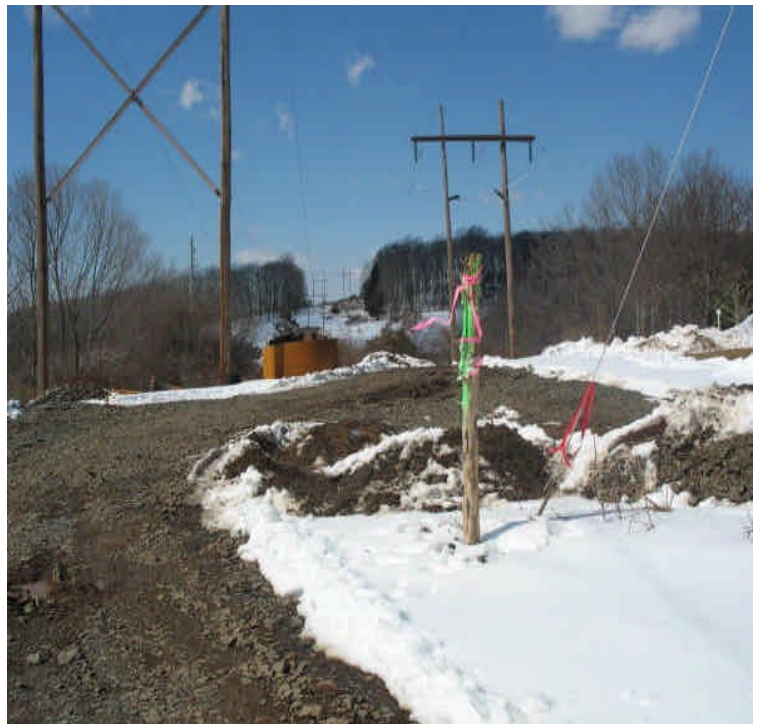
**New pad site installed off of Valley View Drive and east of Beseck SS.**

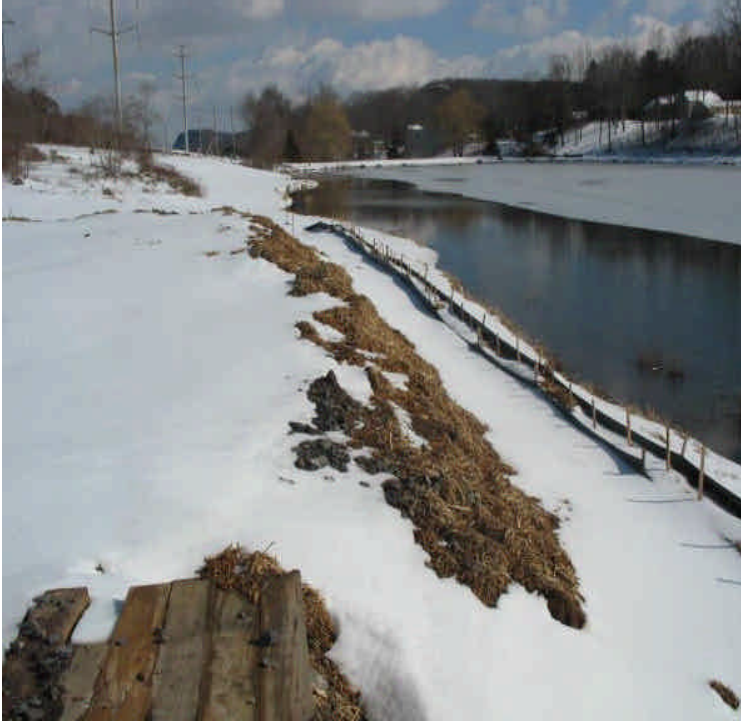
**Controls remain in place along the pond north of Beseck SS to E. Meriden SS off Fleming Rd.**

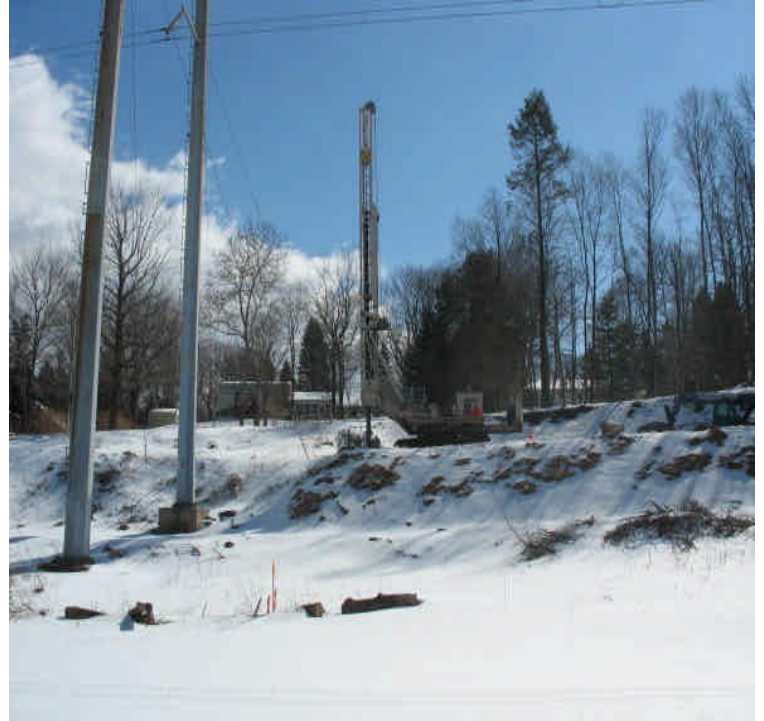
**Foundation drilling just south of E. Meriden SS. Slurry pit has been established if needed.**

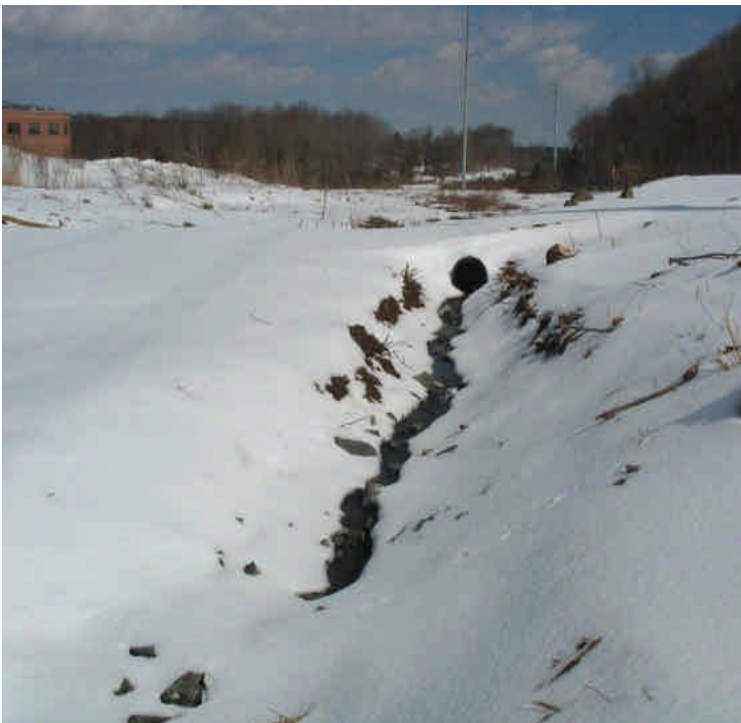
**View of the stream flow diverted through the culvert and riprap channel in the ROW between E. Meriden SS to Black Pond. Water in the channel was clear.**

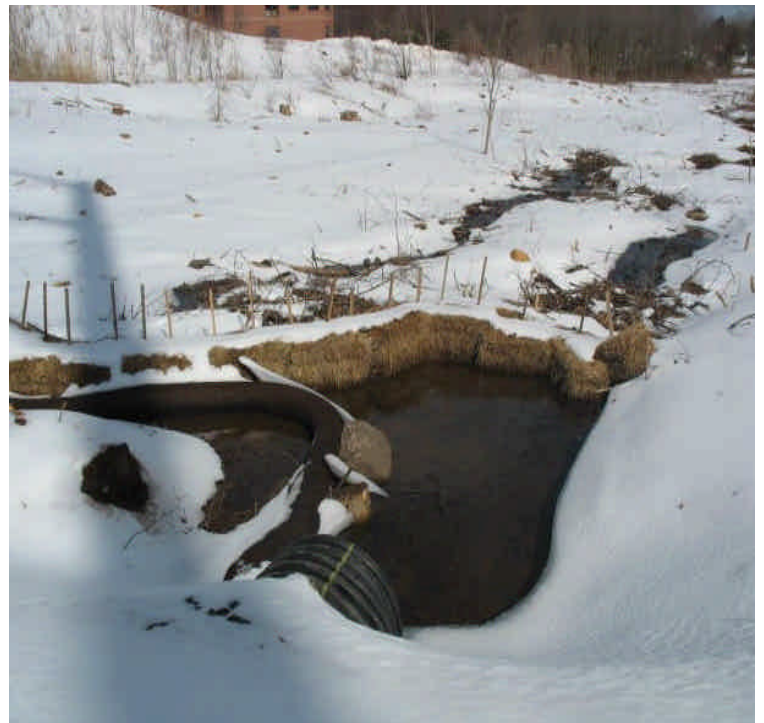
**New controls remain downgradient along the diverted stream channel. Controls appear to be filtering all sediment before it leaves the construction area.**
