Docket No. 272 – Development and Management Plan Inspection

Segment 1b (Royal Oaks Bypass) Inspection

Date: March 26, 2007

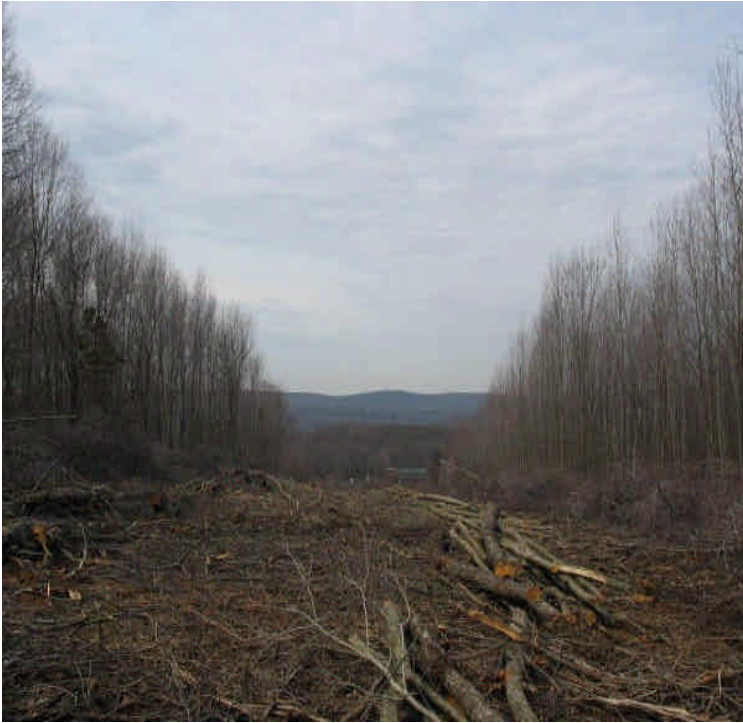
View of the recently cleared portion of ROW looking west toward Route 9.

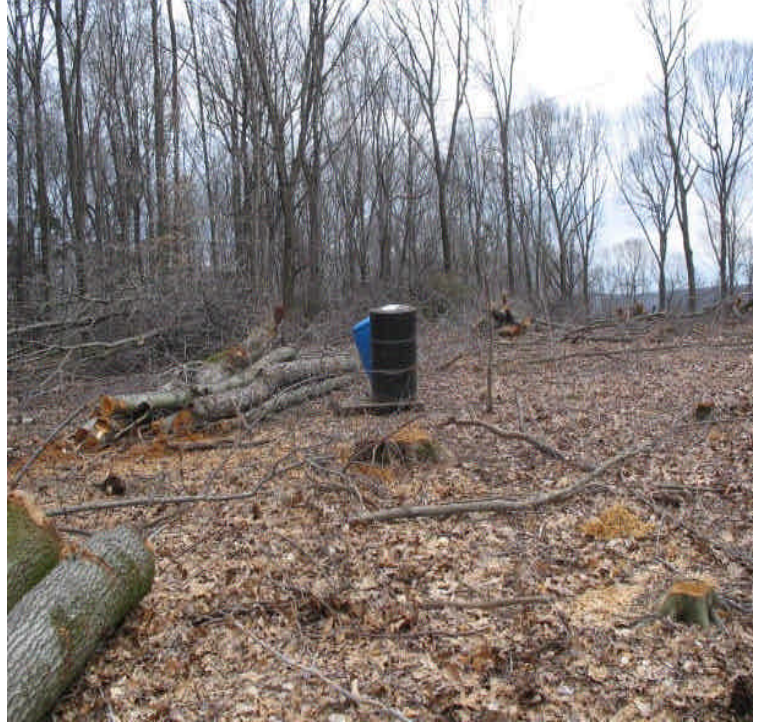
Areas of Inspection	Observation	Recommended Action	Corrected Action
	<p>Two large drums (55 gallon) one plastic, one metal were located within the ROW. These were not located near wetlands. 3/26/07</p>	<p>Unclear whether drums were stored as part of the work or were already present in the woods. Continue to store materials and equipment 100 ft from wetlands where feasible. 3/26/07</p>	<p>NA.</p>
<p>Additional Observations</p>	<p>NA</p>	<p>NA</p>	<p>NA</p>

View of two 55-gallon drums stored along the ROW. Drums were located away from wetlands. Trees were being stockpiled, removed, and chipped.

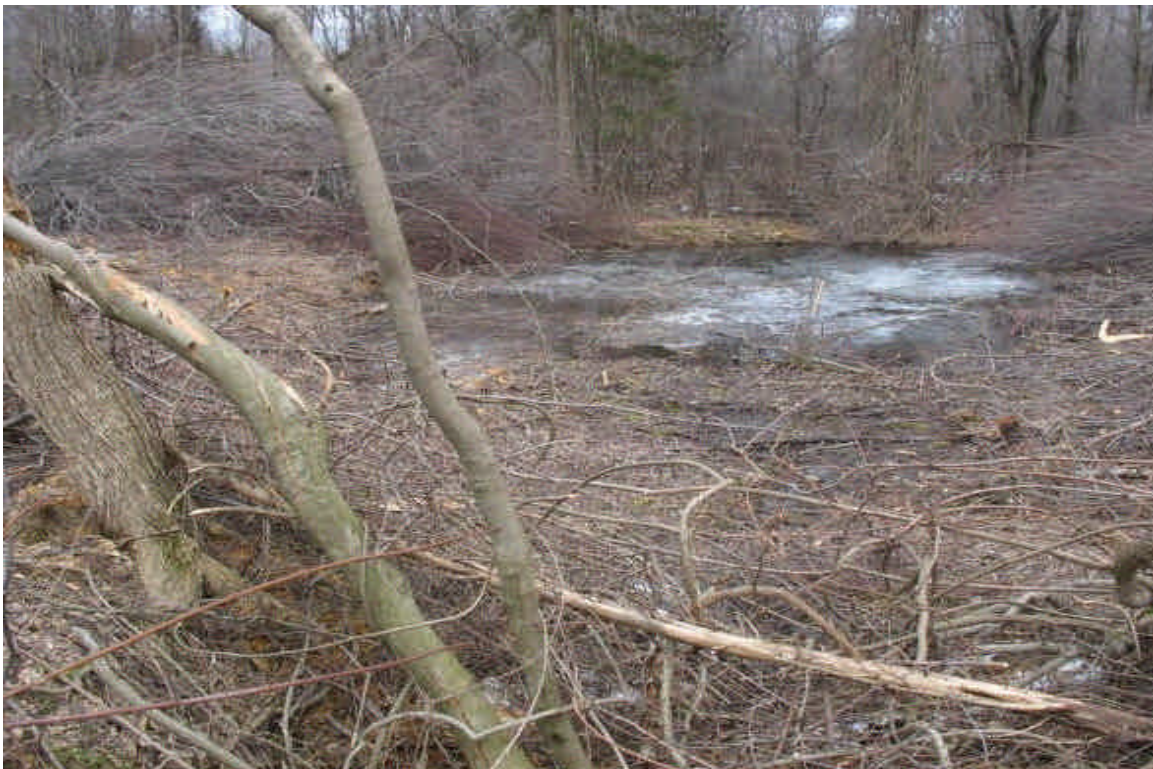
Areas of Inspection	Observation	Recommended Action	Corrected Action
encroachment and mitigation	<p>the site work were avoided. 3/26/07</p> <p>Using multiple access points from Rt 17 and Black Walnut Dr. allowed equipment to stay out of a wetland within the ROW. Controls were not in place here but roots stabilize the soil. 3/26/07</p>	<p>route. 3/26/07</p> <p>Install controls where necessary. Continue to retain as much vegetation as possible in and adjacent to wetlands. 3/26/07</p>	<p>Direct wetland impacts were avoided by using multiple access points. Low impact clearing techniques were noted</p>
State species of concern, threatened and endangered species.	<p>According to the D&M plan, state-listed species are not located in this work area.</p>	<p>None</p>	<p>NA</p>
Vegetative clearing or stabilization	<p>Clearing along the ROW was almost complete. Trees were being removed from the ROW and chipped during the inspection. Several larger trees were left to be felled by hand after the existing timber stockpiles have been removed. 3/26/07</p> <p>Hand clearing was also noted within a wetland in the ROW. 3/26/07</p>	<p>Monitor slopes and wetland for erosion and run-off. Continue to retain the appropriate low growing vegetation and species to the extent feasible in accordance with the D&M Plan. 3/26/07</p> <p>Continue to retain as much vegetation as possible and continue the good efforts for low impact clearing. 3/26/07</p>	<p>Selective cutting measures were noted.</p> <p>Direct impacts and equipment access in wetlands were avoided.</p>

View of a wetland within the ROW, which was bypassed by accessing the ROW from two different points. Equipment remained outside of wetlands to minimize direct impacts.
