**Docket No. 272 – Development and Management Plan Inspection**

**Segment 2a Inspection**

**Date:** March 6, 2007

**Location:** Segment 2a – Beseck Switching Station to Cheshire/Hamden Town Line

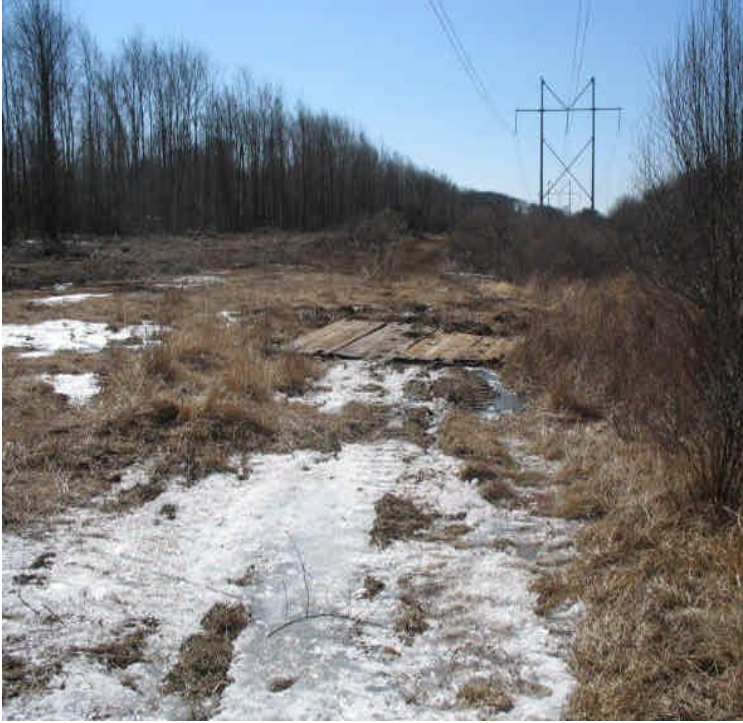
**ROW clearing and timber mat installation south of Beseck SS off High Hill Rd. Low vegetation was retained within the wetlands here appropriately. Controls may be needed if soil becomes disturbed.**

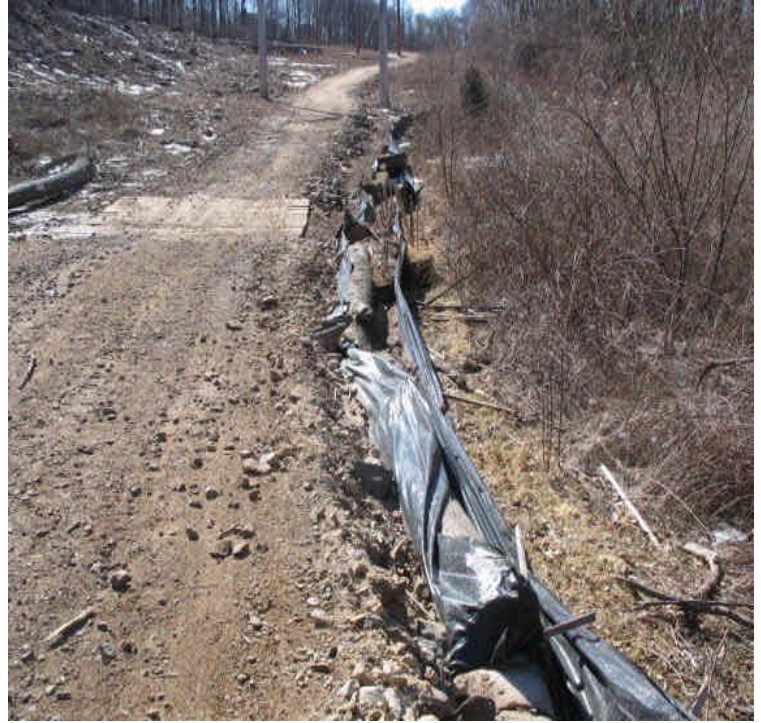
**Silt fence and haybales are degraded along the access road off High Hill Rd. Replace/maintain controls when feasible.**

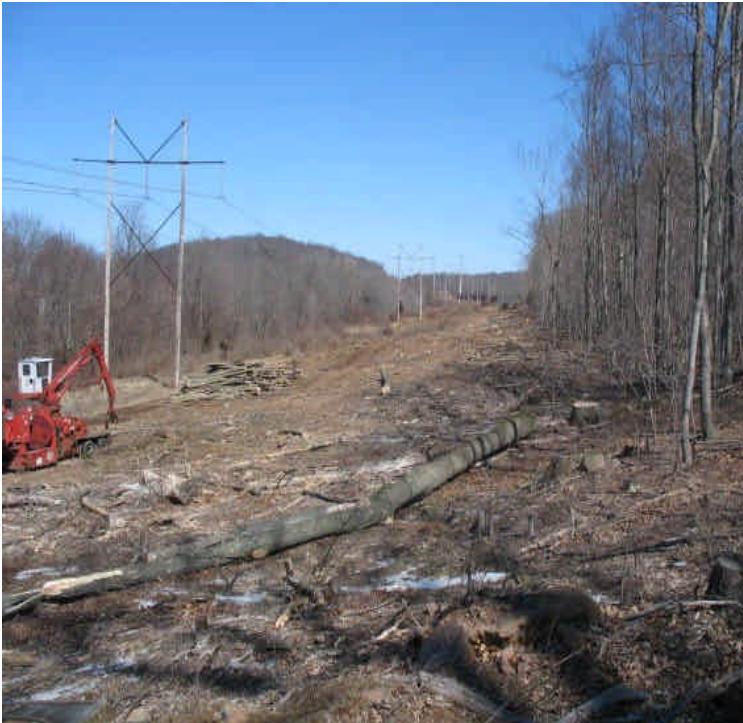
**Clearing was occurring north of High Hill Rd. in the ROW moving toward Carpenter Lane and Beseck SS.**

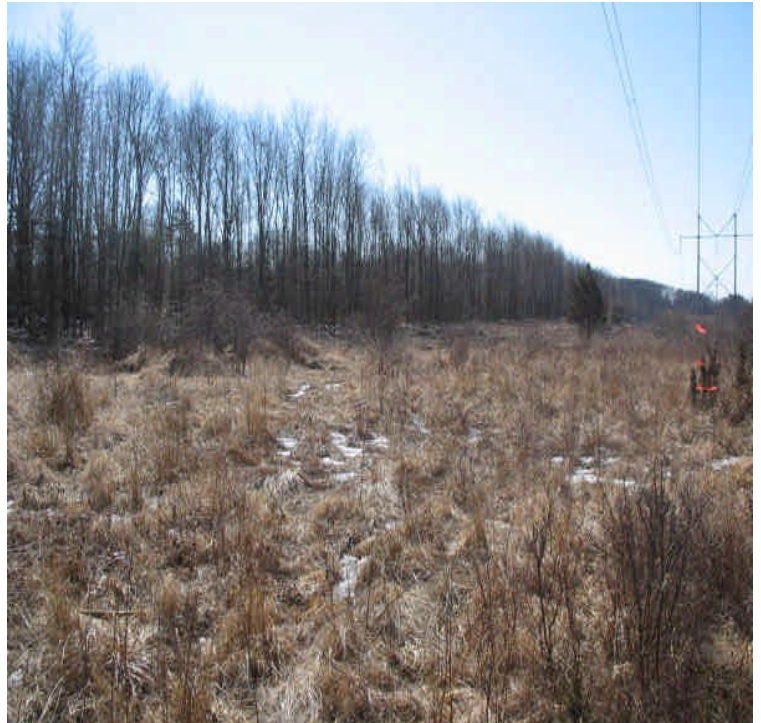
**View of vegetation retained following low impact clearing south of Carpenter Ln and Beseck SS. The remaining vegetation will stabilize soils within the wetland.**

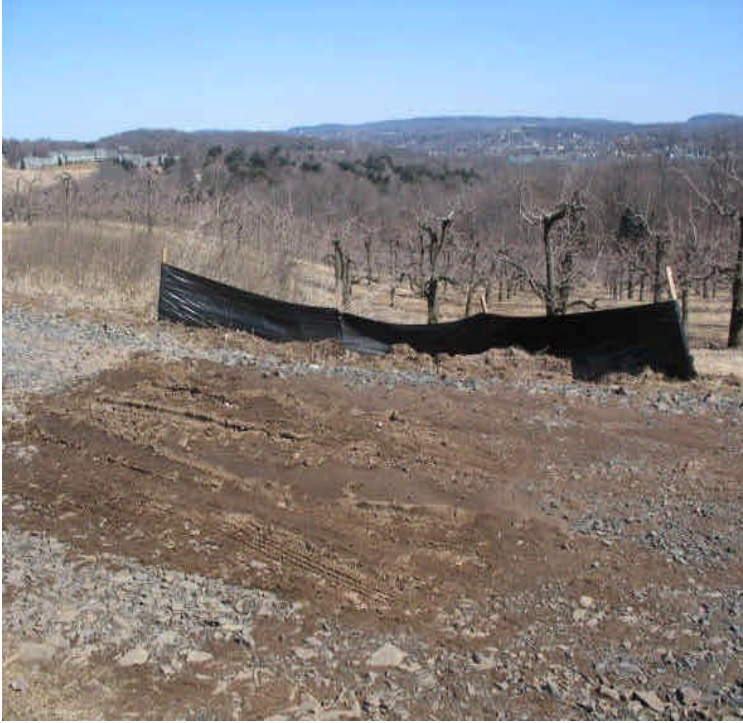
**Sediment accumulation was noted near some of the controls within the apple orchard off Mansion Rd. Pull back sediment to remove stress on the controls when needed.**

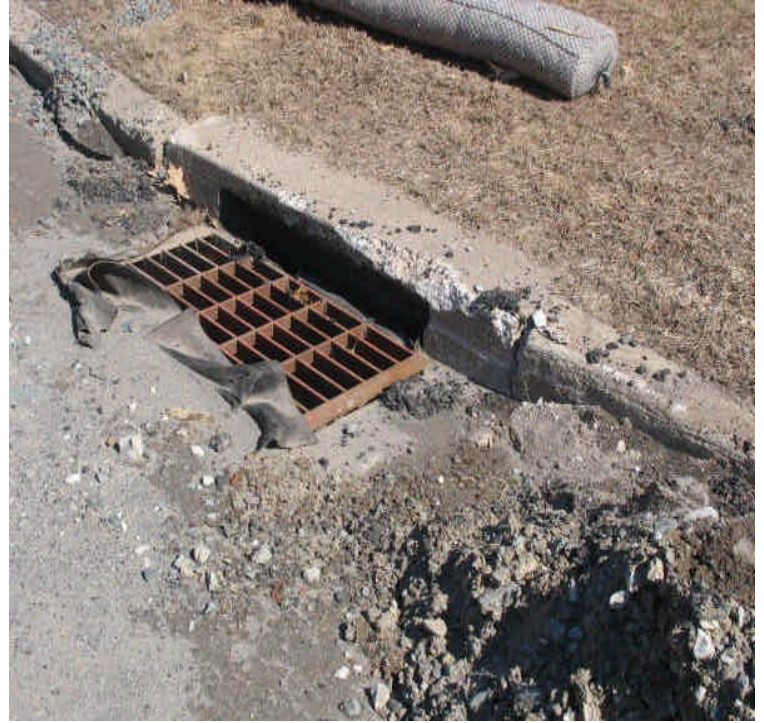
**A sediment pile noted near a CB following dewatering activities along Old Farms Rd. The curb cut inlet is exposed and the silt liner is torn here. Replace controls and remove sediment along the roadway.**

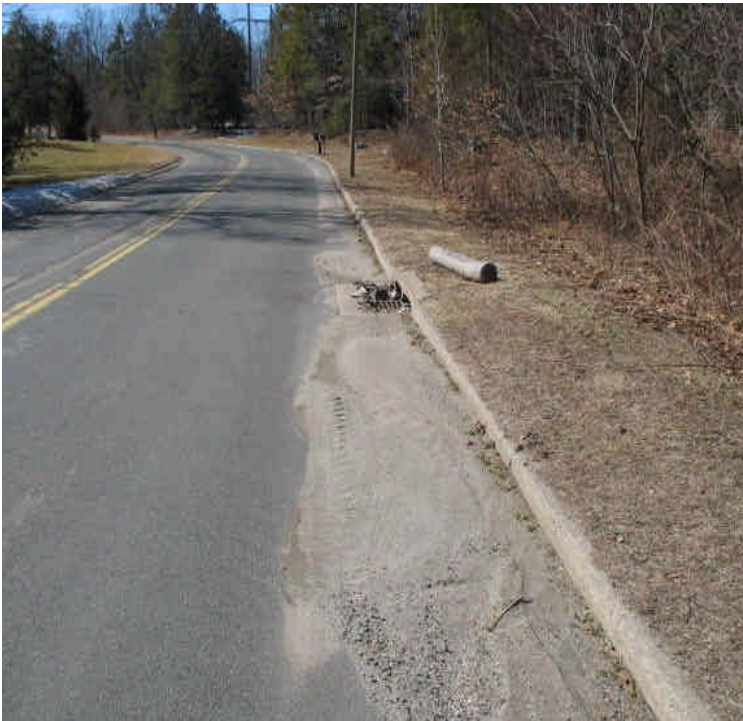
**View of a catch basin along Old Farms Rd. Liners are in place but gutter buddies were removed for town plowing last week. Replace as soon as feasible so the curb drop inlet is protected. Sediment accumulation on the road is a combination of road sand and project sediment. Regular sweeping should continue to occur.**

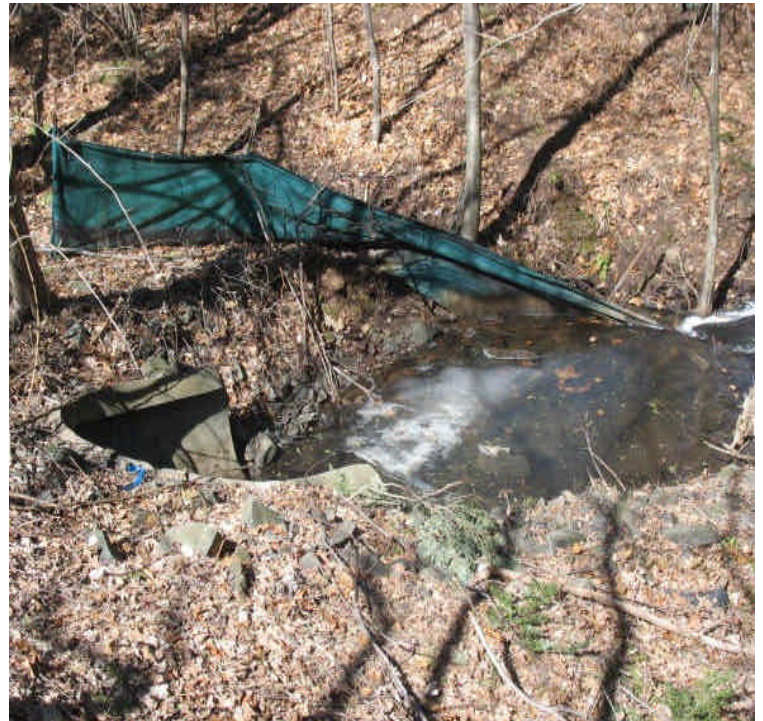
**View of one of the receiving wetlands/inlets along Old Farms Rd. Turbidity related to the project was not evident in the wetland at this time. However, issues have been noted during thaw periods. Continue to monitor.**
