Docket No. 272 – Development and Management Plan Inspection

Segment 2a Inspection

Date: March 13, 2007

Location: Segment 2a – Beseck Switching Station to Cheshire/Hamden Town Line

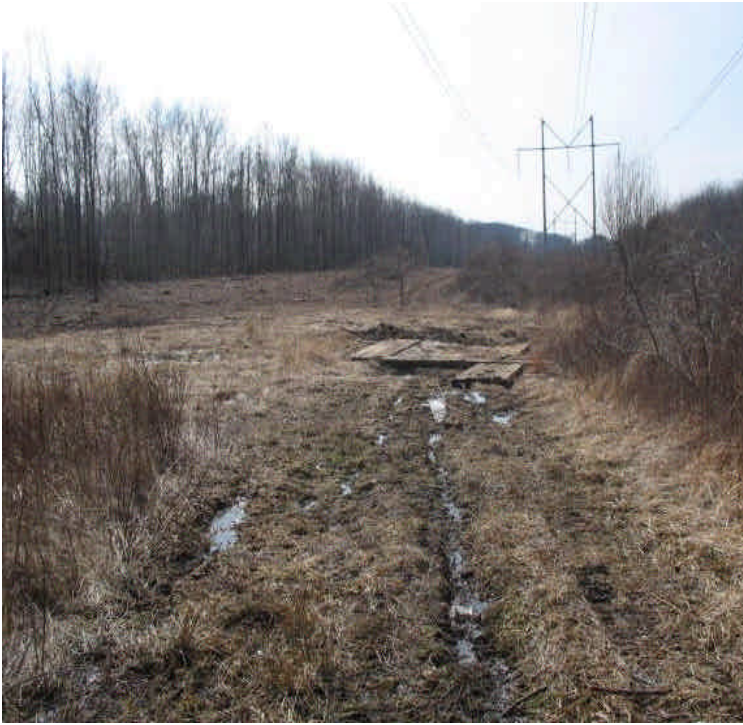
ROW clearing and timber mat installation south of Beseck SS off High Hill Rd. Low growth vegetation was retained within the wetlands here appropriately. Controls may be needed if soil becomes disturbed.

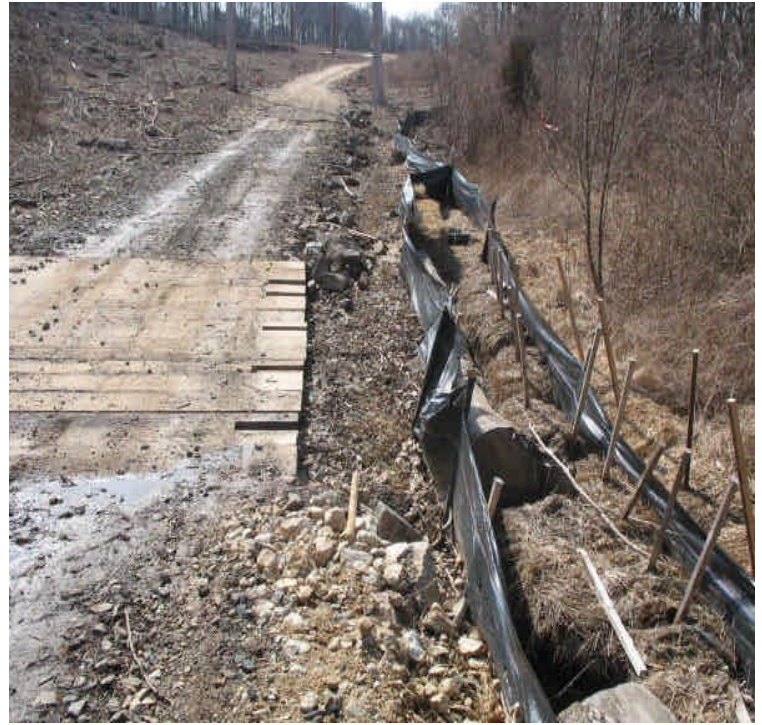
| Areas of Inspection | Observation | Recommended Action | Corrected Action |
|---|--|---|--|
| <p>Erosion and sediment controls</p> <p>High Hill Rd. to Rt. 68</p> | <p>Silt fence and haybales adjacent to the wetland near High Hill Rd. entrance are in disrepair. However a line of</p> | <p>Inspect and maintain silt fence/haybales on a regular basis. Monitor area for run-off and adjust controls for</p> | <p>Haybales added to reinforce degraded controls.</p> |

| Areas of Inspection | Observation | Recommended Action | Corrected Action |
|---|---|---|--|
| | <p>haybales was installed to reinforce the controls. Logs also remain in place for support. 3/13/07</p> | <p>containment. 3/13/07</p> | |

Silt fence and controls are degraded along the access road off High Hill Rd. Haybales were added to reinforce controls. Run-off issues were not observed.

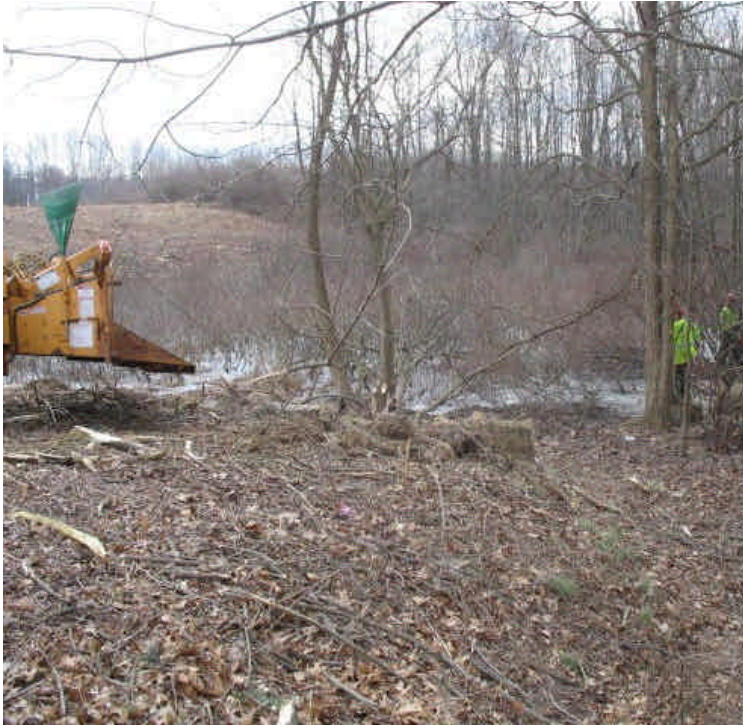
| Areas of Inspection | Observation | Recommended Action | Corrected Action |
|---|--|--|--|
| | Clearing and access road installation continues this week within wetlands south of Carpenter Ln. and Beseck SS. Timber mats remain in place at a small stream crossing. 3/13/07 | Add controls as needed along the wetlands and during access road construction. 3/13/07 | Clearing underway off Carpenter Ln. |

Clearing was occurring in wetlands within the ROW moving south from Carpenter Lane and Beseck SS.

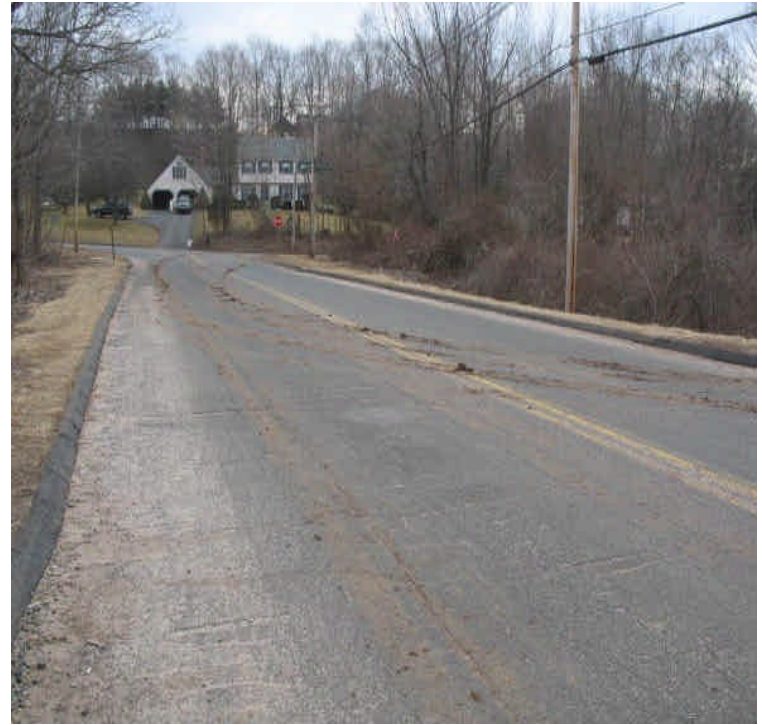
| Areas of Inspection | Observation | Recommended Action | Corrected Action |
|---|--|--|--|
| | Sediment tracking was noted along Carpenter Lane as a result of clearing crews accessing the ROW. 3/13/07 | Clean/sweep High Hill Road, Route 68, and Carpenter Lane regularly. Consider installation of a stone construction entrance. 3/13/07 | Needs attention on Carpenter Lane. |

Sediment tracking was noted on Carpenter Ln. resulting from clearing crews accessing the ROW. Sweep the roadway on a regular basis and install a construction access pad as necessary.

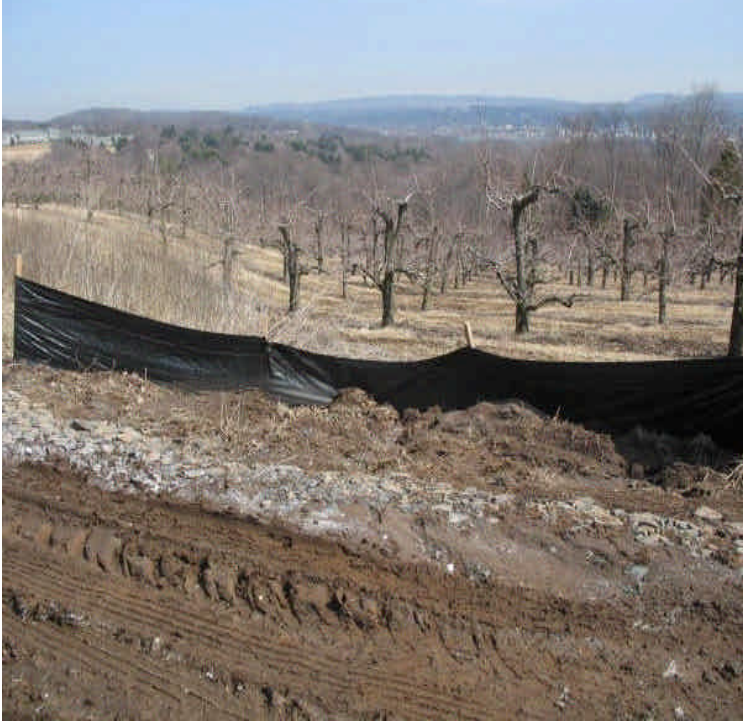
| Areas of Inspection | Observation | Recommended Action | Corrected Action |
|---|---|---|--|
| <p>Mansion Rd. Apple Orchard</p> | <p>Small sections of silt fence are in place strategically at run-off points and near wetlands. Run-off was not an issue this week. Some sections need minor repair and</p> | <p>Continue to monitor and adjust controls as needed. Repair fallen section of silt fence and continue to remove sediment when feasible. 2/21-3/13/07</p> | <p>Needs regular maintenance.</p> |

Sediment accumulation was noted near some of the controls within the apple orchard off Mansion Rd. Pull back sediment to reduce stress on the controls when needed.

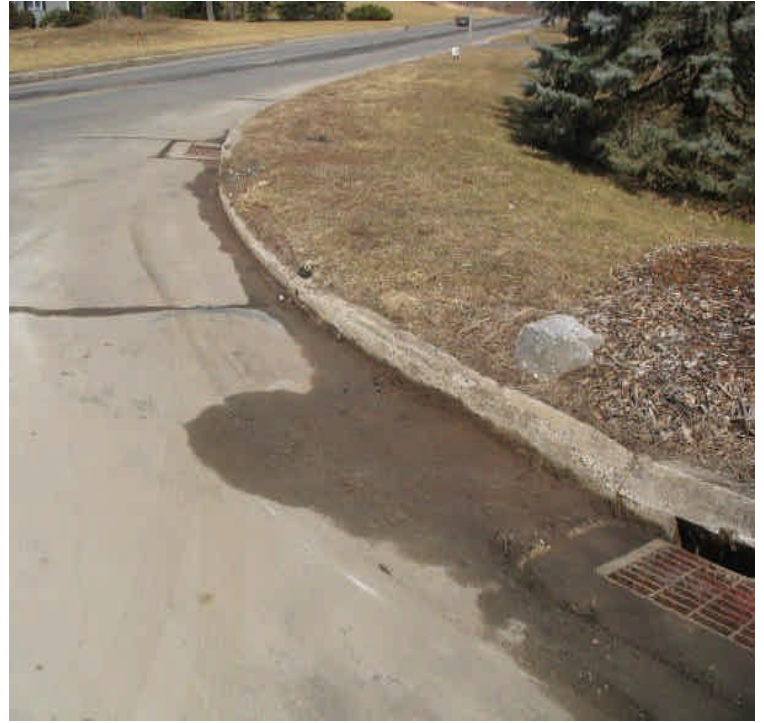
Efforts to sweep and remove sediment accumulation along Old Farms Rd. were noted.

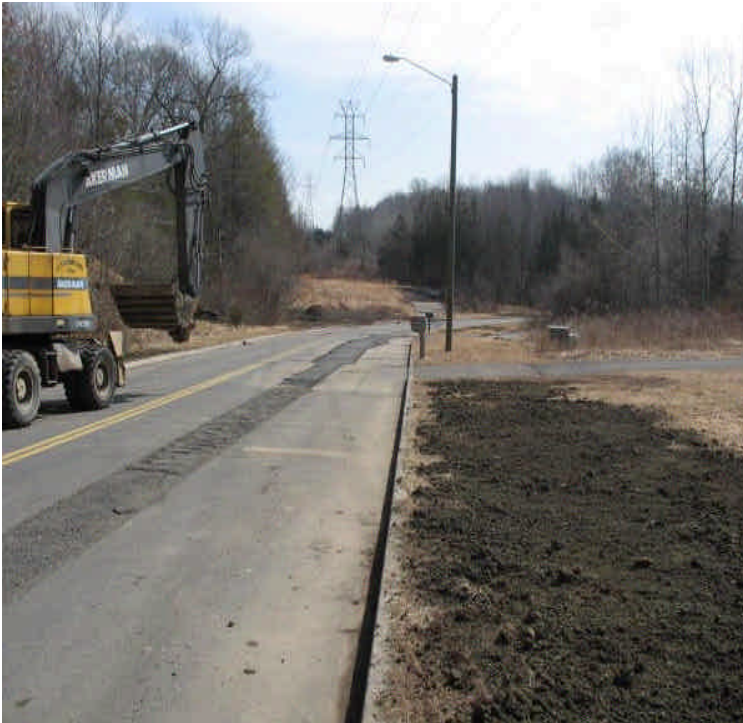
Topsoil is being applied and graded along Old Farms Rd. in an effort to repair ruts. Crews were also working to clean sediment from the gutters

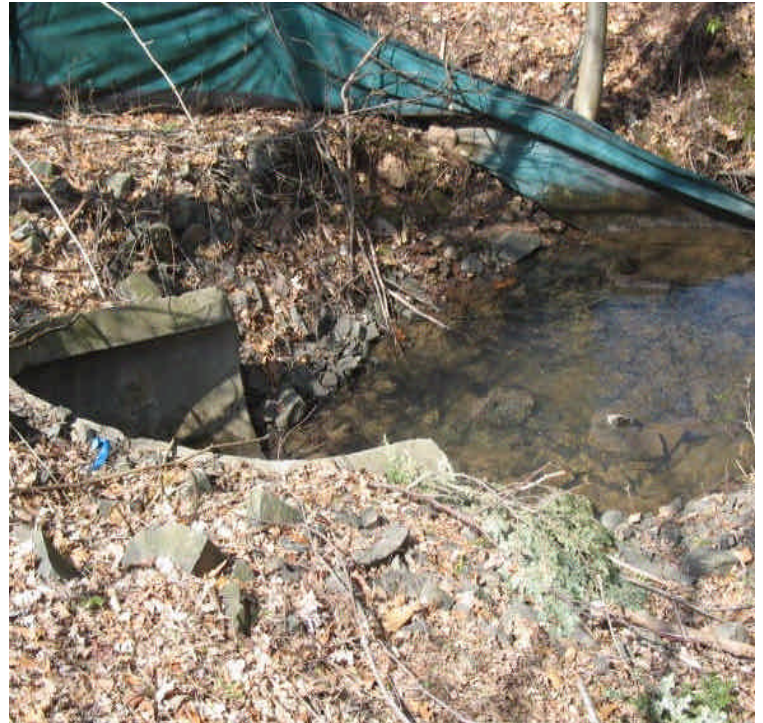
| Areas of Inspection | Observation | Recommended Action | Corrected Action |
|---|---|--|---|
| | Run-off from the low, saturated spot (filled during access road construction) is currently clear. However, in the past, turbid run-off has been observed reaching Old Farms Rd and entering a CB, flowing directly to receiving wetlands off-site. 3/13/07 | Monitor run-off and hydrology in the area and add controls as needed. 12/18/06-3/13/07 Evaluate whether pre-existing drainage patterns were altered during construction. It appears run-off diversion is necessary. 2/21-3/13/07 | No immediate issues but needs future evaluation and attention. |

View of one of the receiving wetlands/inlets along Old Farms Rd. Turbidity related to the project was not evident in the wetland at this time. However, issues have been noted during past thaw periods. Continue to monitor.
