Docket No. 272 – Development and Management Plan Inspection

Segment 2b Inspection

Date: March 1, 2007

Location: Segment 2b – Cheshire/Hamden Town Line to East Devon Substation

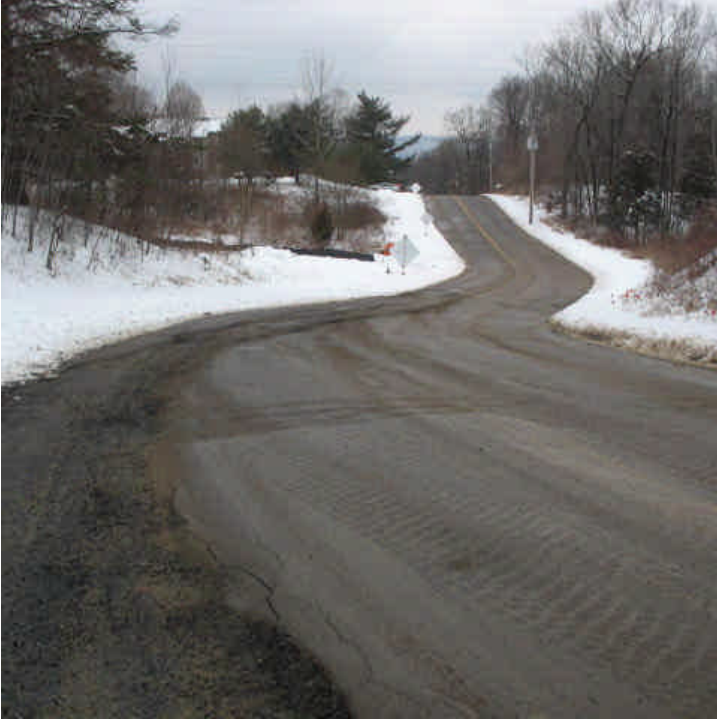
View of backfilling and trench patching/paving associated with the 115-kV underground work (Section 2b) in Old Lane Road.

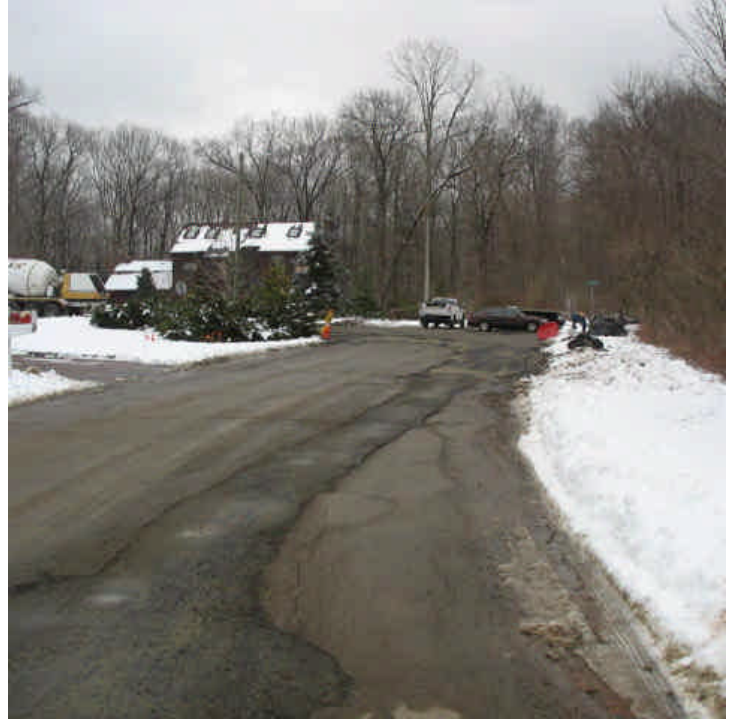
An additional view of the 115-kV work within Old Lane Road.

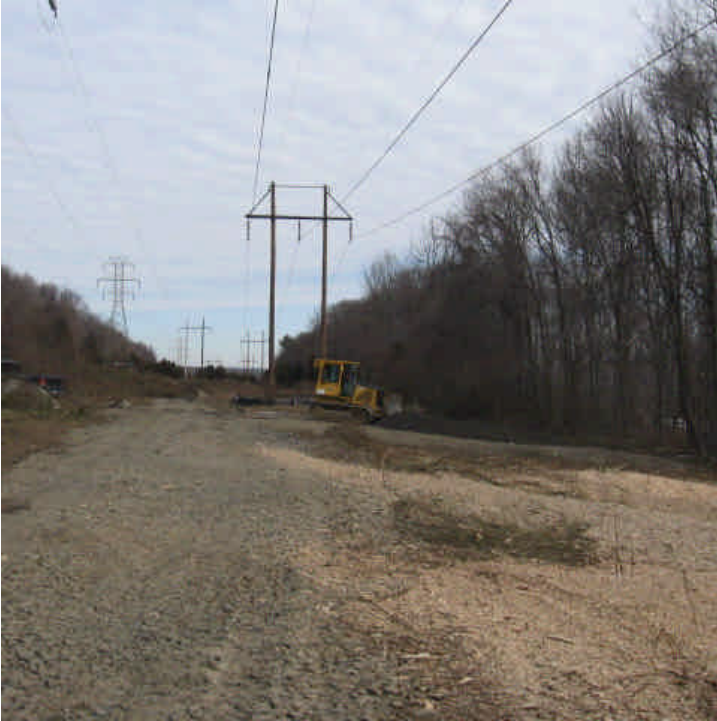
View of the new clearing and stone access roads constructed within from the the ROW accessed from Pease Road.

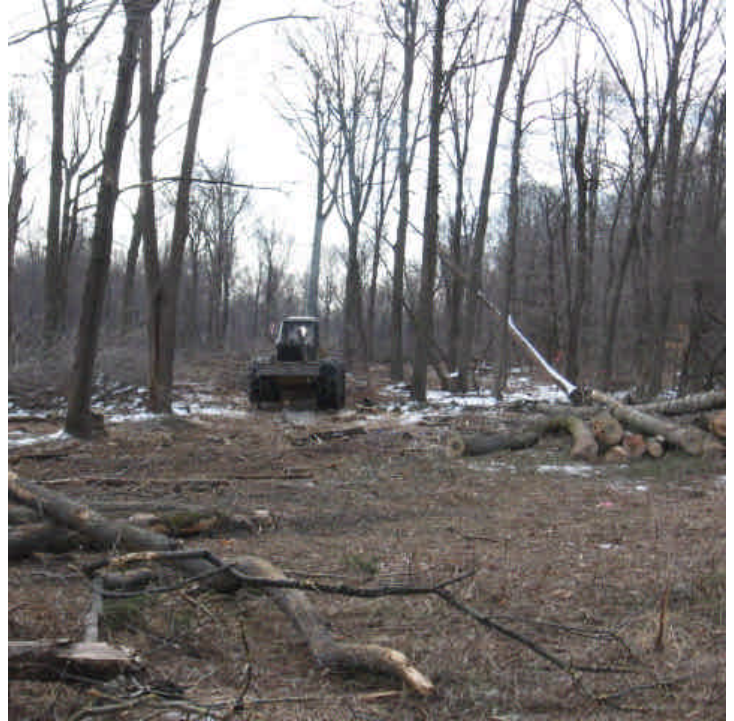
View of the new clearing associated with the re-location of the ROW near Pease Road and the JCC.

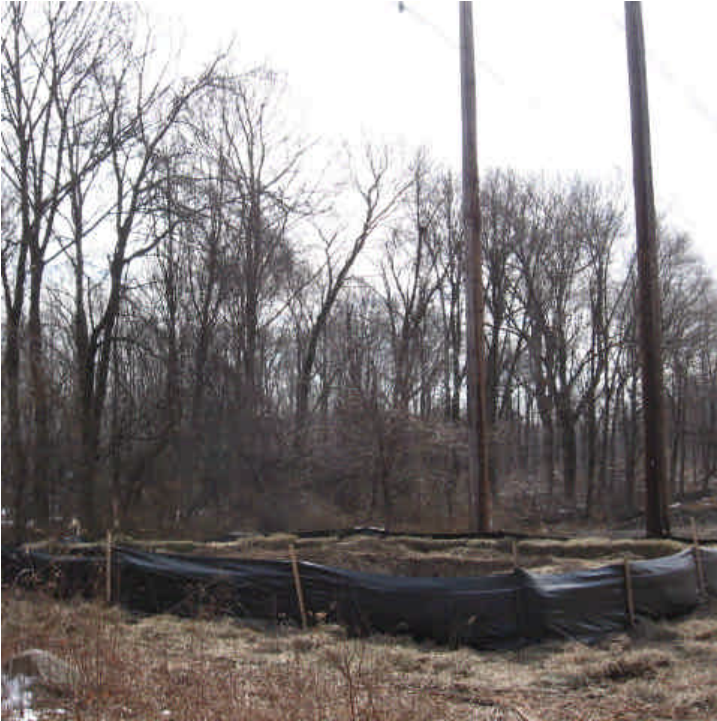
Dewatering controls were installed proactively within the ROW here (Pease Road).

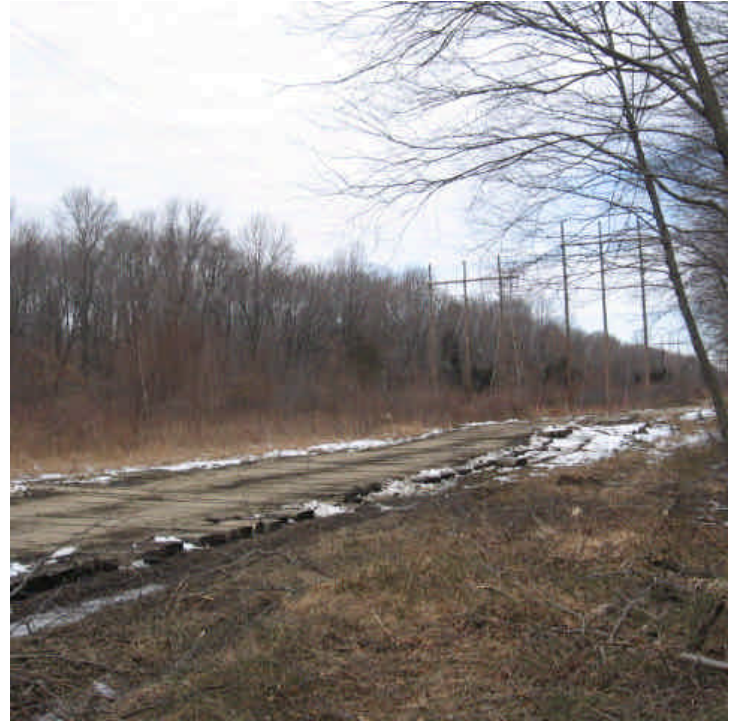
Additional timber mats have been placed along the access road to support equipment here (Pease Road).

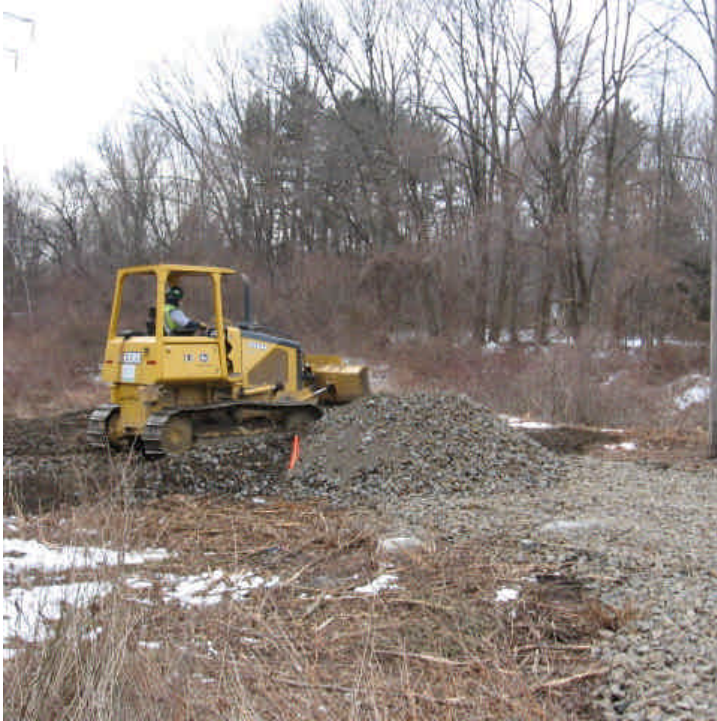
View of the clearing and access road construction off Rimmon Road in Woodbridge. Haybales had been delivered for installation near the wetland here.

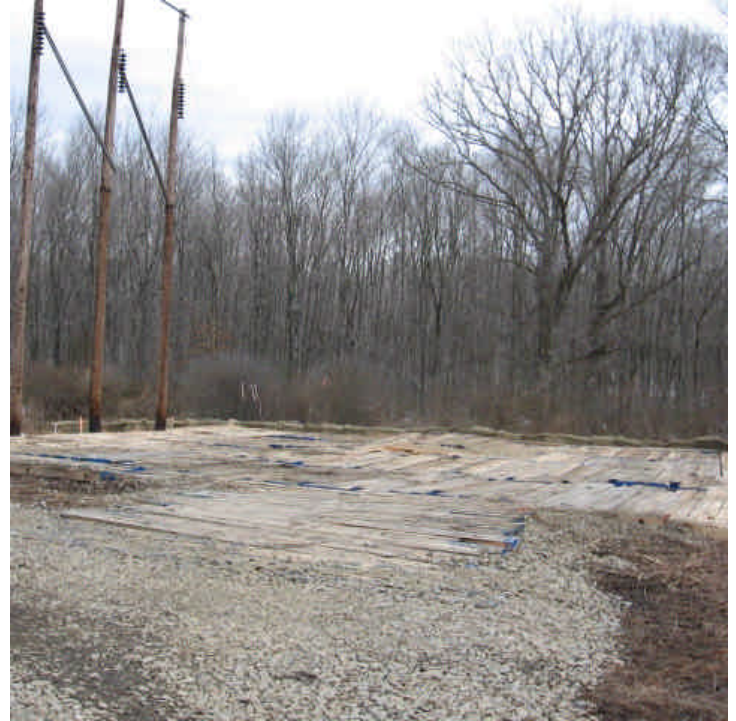
A timber mat and crane pad were installed within the wetland off Manville Road (east). Hay bales were placed along the crane pad, at the undisturbed wetland edge

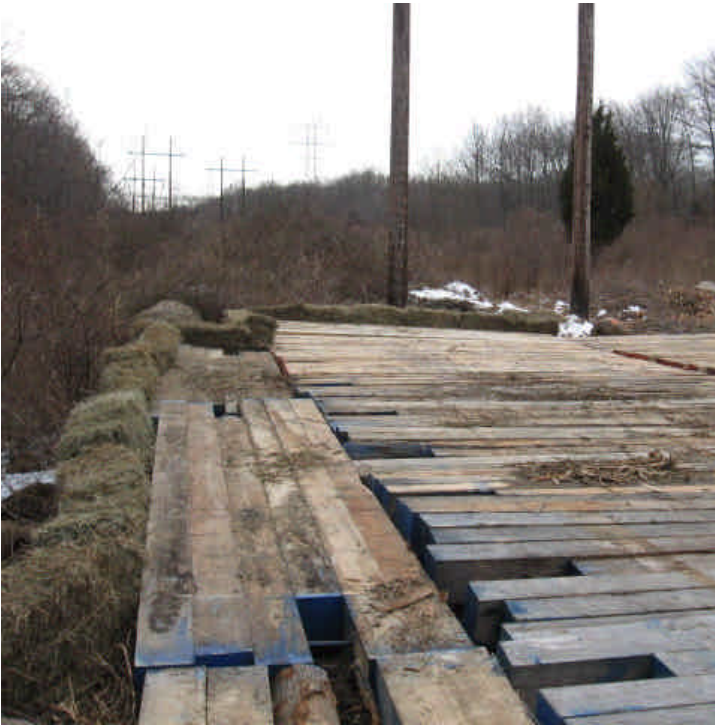
View of the crane pad and haybales installed within the wetland area off Marville Road (west).

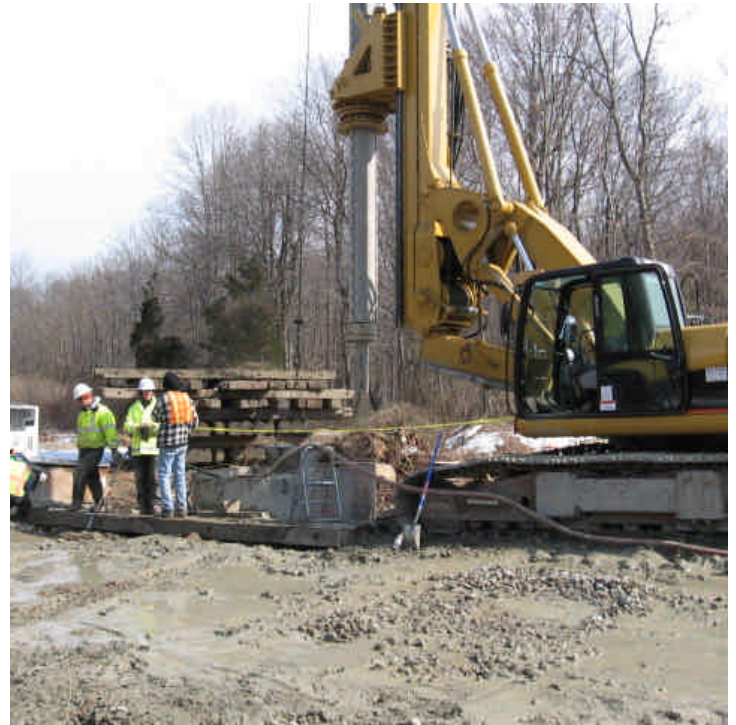
View of the foundation drilling/pouring near the wetland off Dogwood Rd (east).

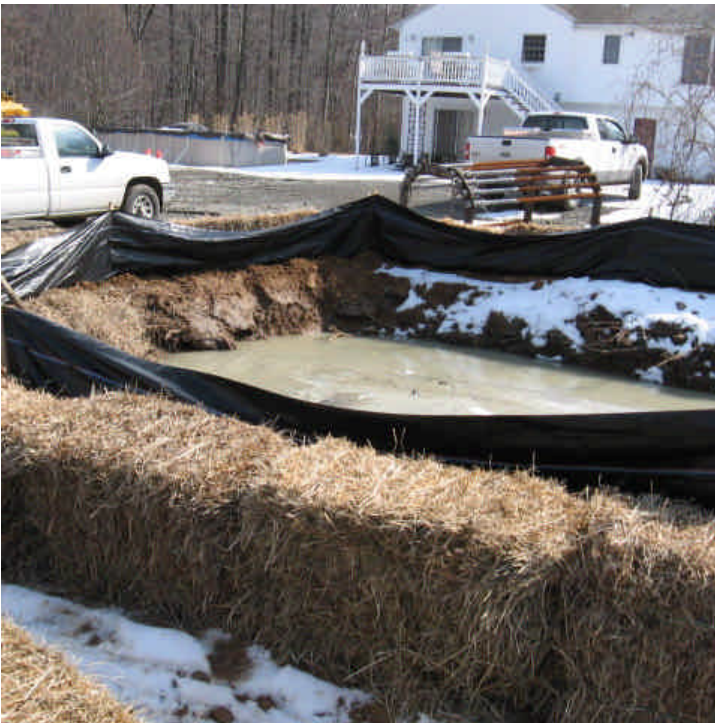
View of the primary dewatering basin within the ROW off Dogwood Rd (east). Active dewatering was occurring at the time of inspection.

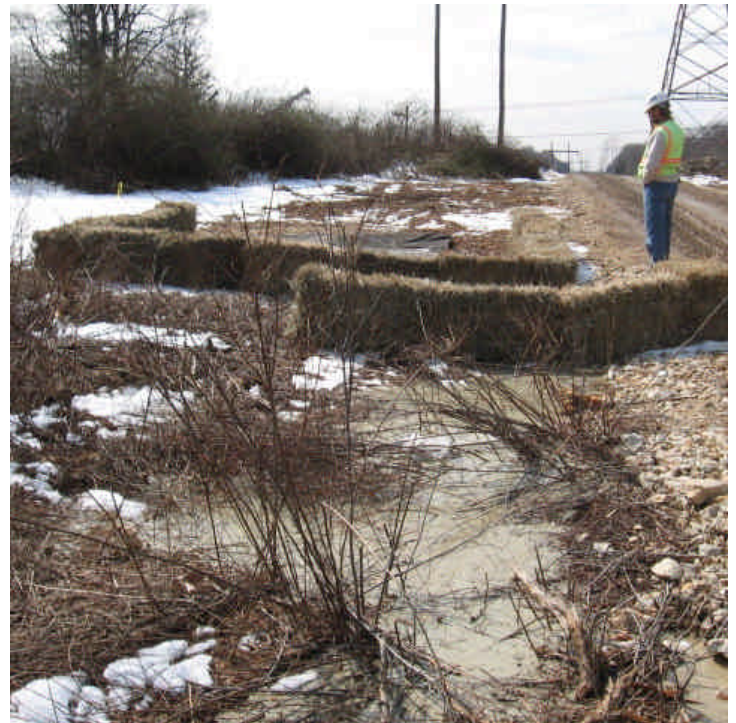
A second dewatering area, consisting of a filter bag and two lines of haybales, was used as an alternative to the primary basin. Slurry/sediment had breached the controls here but did not reach the wetland area. Solutions and additional controls were being discussed.

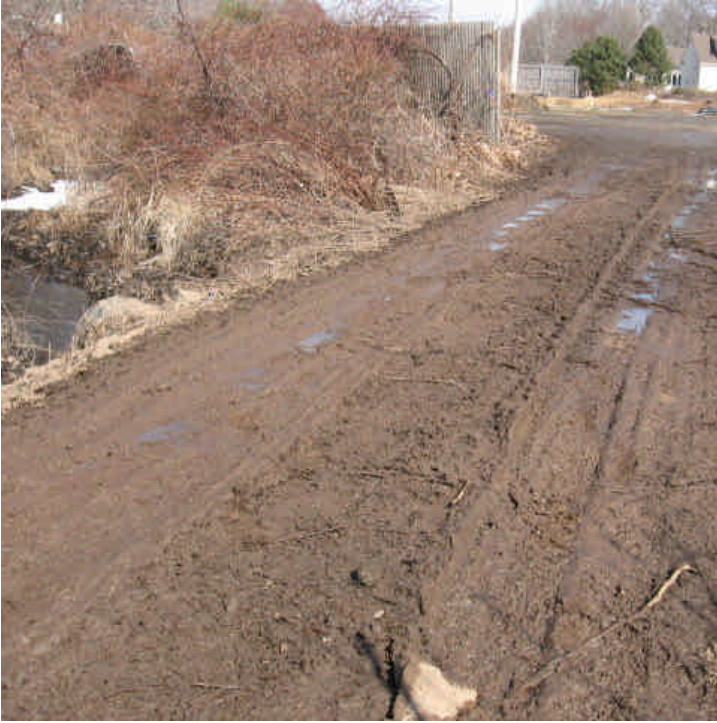
The access road crossing the wetland off Treat Lane was very muddy this week. Additional stabilization measures may be needed here.

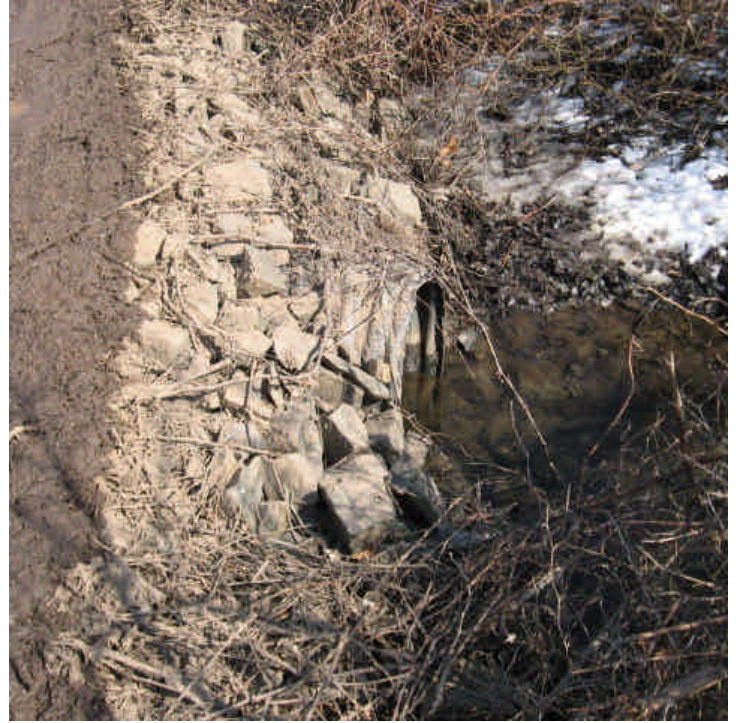
Some sediment from the muddy access road had migrated toward the stream channel here (Treat Lane). Erosion controls are required here per the D&M plan (especially with warming temperatures).

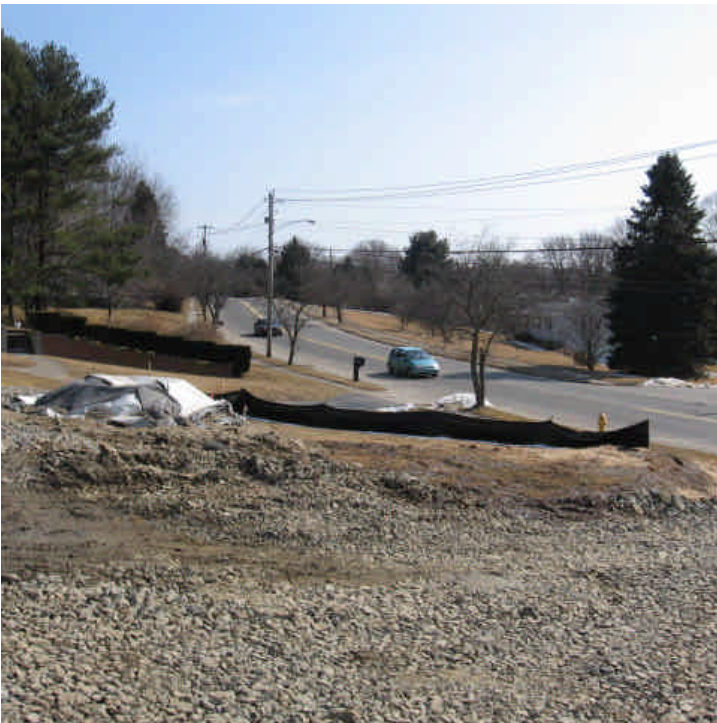
View of the foundation installed within the ROW off Woodruff Rd.

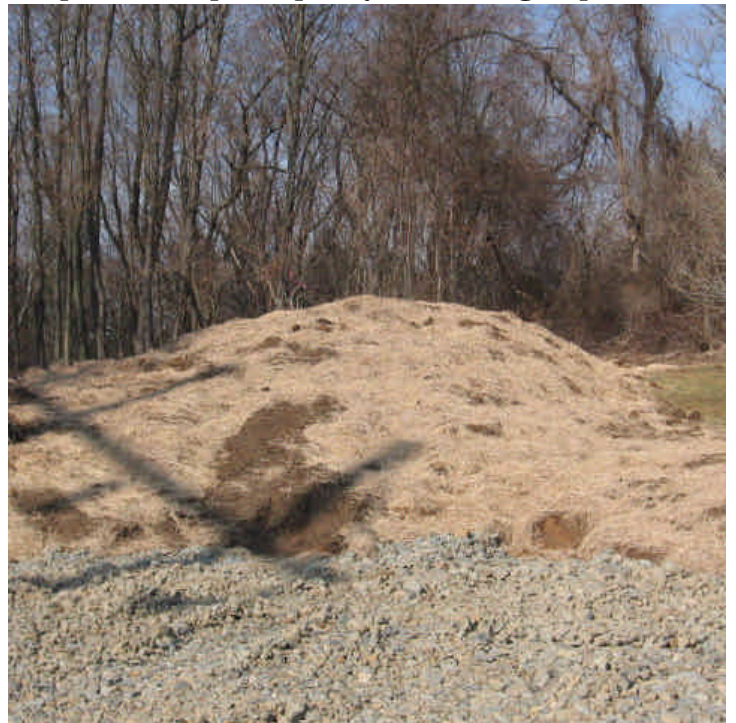
Hay mulch has been applied to the disturbed areas here (Woodruff Rd.)
