**Docket No. 272 – Development and Management Plan Inspection**

**Segment 2b Inspection**

**Date:** March 30, 2007

**Location:** Segment 2b – Cheshire/Hamden Town Line to East Devon Substation

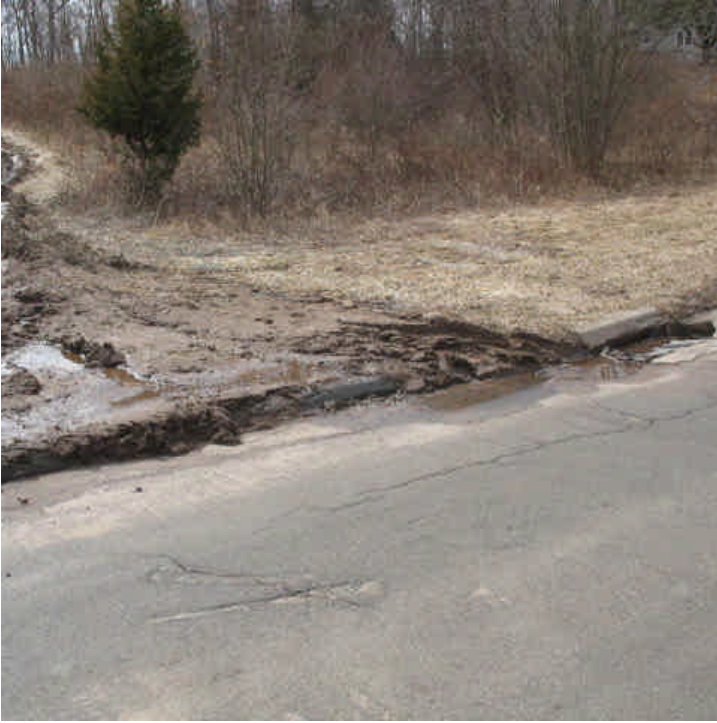
**Old Lane Rd (Hamden):** The entrance to the overhead ROW access was still very muddy this week. There is still no drop inlet protection here and turbid water was observed entering the catch basin.

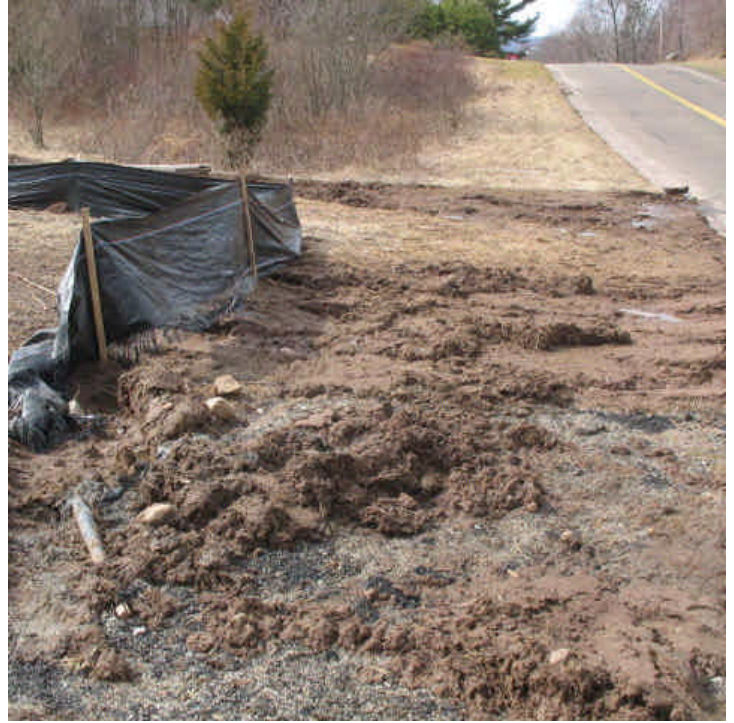
**Old Lane Rd:** Silt fence was installed to protect the area downgradient of the access road, but it does not protect the catch basin from the adjacent, exposed soil and run-off.

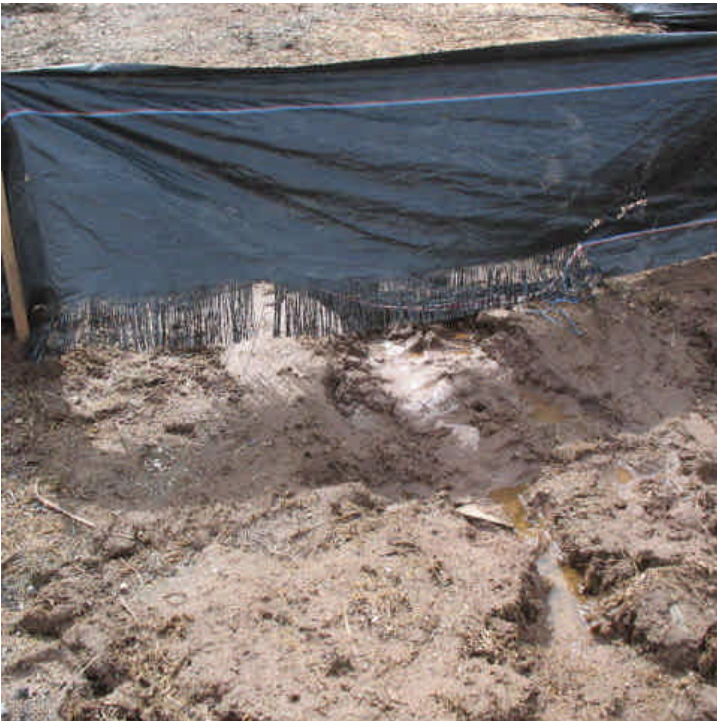
**Old Lane Rd:** Some areas of silt fence were ripped and not toed in. A small gully has formed and turbid water is flowing toward the road.

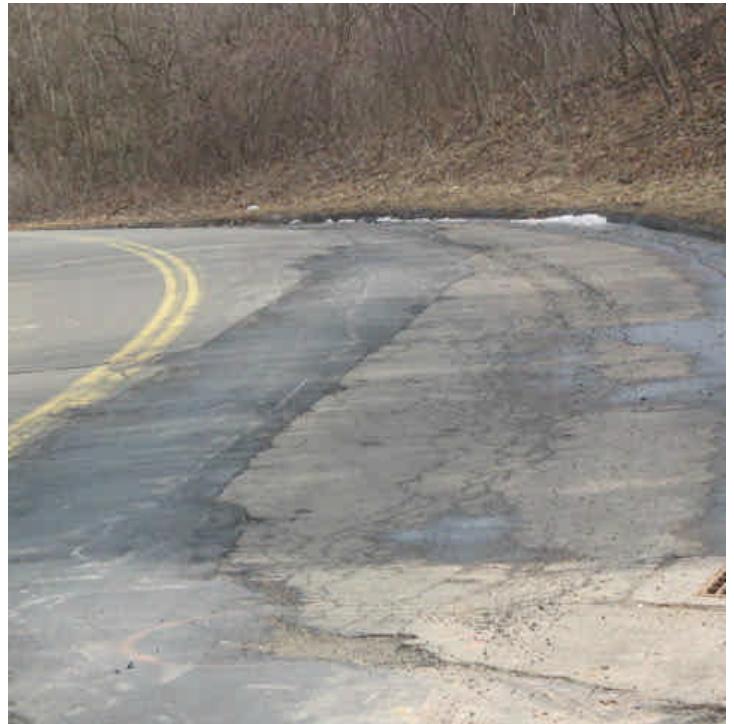
**Old Lane Rd:** Underground trenchwork in the roadway appears to be complete.

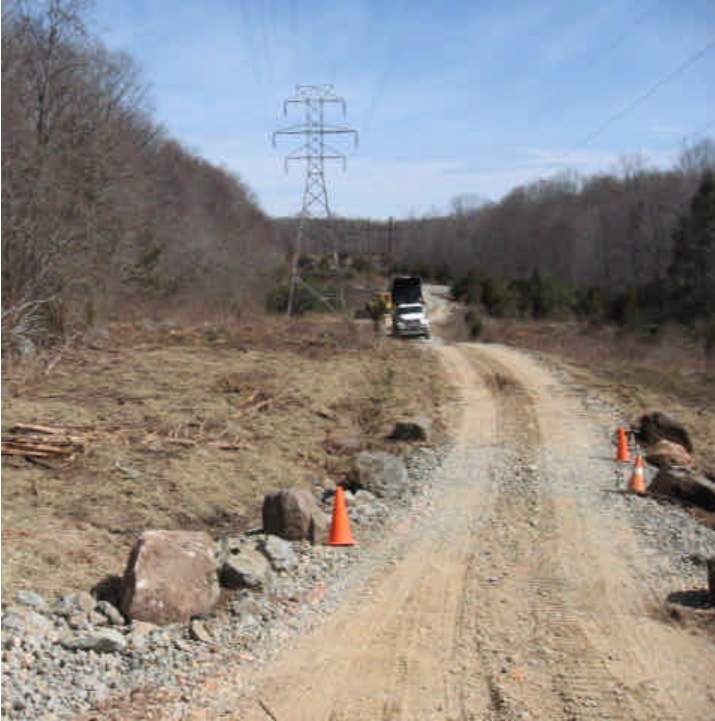
**Tom Swamp/Arrow Rd (Hamden): View of the constructed access road and clearing within the ROW.**

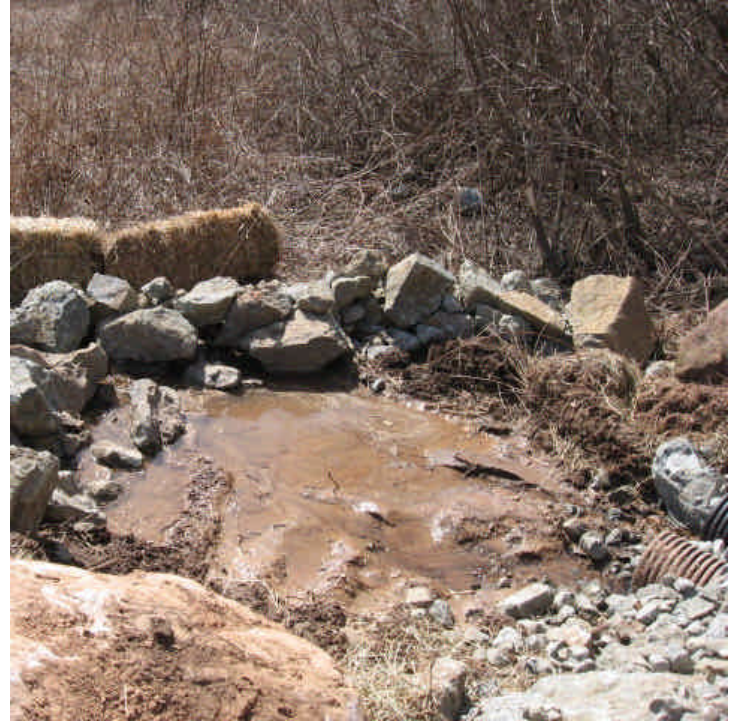
**Tom Swamp/Arrow Rd: Sediment was present within the sediment trap at the outlet of the smaller culvert during the inspection. Water exiting the stone trap was clean. Restore capacity if necessary.**

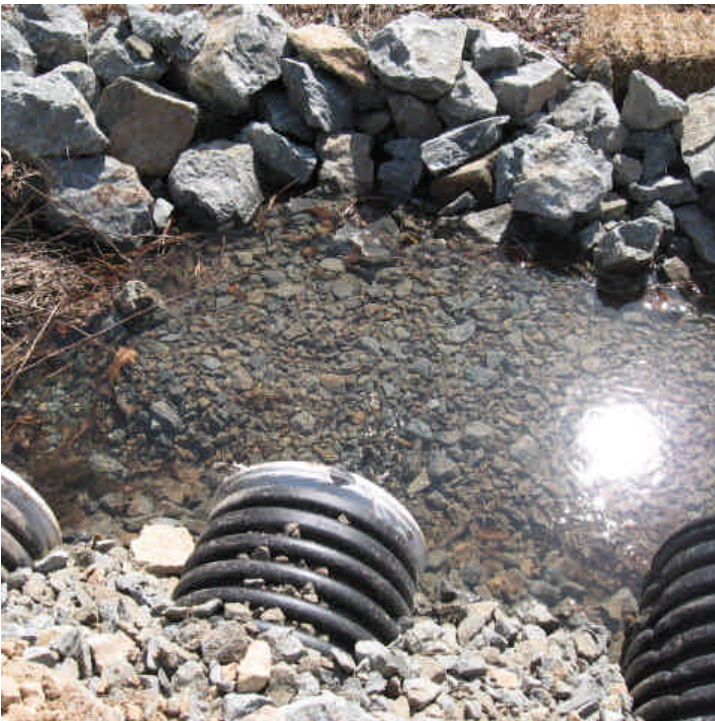
**Tom Swamp/Arrow Rd: A triple culvert crossing was constructed within the access road at the stream crossing. Water at the outlet was clear.**

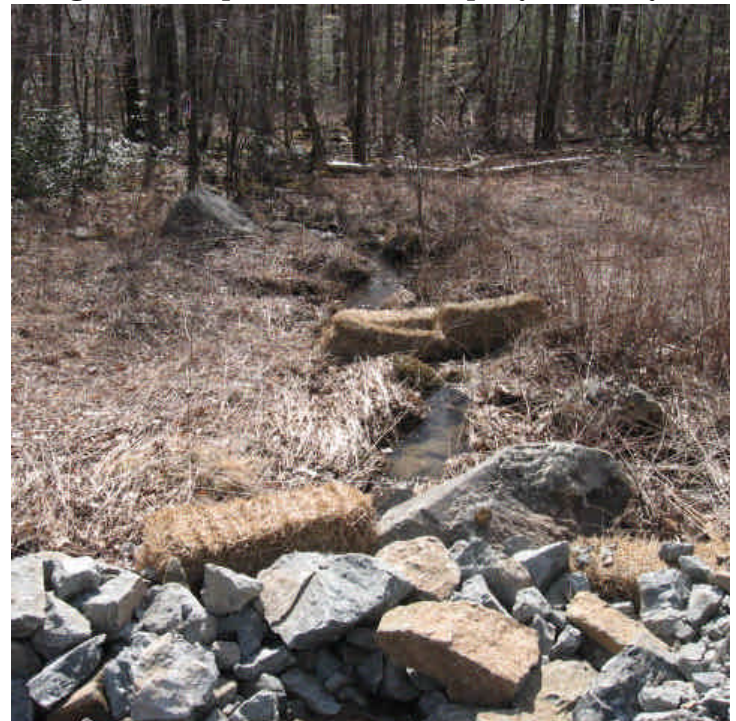
**Tom Swamp Rd/Arrow Rd: Haybale check dams were installed down-gradient of the crossing. Although some sediment was present within the channel, it had not migrated beyond the check dams.**

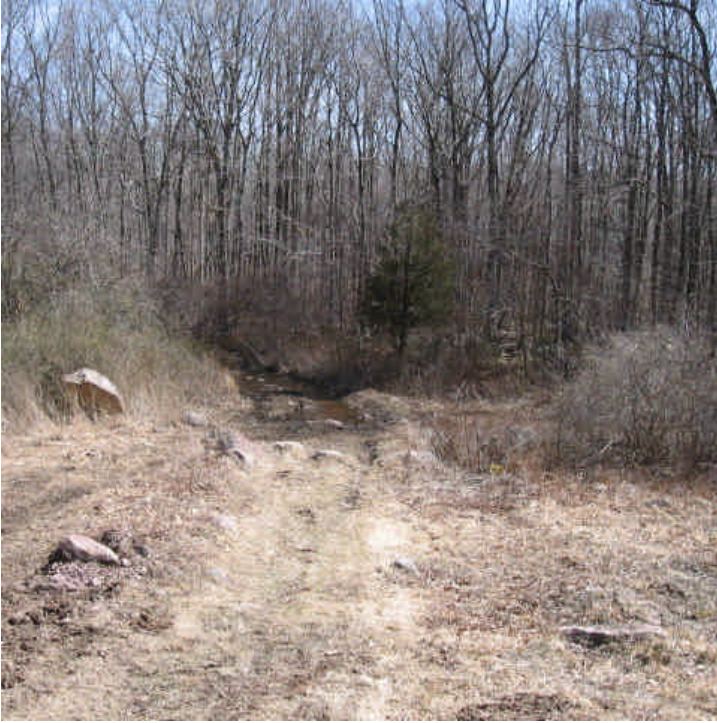
**Vicinity of Tom Swamp Rd: View of the "No Access" area near Vicinity of Tom Swamp Rd: Brook. There was no evidence that crews had entered this area.**

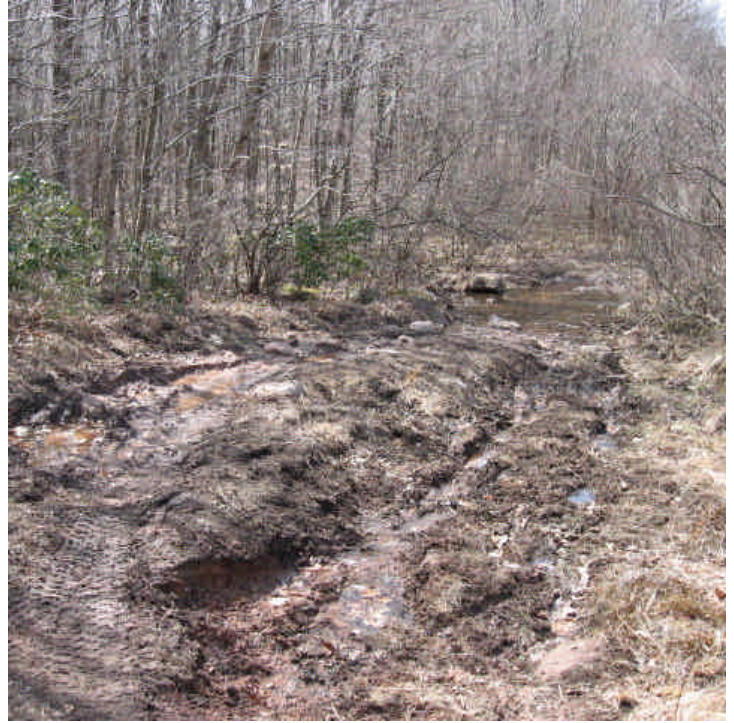
**Vicinity of Tom Swamp Rd: What appears to be ATV tracks were noted within the wetland associated with Jepp Brook.**

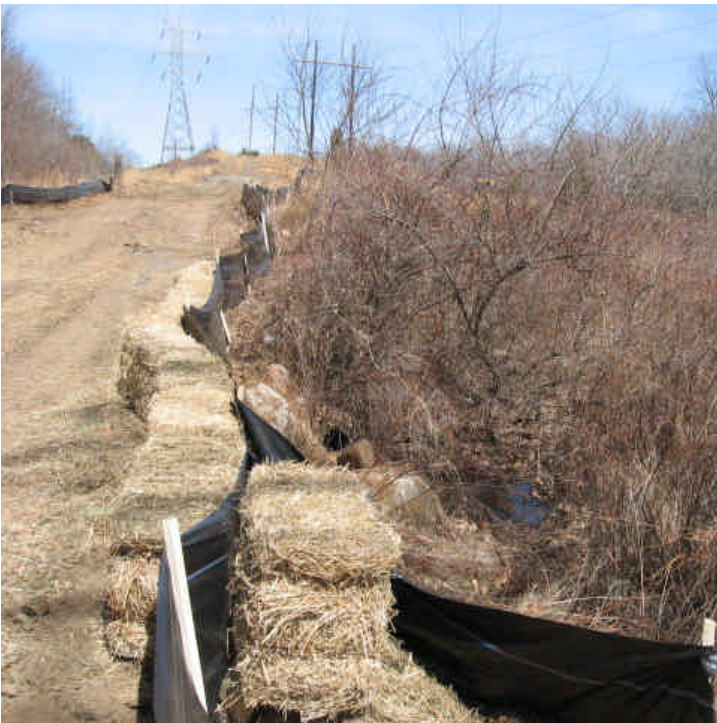
**SCCRWA (Glen Dam): View of the haybales and silt fence installed at the wetland area located along the access road.**

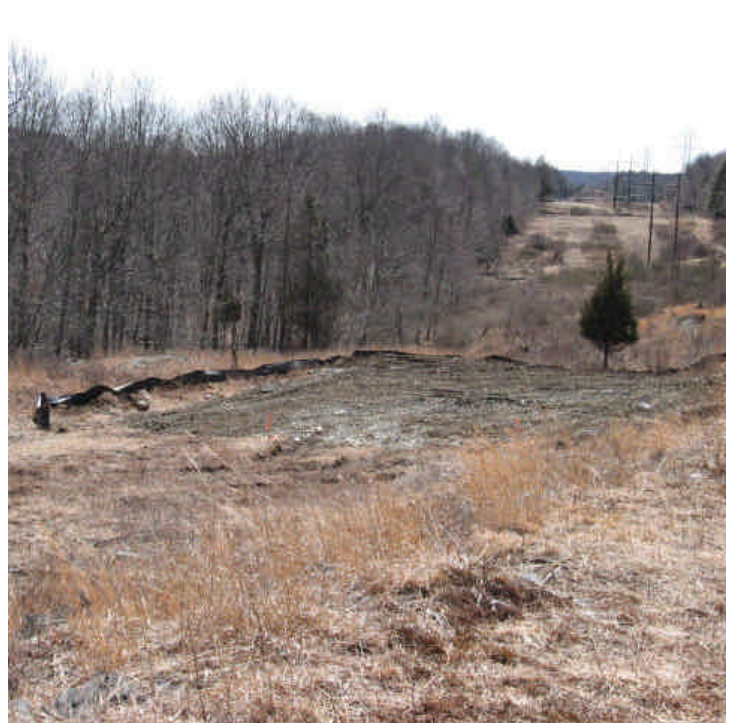
**Cow Path Lane: Additional silt fence was added along the new crane pads and throughout the ROW.**

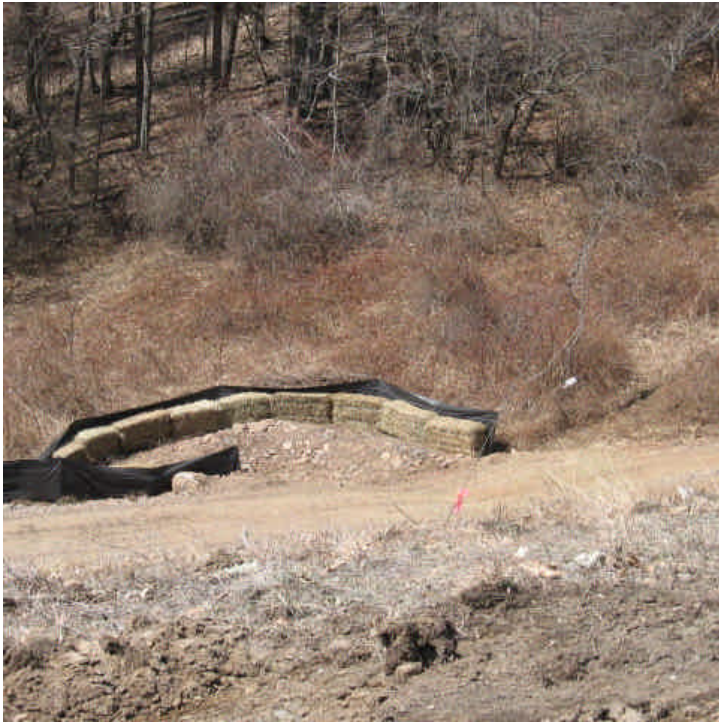
**SCCRWA (Glen Dam):** Additional water bars were added along the access road. Haybales and silt fence were installed at the outlets.

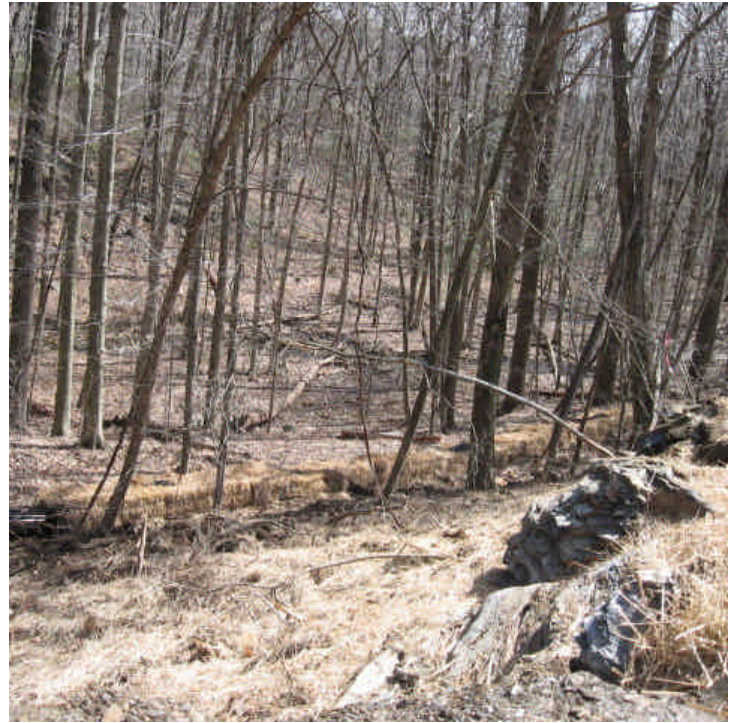
**Cowpath Lane:** A double line of haybales and silt fence were installed upgradient of the wetland system located off the ROW, and below a recently graded pad.

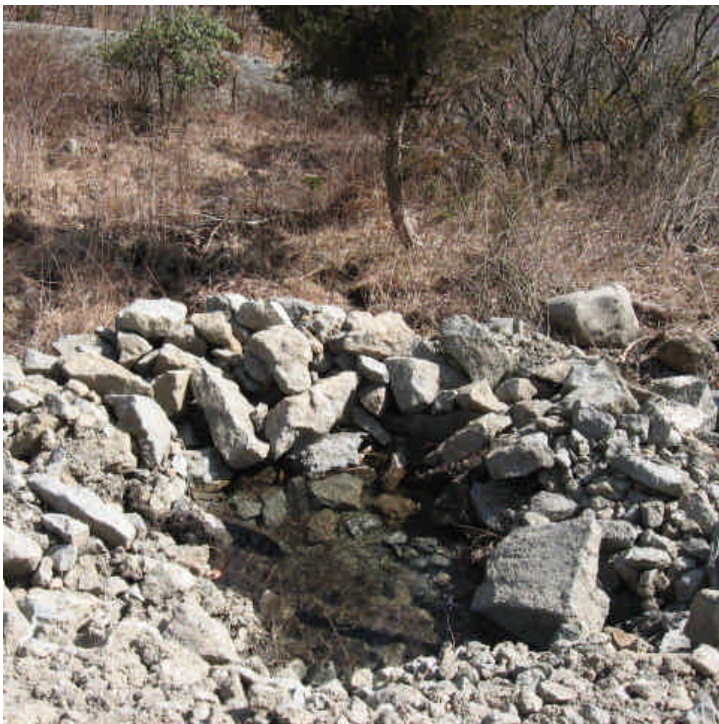
**Cow Path Lane:** Additional stone sediment traps were installed along the access road.

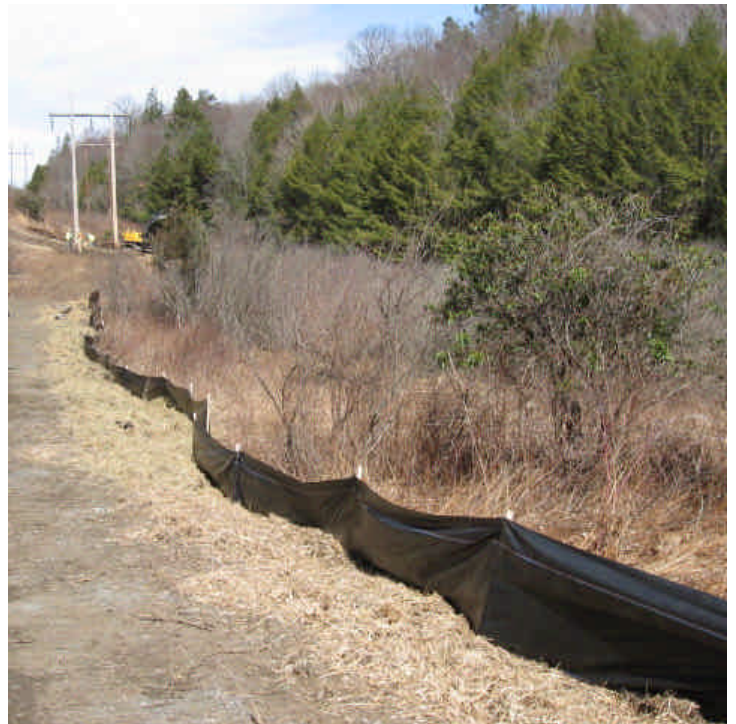
**Cow Path Lane:** Mulch was in place along the disturbed edges of the access road.

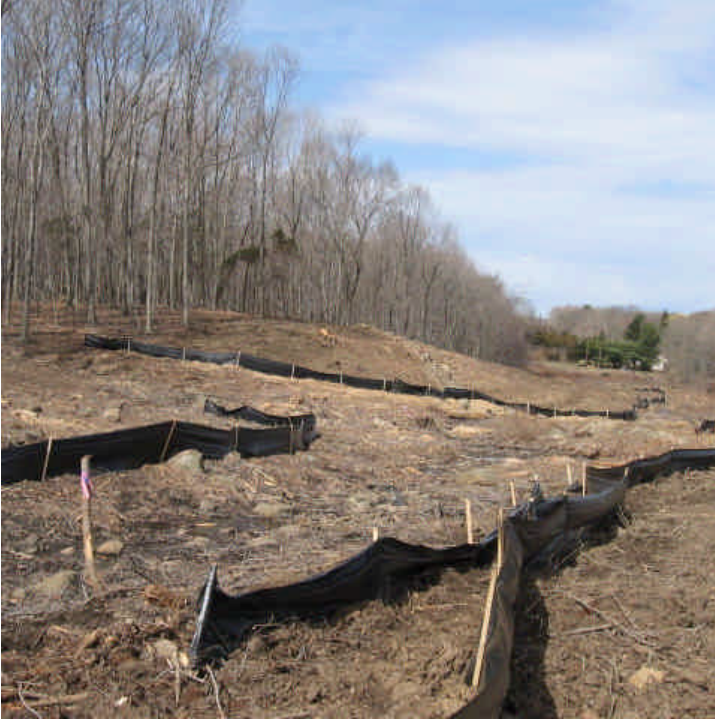
**JCC (Woodbridge):** Additional silt fence was installed along the wetland area here. All other silt fence remains intact.

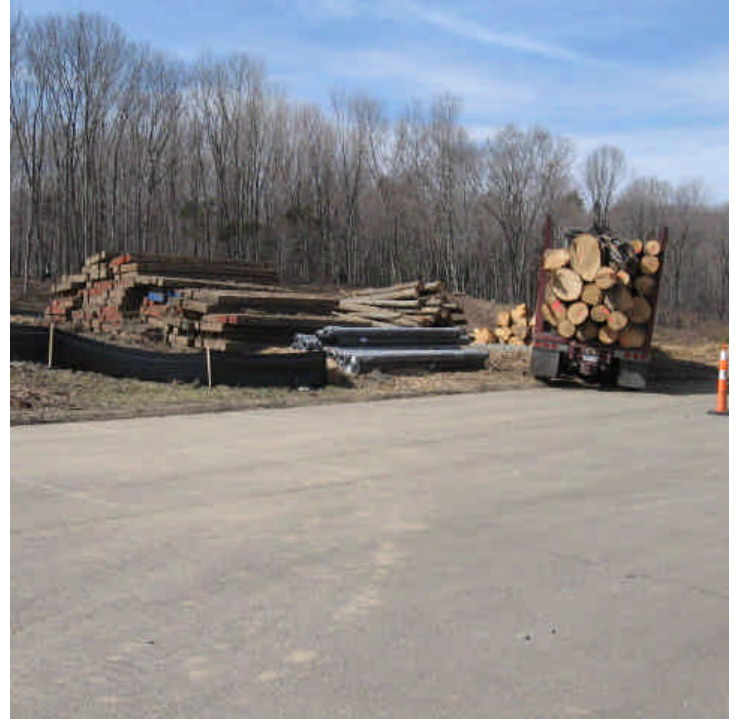
**JCC:** The parking lot was free of sediment this week. Logs were being removed from site.

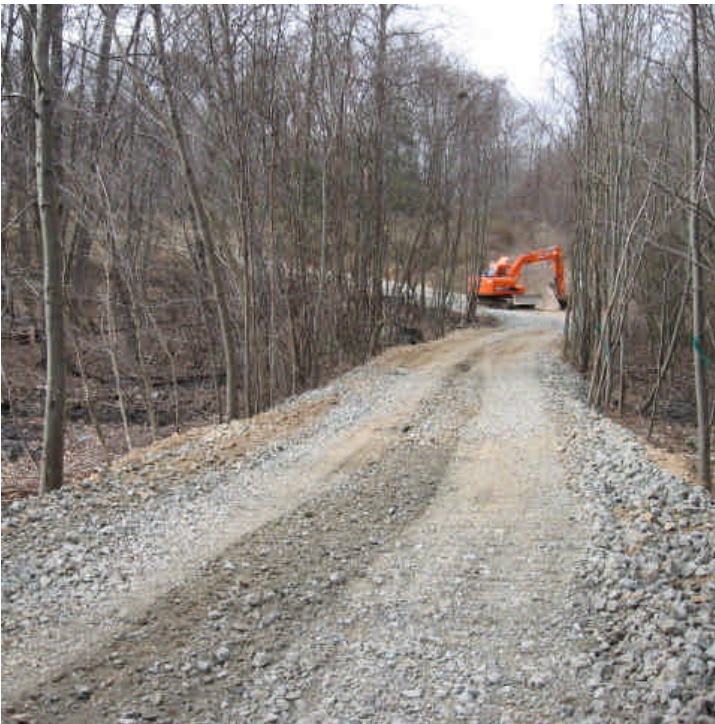
**East Rutland Rd. (Milford):** View of the constructed access road. Road building was actively occurring during the inspection.

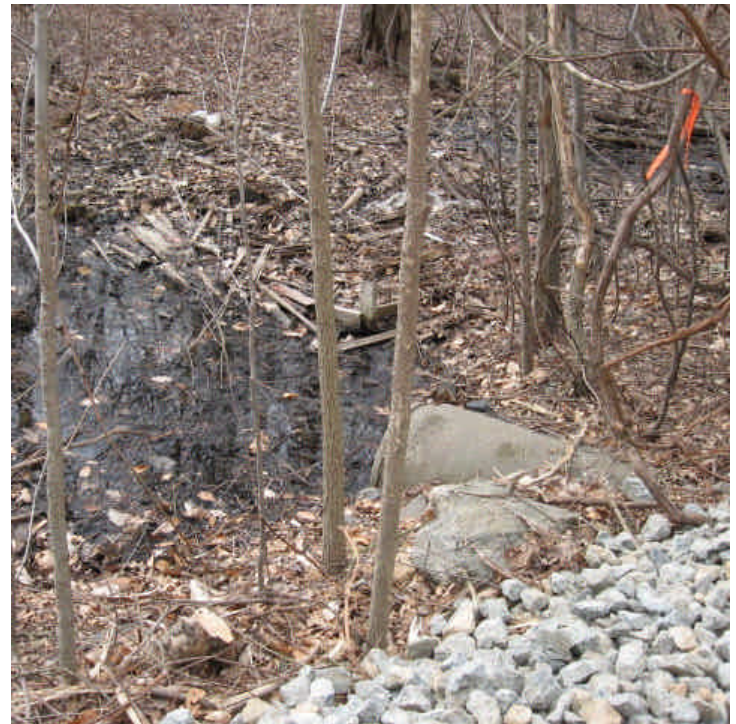
**East Rutland Rd:** View of the pre-existing culvert crossing

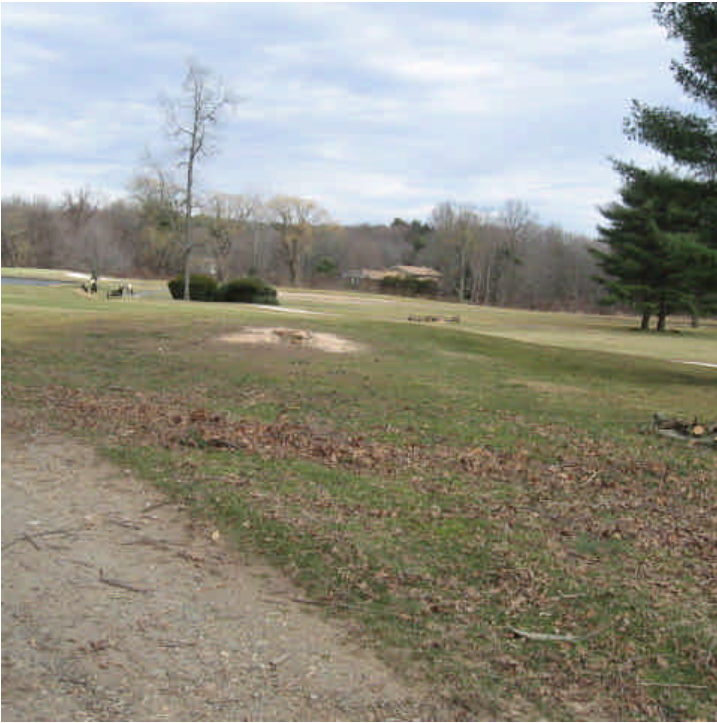
**Oak Lane Country Club (Woodbridge): Large trees were cut and removed carefully from the golf course area.**

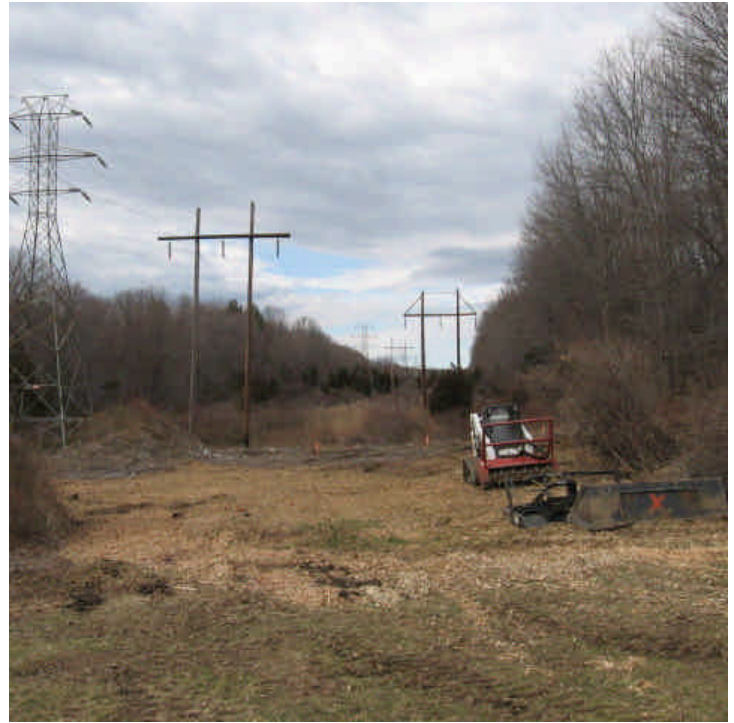
**Oak Lane Country Club: View of the clearing within the ROW here.**

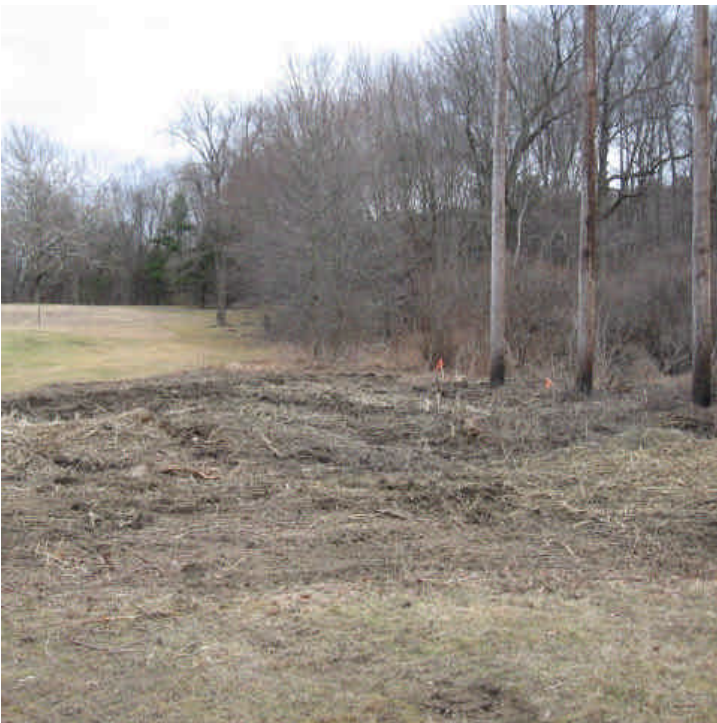
**Oak Lane Country Club: The wetland has been cleared for crane pad construction.**

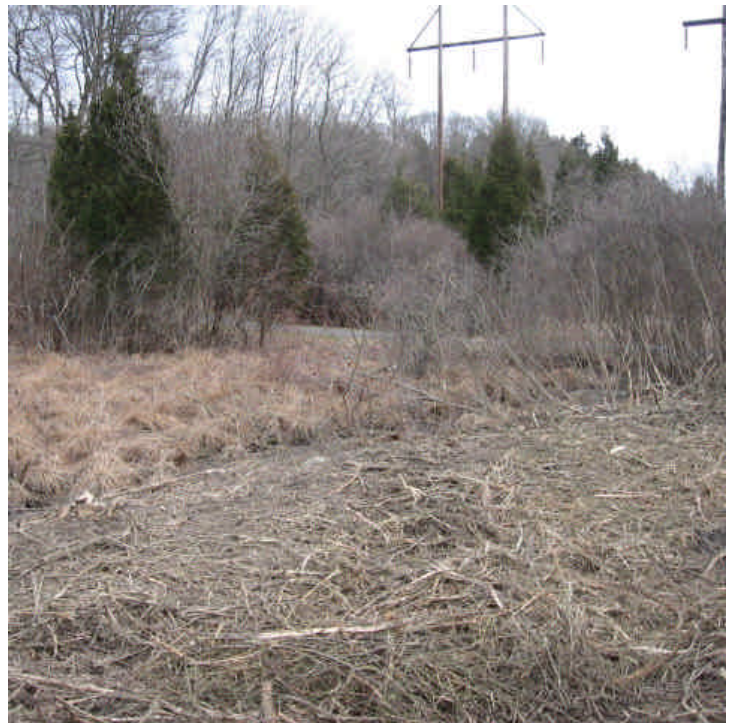
**Oak Lane Country Club: Additional view of the wetland clearing. Trees and shrubs were retained here where feasible.**
