**Docket No. 272 – Development and Management Plan Inspection**

**Segment 3 Underground Line**

**Date:** March 1, 2007

**Location:** East Devon Substation to the Housatonic River Crossing

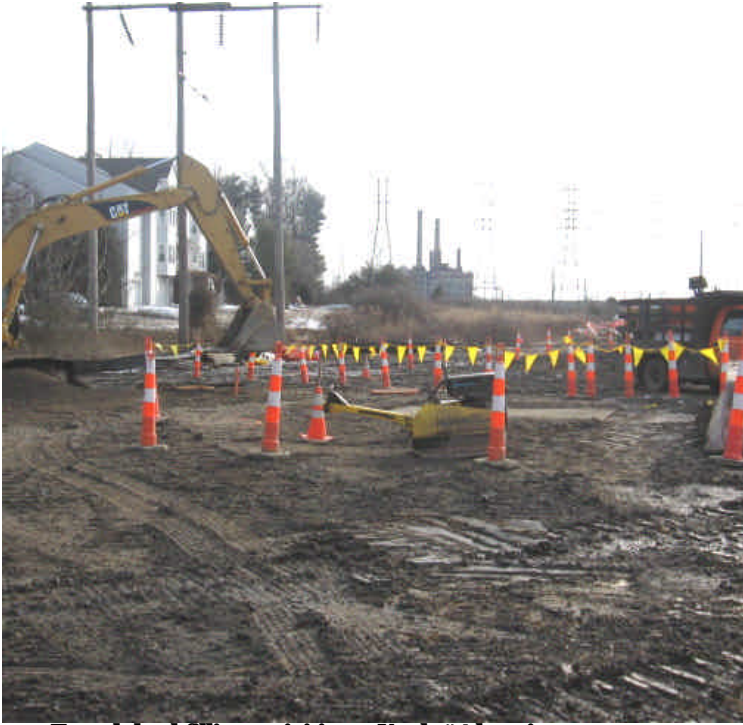
**Trench backfilling activities at Vault #4 location.**

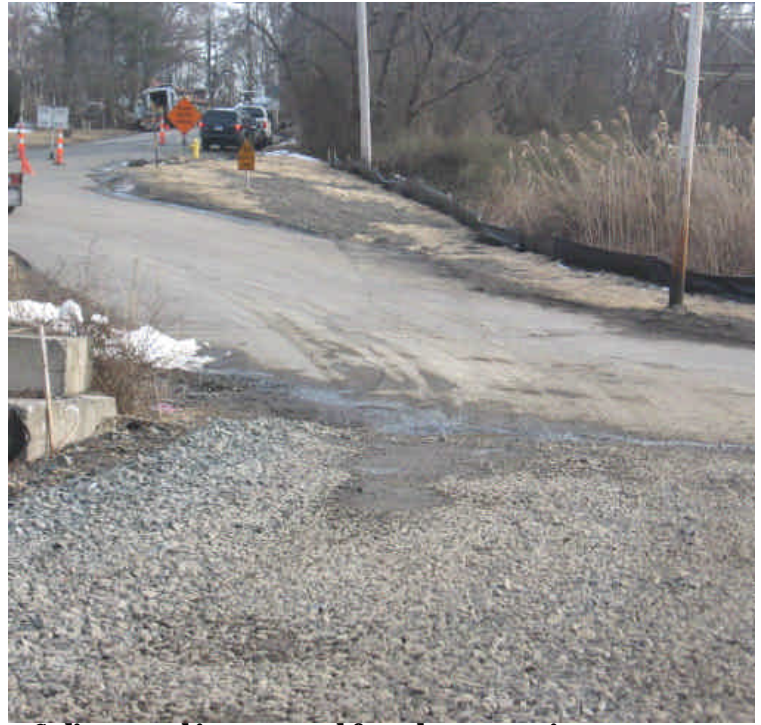
**Sediment tracking was noted from the construction entrance at station #1053 onto Naugatuck Ave. The construction entrance appears clean but the roadway should be swept.**

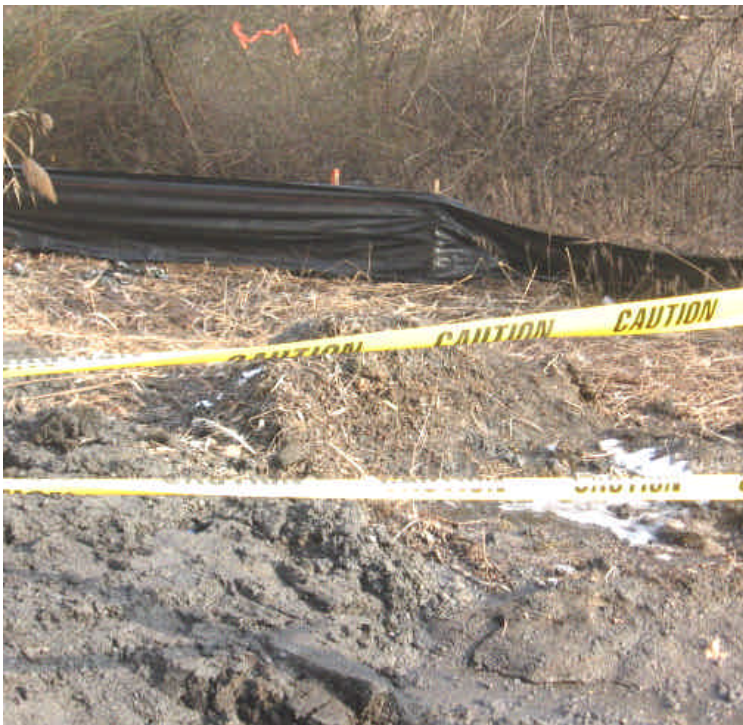
**Silt fence was in place between trenching activities and the adjacent resource area at #1016+50, but it needs to be properly installed (toed-in).**

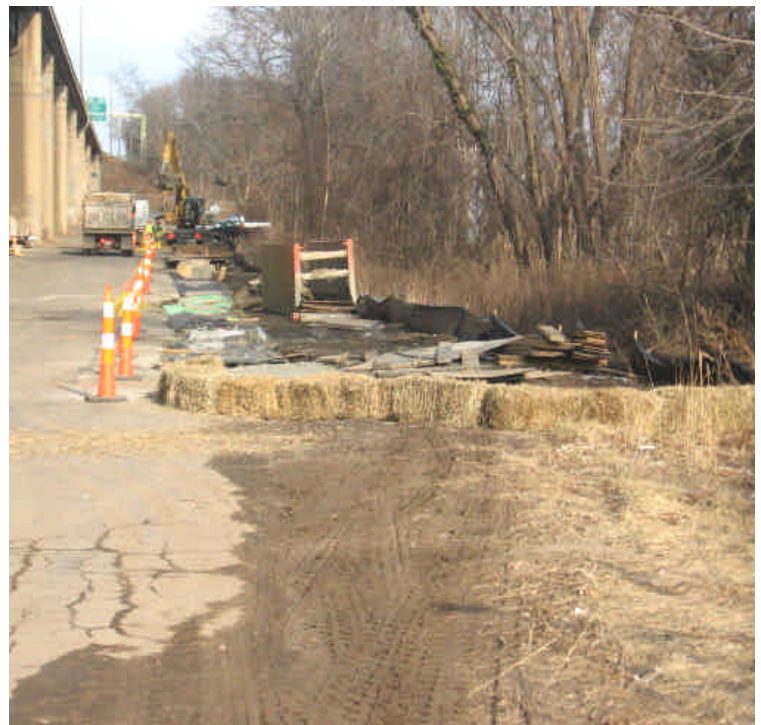
**Haybales have been proactively installed to control sediment migration at station #1017. The sediment seen in the foreground of the photo was present prior to the construction activities.**

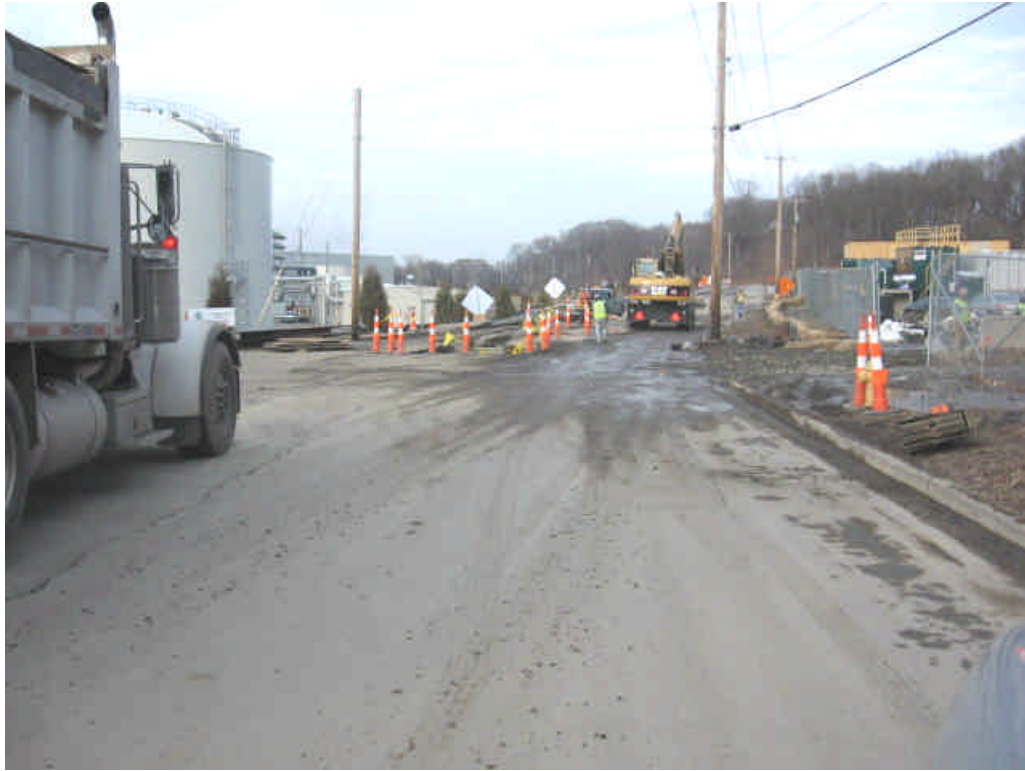
**Photo of trenching activities on Shelland St. near the entrance to the Milford lay-down yard. Minimal tracking from the yard was noted.**

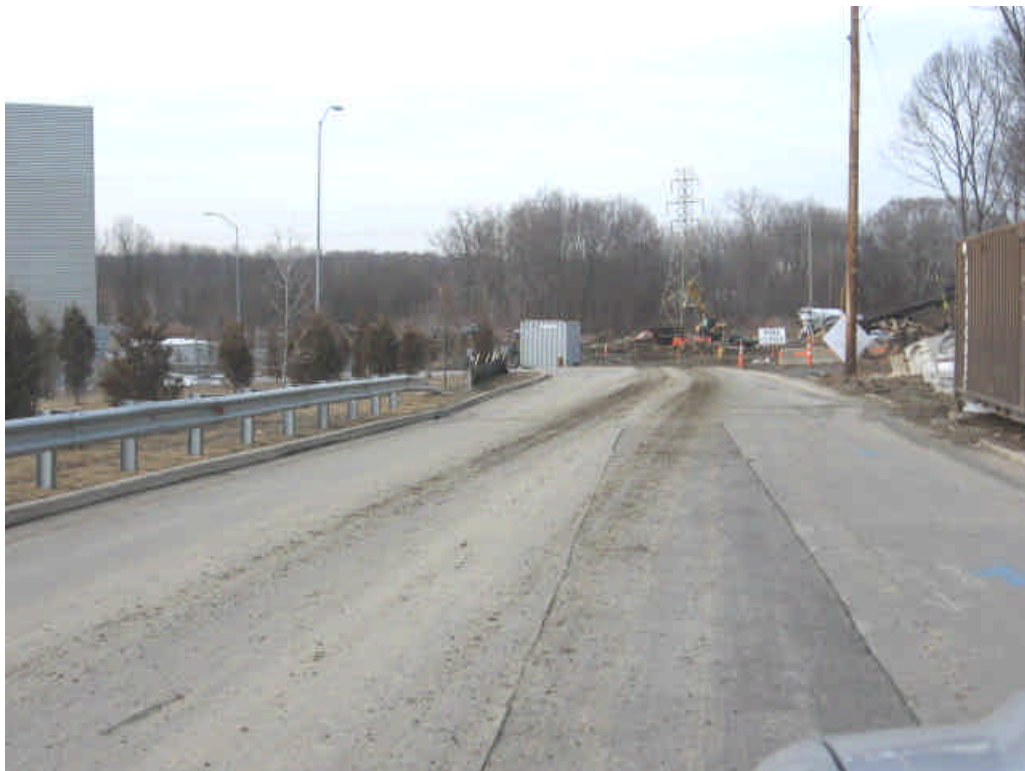
<b>Shelland St</b>	<b>Some sediment tracking was noted from the unpaved portion/active work area of the roadway near East Devon sub. 3/1/07</b>	<b>A stone construction entrance should be considered here. The street will need to be swept regularly. 3/1/07</b>	<b>Needs regular attention and evaluation.</b>
<b>Milford contractor yard</b>	<b>The stone access stone pad at the entrance of the</b>	<b>Continue to monitor and maintain as necessary.</b>	<b>No issues noted but needs regular</b>

**Sediment tracking from the unpaved portion of Shelland St. was apparent on the remainder of the roadway. A stone construction entrance may be necessary to reduce sediment tracking in this area. Sweep the roadway on a regular basis.**
