Docket No. 272 – Development and Management Plan Inspection

Segment 3 Underground Line

Date: March 6, 2007

Location: East Devon Substation to the Housatonic River Crossing

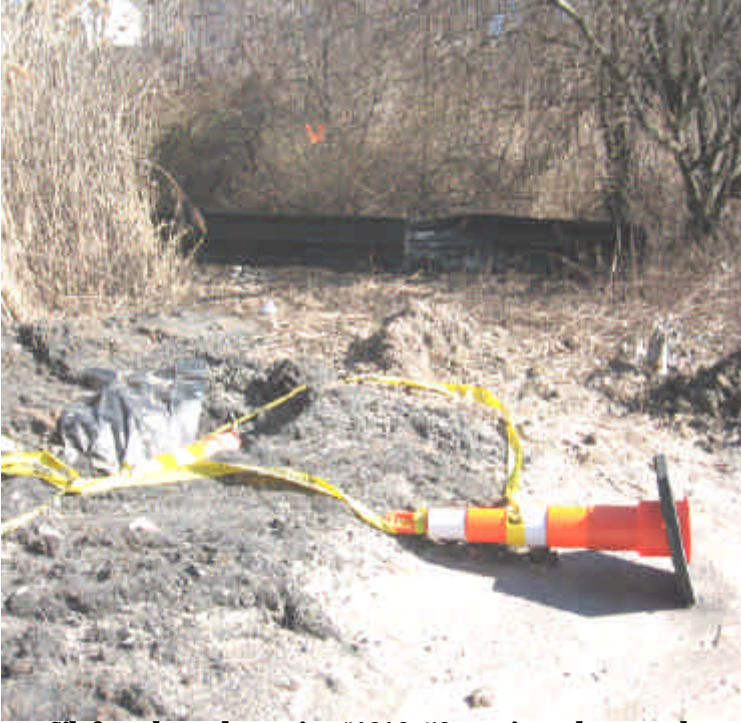
Silt fence located at station #1016+50 remains to be properly installed (toed-in). A resource area is adjacent so maintenance is necessary.

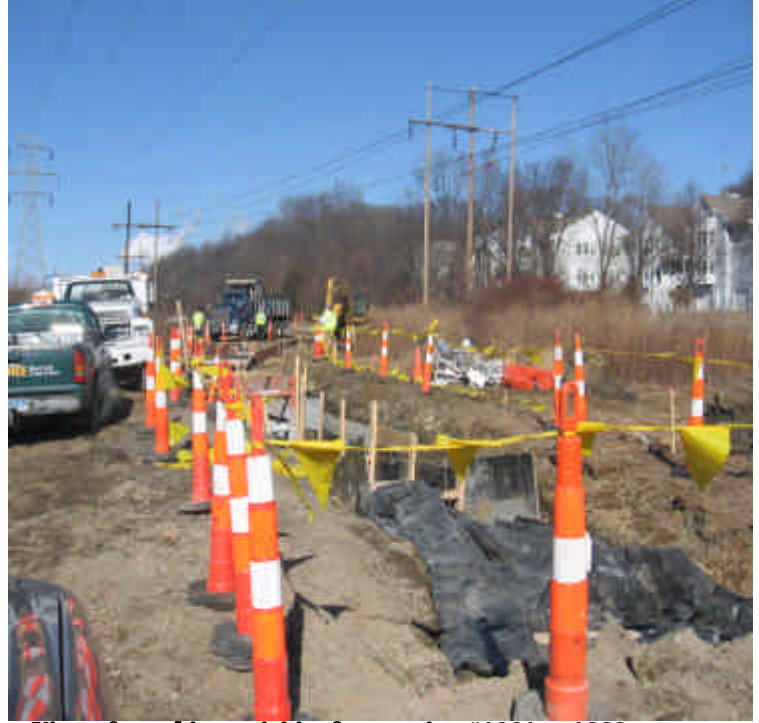
View of trenching activities from station #1061 to 1063.

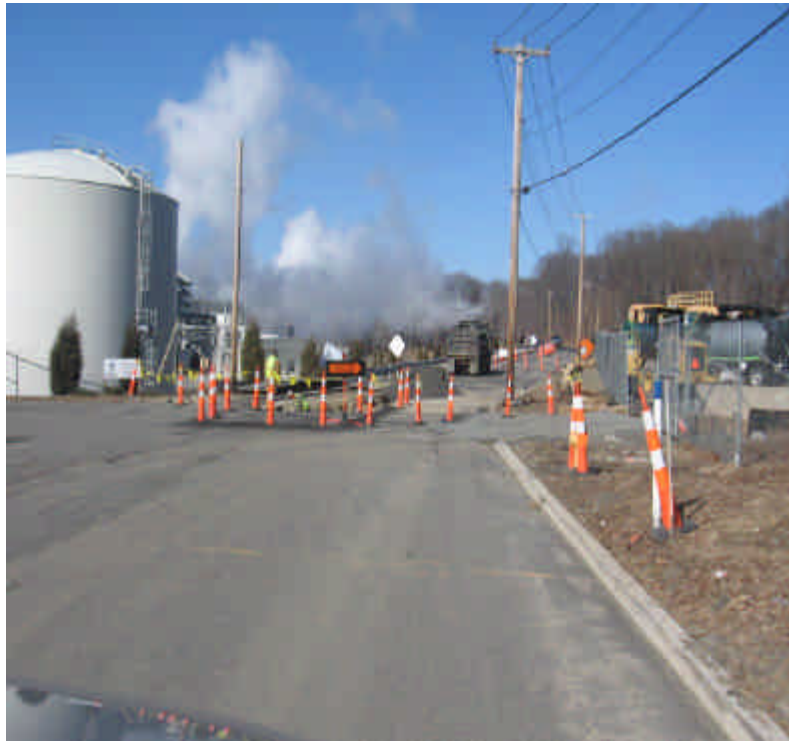
View of trenching activities on Shelland St. adjacent to the entrance to Milford lay-down yard. No sediment tracking was observed from the yard onto Shelland St.
