Docket No. 272 – Development and Management Plan Inspection

Segment 3 Underground Line

Date: March 22, 2007

Location: East Devon Substation to the Housatonic River Crossing

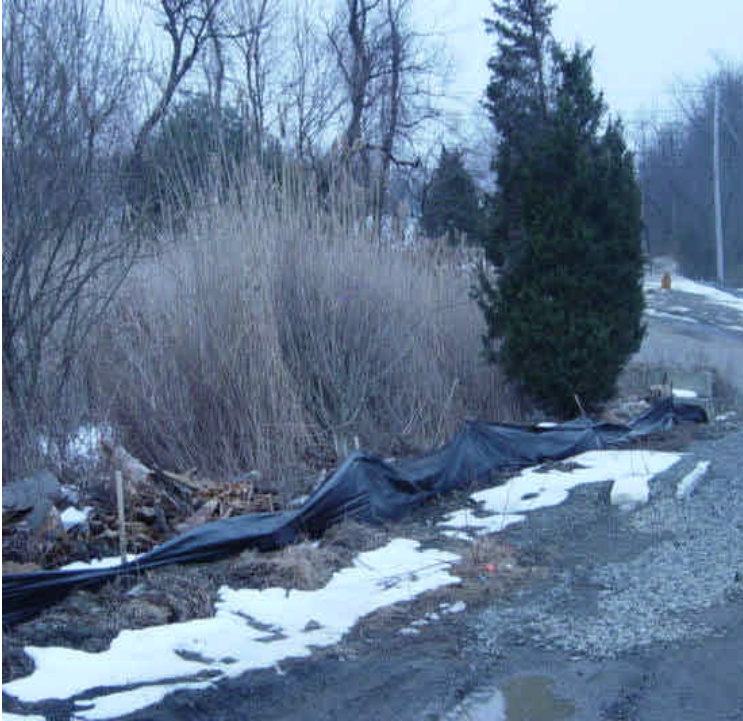
Brush and stumps have been piled in a resource area beyond the silt fence. The gate at Naugatuck Ave has been removed and also remains stored in the adjacent resource area. Erosion controls are degraded here and need repair.

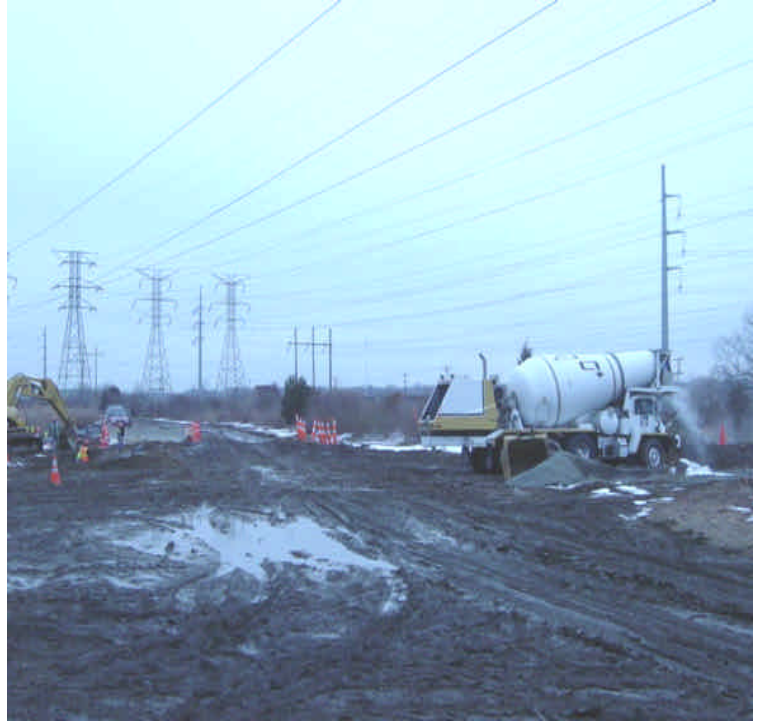
Trenching activities near sta. #1063. Concrete truck was observed washing out in a contained area.

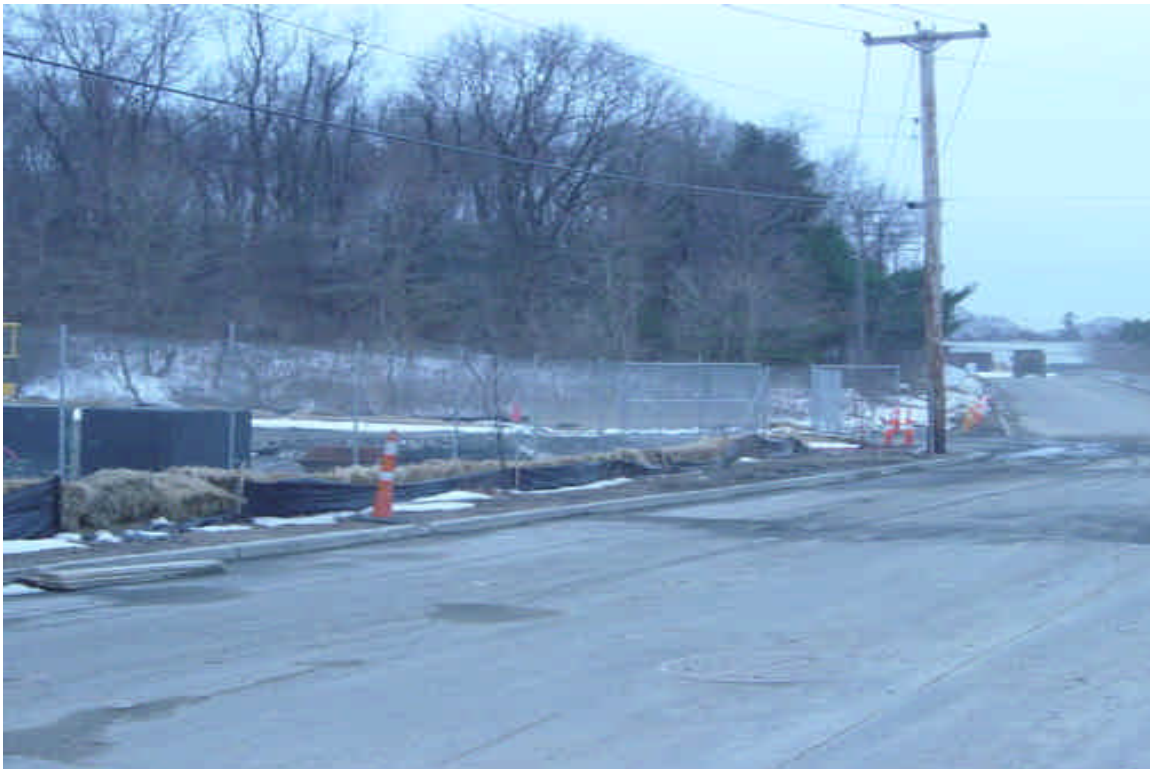
Minor tracking was evident along the roadway at the entrance to the Milford lay-down yard.
