Docket No. 272 – Development and Management Plan Inspection

Segment 4a Underground Line

Date: March 1, 2007

Location: Singer Substation to Fairfield/Westport Town Line

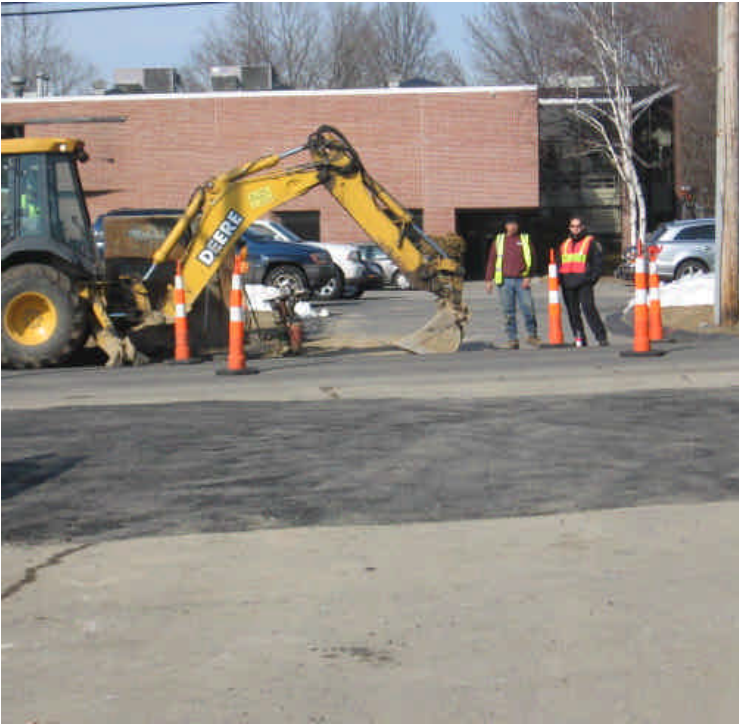
Utility work being conducted adjacent to Vault #28. Continue to sweep pavement as necessary.

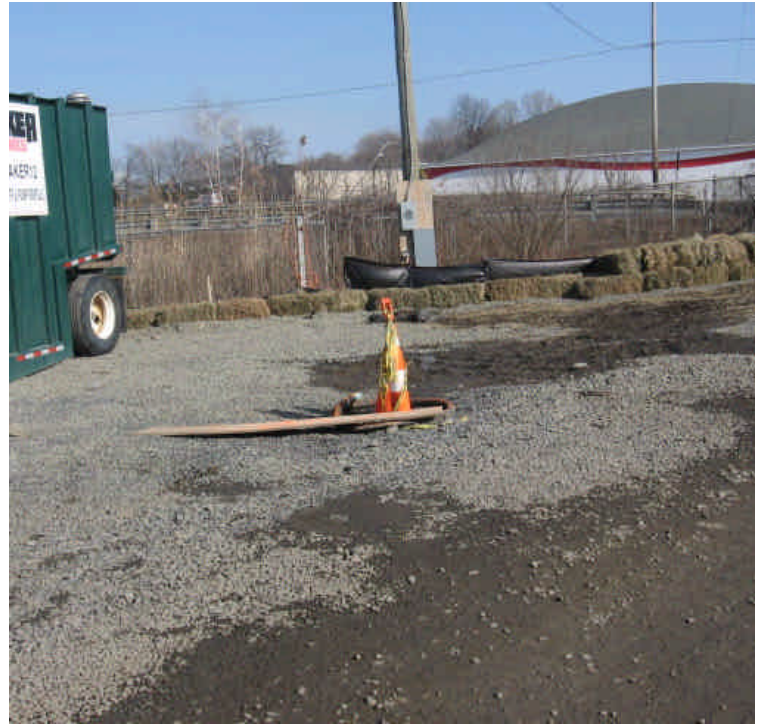
Perimeter erosion controls have been re-established proactively in the King Highway lay-down yard.

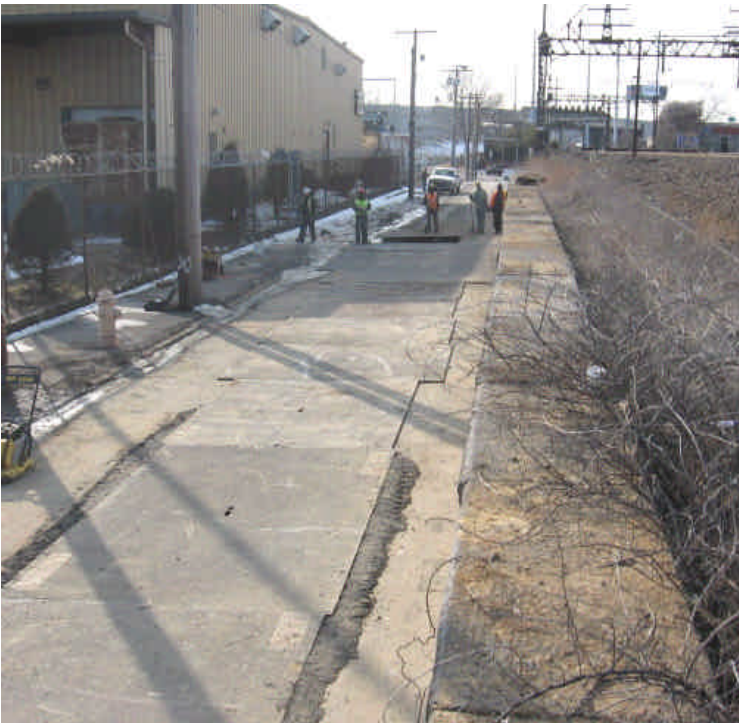
Trenching activities being conducted on Railroad Ave. between Rt. 1 and Bostwick Ave.

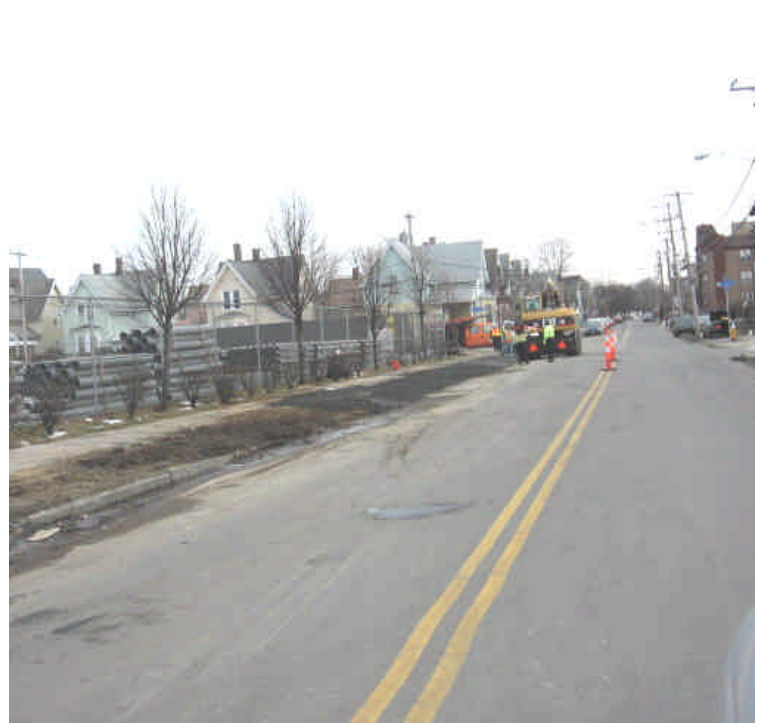
The roadway shoulder on Broad St. is being restored with aggregate as the trench is backfilled. The decision was made to use aggregate to prevent rutting along the roadway after this issue was noted along Railroad Ave.

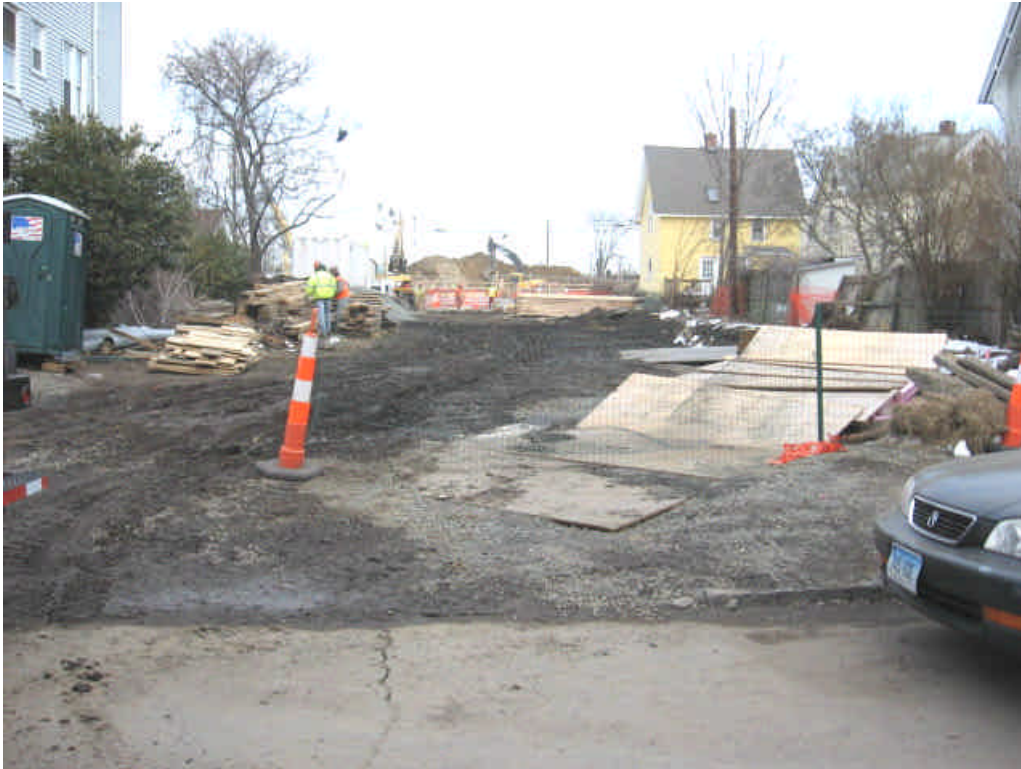
Trenching activities between Broad and Main Sts. Some sediment tracking was noted on Broad St.; Street sweeping should be performed.

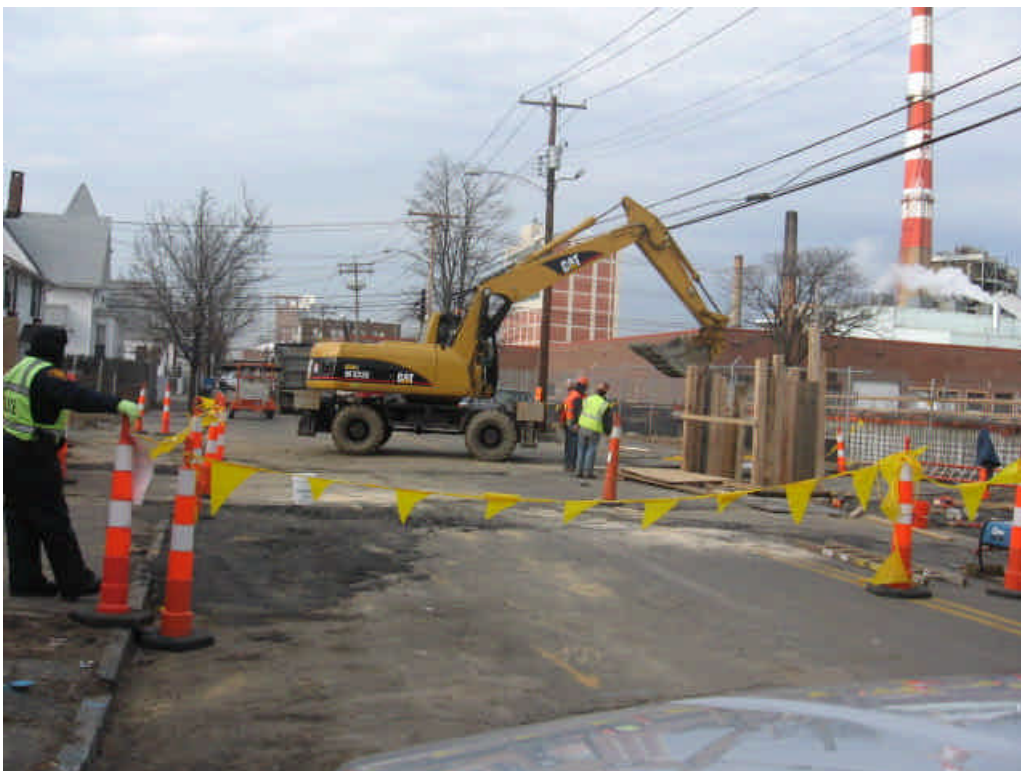
View of trenching activities on Main St. Sediment tracking was noted along the roadway; Street sweeping should be performed.
