Docket No. 272 – Development and Management Plan Inspection

Segment 4a Underground Line

Date: March 15, 2007

Location: Singer Substation to Fairfield/Westport Town Line

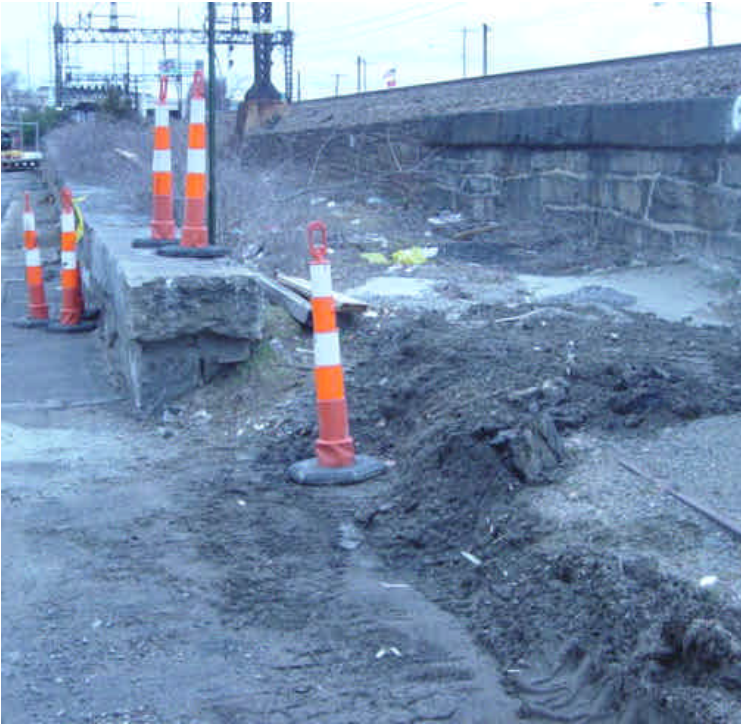
Concrete washout has been released in an uncontained location on Railroad Ave. between Rt. 1 and Bostwick Ave.

Areas of Inspection	Observation	Recommended Action	Corrected Action
	<p>aggregate were noted in this area during the inspection. 3/6-3/15/07</p> <p>Aggregate/crushed stone is being installed over the backfilled trench in various locations, including along bermed areas. 3/6-3/15/07</p>	<p>Unless part of the agreement with the city, consider using the aggregate cover only in the lower lying shoulder areas that are more prone to tracking. Higher areas could be restored to grass or original conditions. 3/6-3/15/07</p>	Needs evaluation
Dewatering	Dewatering activities were not observed during this week's inspection. 3/15/07	Continue to appropriately contain or filter 3/15/07	NA
Blasting	No blasting has been proposed. 3/15/07	None 3/15/07	NA
Spills and Material Storage	<p>Spill cleanup materials/kits were observed in the storage yards. 3/15/07</p> <p>A concrete washout was observed in an uncontained location, immediately adjacent to the railroad on Railroad Ave. between Rt. 1 and Bostwick Ave. 3/15/07</p>	<p>Ensure that spill kits are also present with each vehicle during active construction 3/15/07</p> <p>Remove and properly dispose of concrete. Concrete washouts should only be released in an approved, contained location. 3/15/07</p>	<p>NA</p> <p>Needs attention.</p>

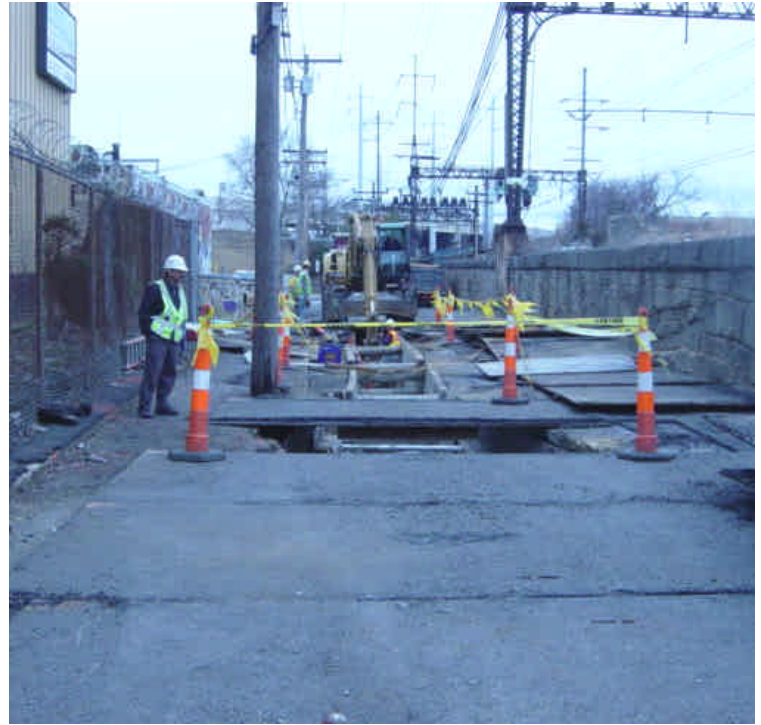
View of trenching activities within Railroad Ave. between Rt. 1 and Bostwick Ave.

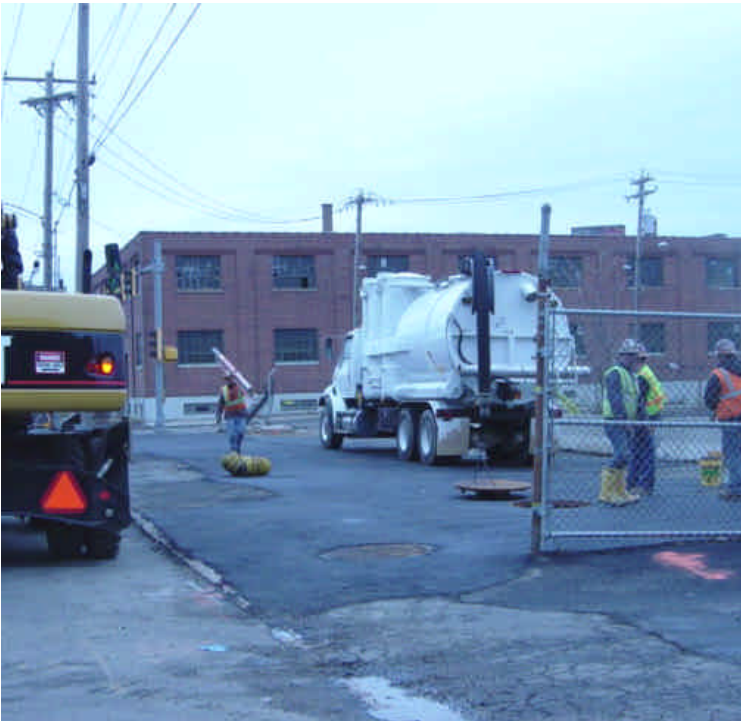
Trenching activities at the corner of Bostwick Ave. and Railroad Ave.

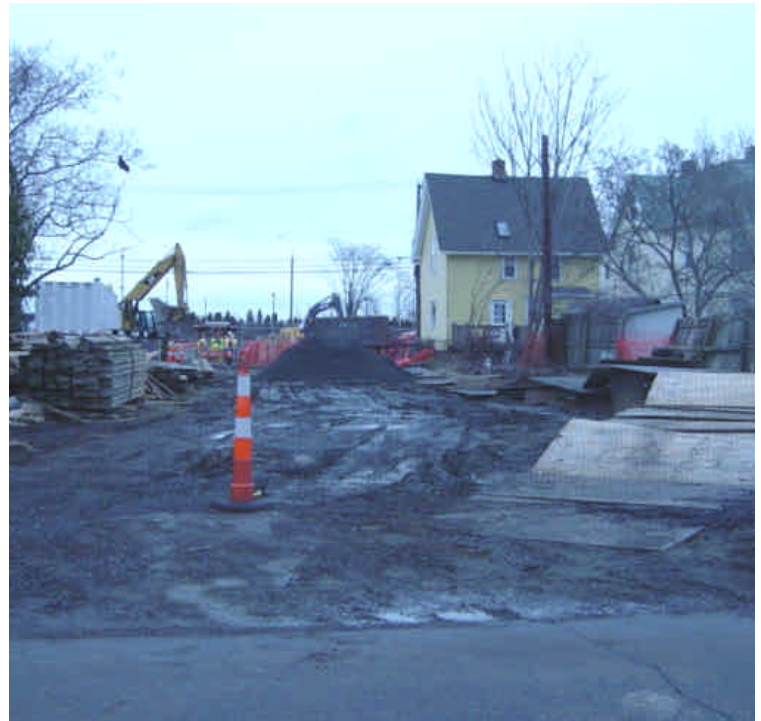
Trenching activities between Broad and Main St. No tracking was noted on either of the roadways as a result of the work.
