Docket No. 272 – Development and Management Plan Inspection

Segment 4a Underground Line

Date: March 22, 2007

Location: Singer Substation to Fairfield/Westport Town Line

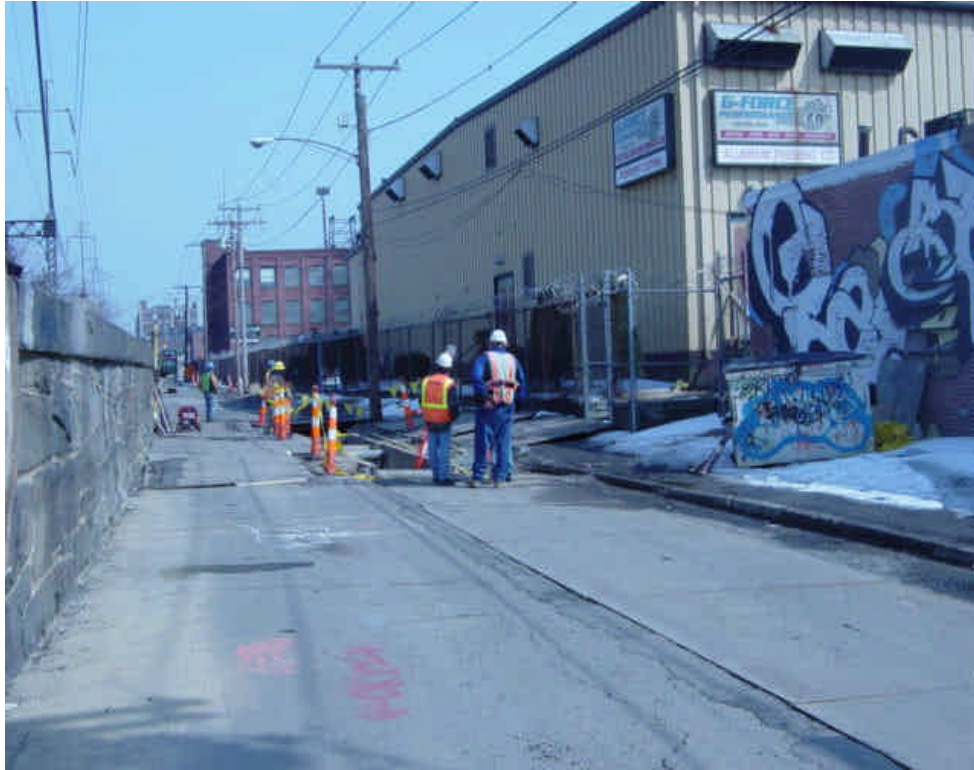
Vault Openings and Trench Construction Bridgeport	Trenching activities continue on Railroad Ave. between Rt. 1 and Bostwick Ave. 3/22/07	Continue to monitor and be proactive. Continue to mulch/ temporarily stabilize areas as they are completed. Continue to sweep roadways as soon as feasible. 3/22/07	Catch basins are protected.(Proactively)
Fairfield	Trenching activities	See erosion and sediment	NA

View of trenching activities within Railroad Ave. between Rt. 1 and Bostwick Ave.

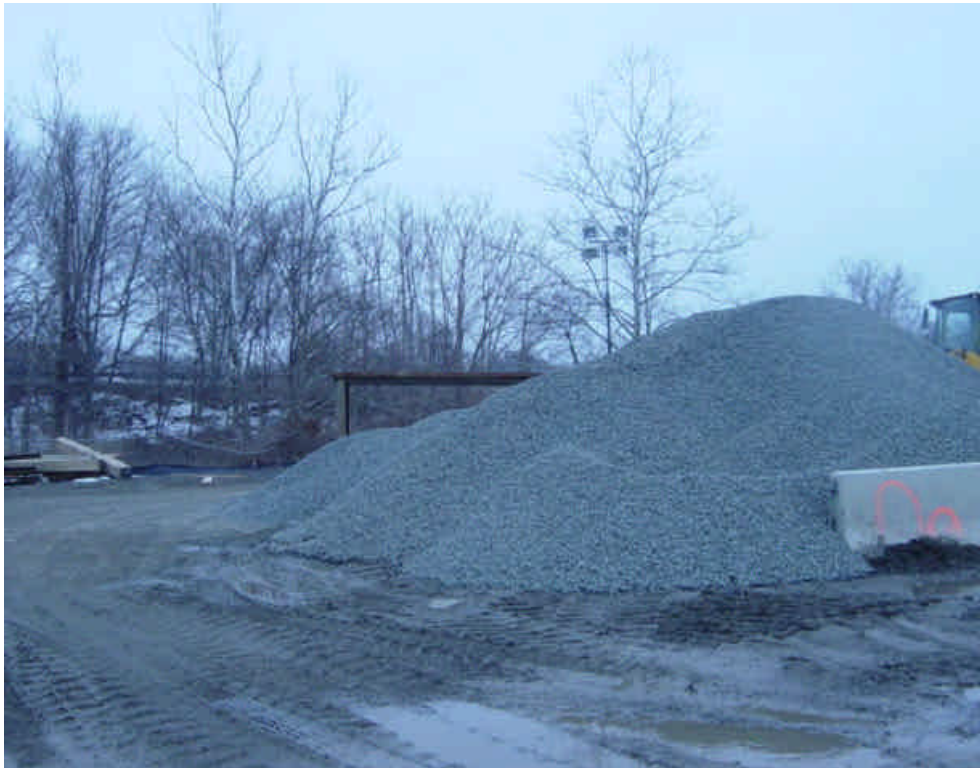
Concrete washout basin materials have been removed from the Kings Highway lay-down yard (off Kings Highway, near Rt. 1 rotary). Materials are contained within the yard.
