Docket No. 272 – Development and Management Plan Inspection

Segment 4b Underground Line

Date: March 27, 2007 (night inspection)

Location: Fairfield/Westport Town Line to Westport Avenue in Norwalk

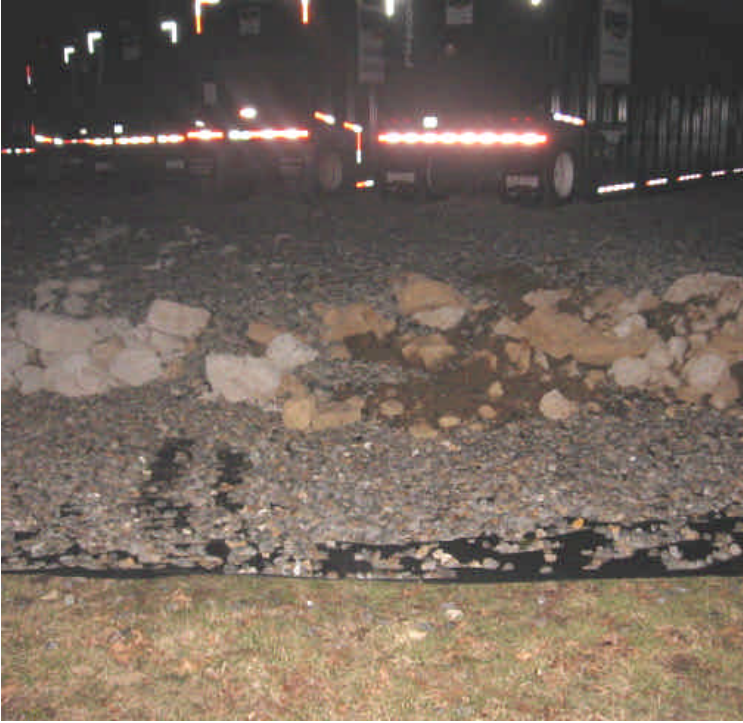
Both photo are of the Sherwood Island lay-down yard. Left: The entire yard has been lined with fabric and covered with a layer of stone. This will reduce mud and tracking as well as allow for simplified clean-up or restoration. Right: The only stormwater discharge point from the site has been adequately protected with erosion controls.

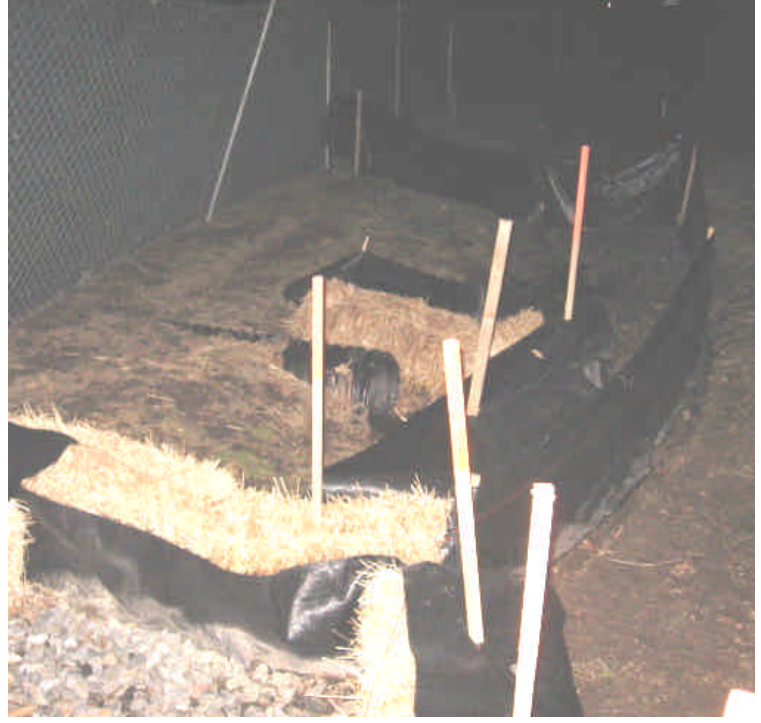
The only stormwater discharge point has been adequately controlled with haybale and silt fence barriers. 3/27/07	Continue to monitor this spot but it is currently well-controlled. 3/27/07	Controls were installed proactively.
Inland Wetland and Watercourse encroachment and mitigation	The Kings Highway lay-down yard is located adjacent to potential resource areas and a concrete lined waterway. 3/27/07	See erosion control section. 3/27/07	NA
	The Imperial Ave. lay-down yard is surrounded by the Saugatuck River on the southwestern, western, and northern sides. The majority of the yard is isolated from the nearby resource areas by an earthen berm. 3/27/07	None. 3/27/07	NA
Staging, Storage, and Parking Areas	A contractor lay-down yard is located off of Kings Highway near the Rt. 1 rotary. This is being used for both 4a and 4b activities. 3/27/07	See Erosion Control section and Spills and Material Storage section for more detail. 3/27/07	NA

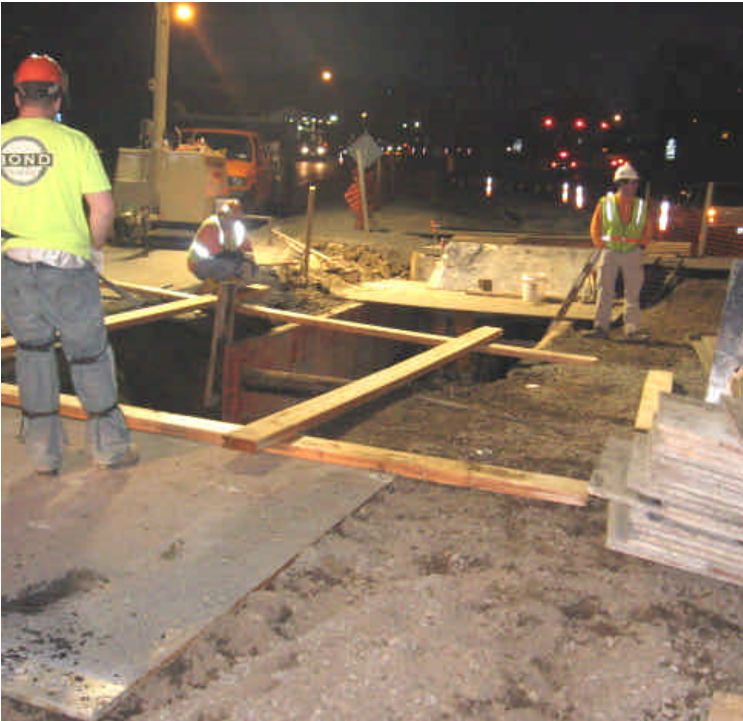
Trenching activities were being conducted at numerous locations along the project route.

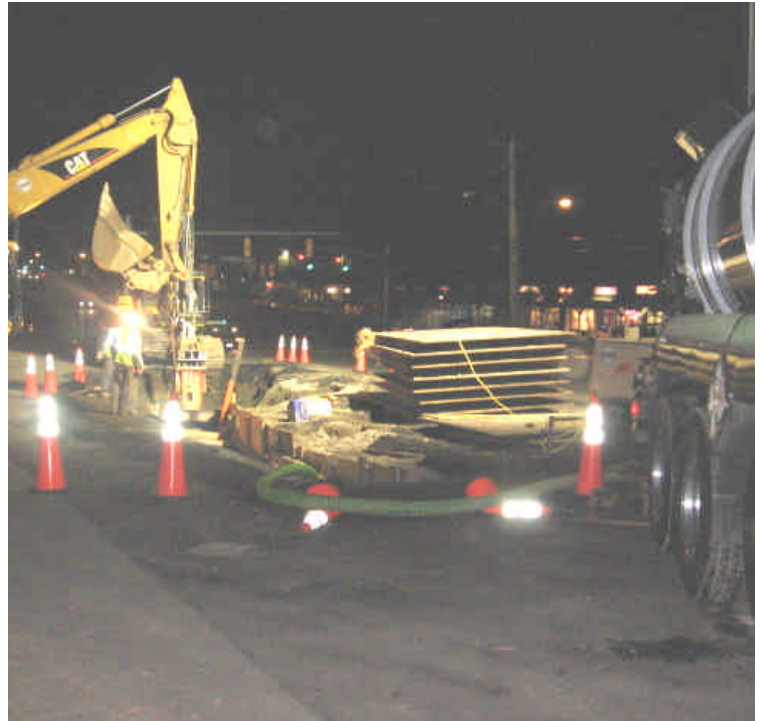
Trenching activities at vault #18 required dewatering. A vac truck was used appropriately.

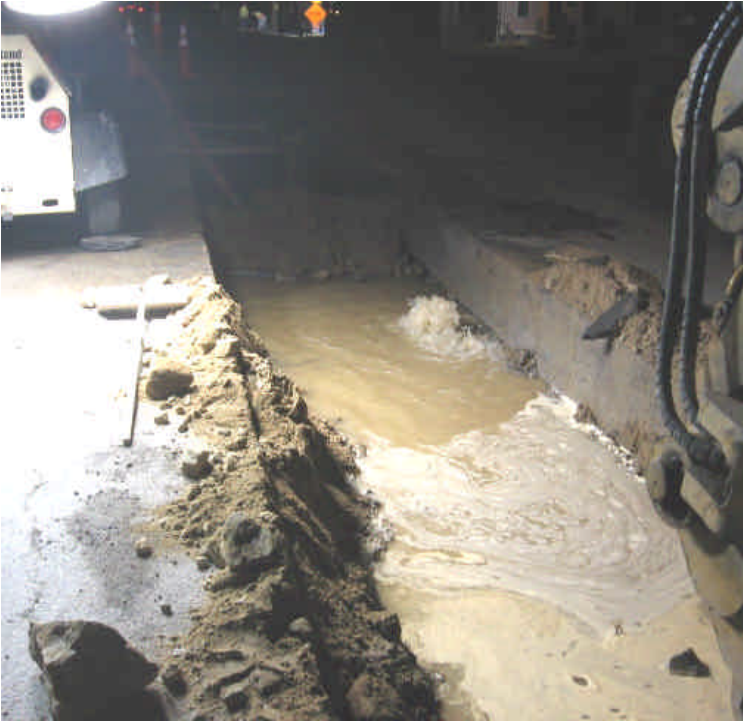
During trenching activities at sta. #226 to 228, the crew hit a water main that delayed construction. All water remained contained to the trench.

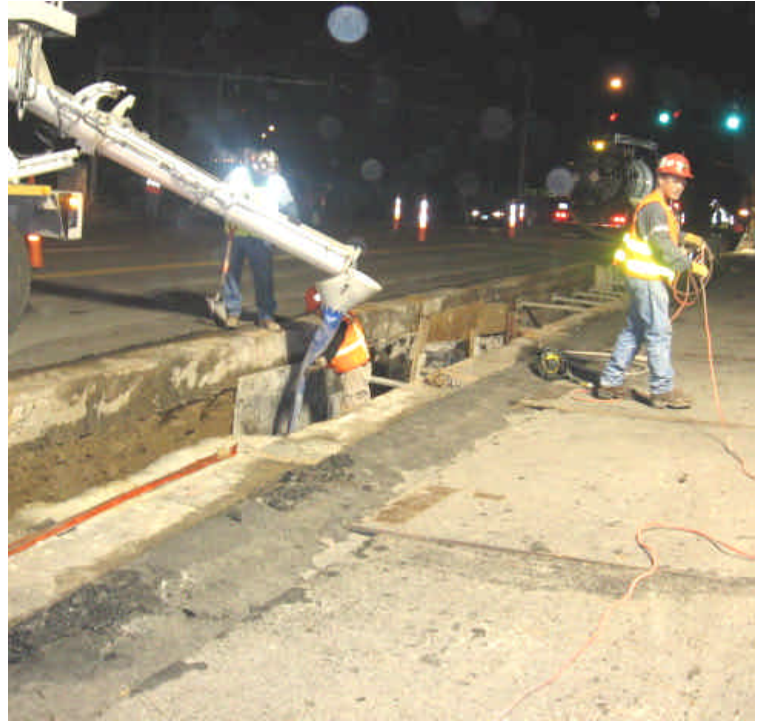
View of crews backfilling the trench located at sta. #195 to 197. A vac truck was dewatering the opposite end of the trench in the background of the photo.

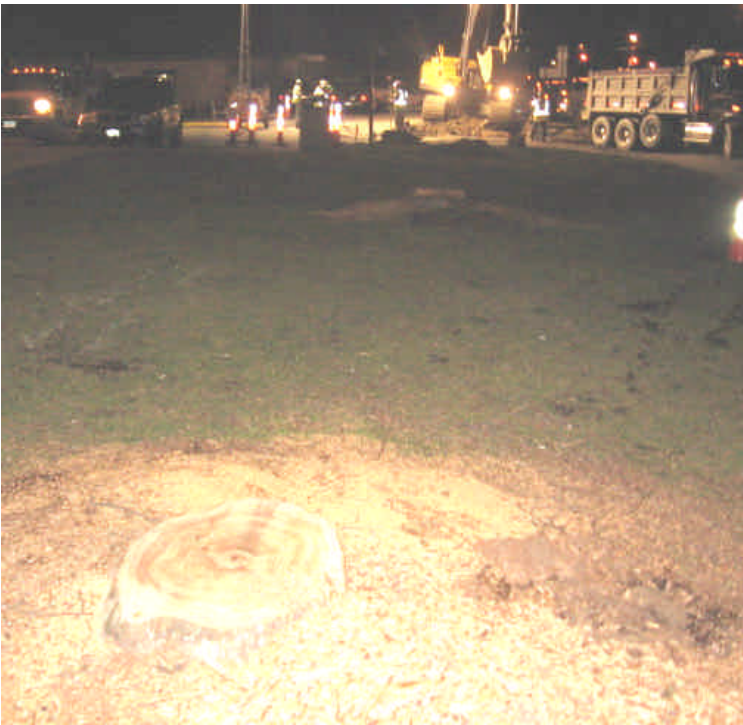
Five trees were removed south of vault #20 to accommodate trenching activities, and as approved by the D&M Plan.

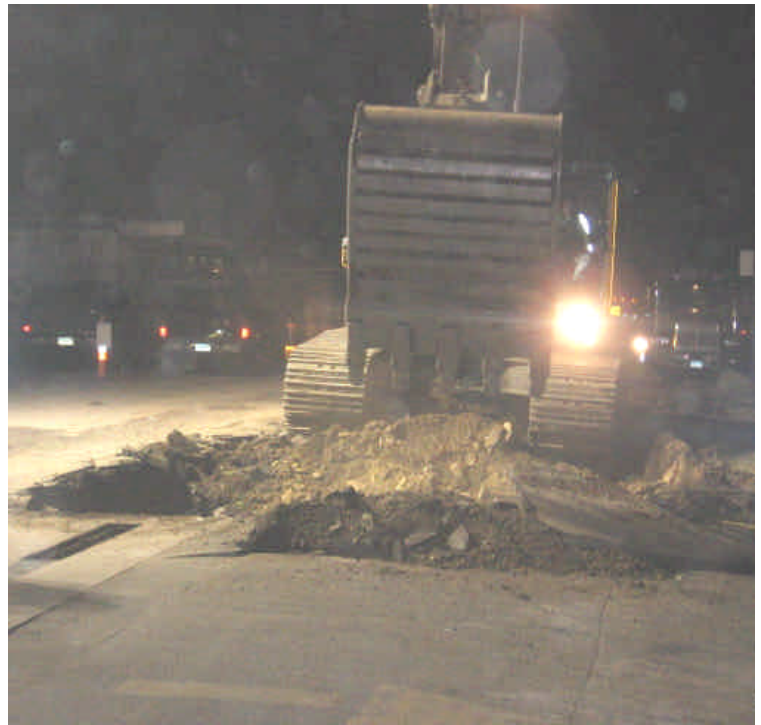
Excavation activities for Vault #20 were initiated during this week's inspection.
