Docket No. 272 – Development and Management Plan Inspection

Beseck Switching Station Inspection

Date: May 2, 2007

Location: Beseck Switching Station

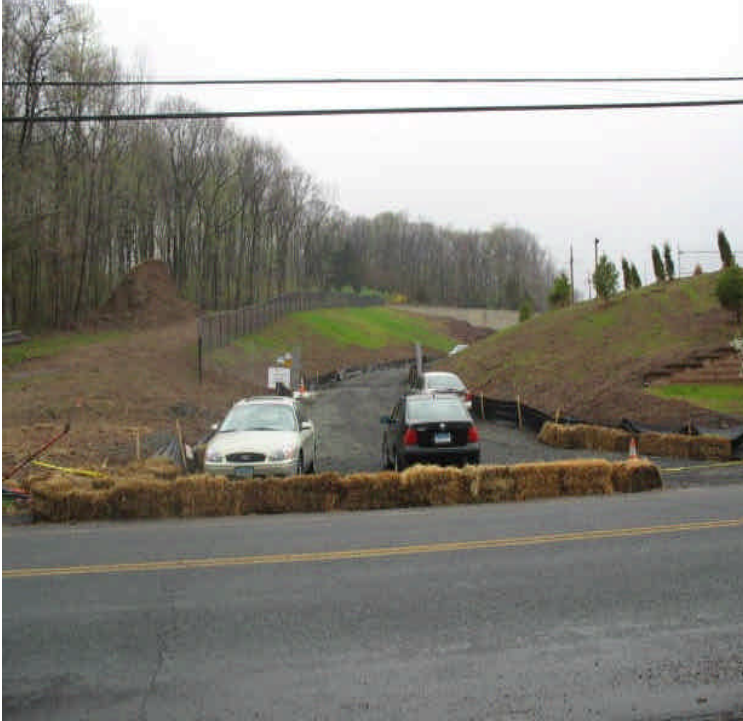
Site entrance off Carpenter Lane is well controlled; the area is being used for temporary parking of personal vehicles.

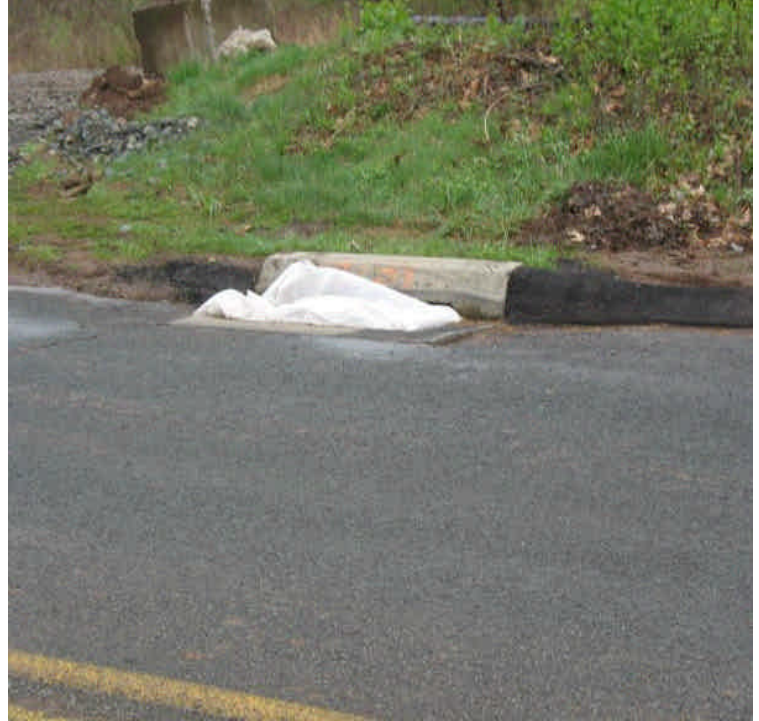
The catch basin liners along Carpenter Lane have been replaced.

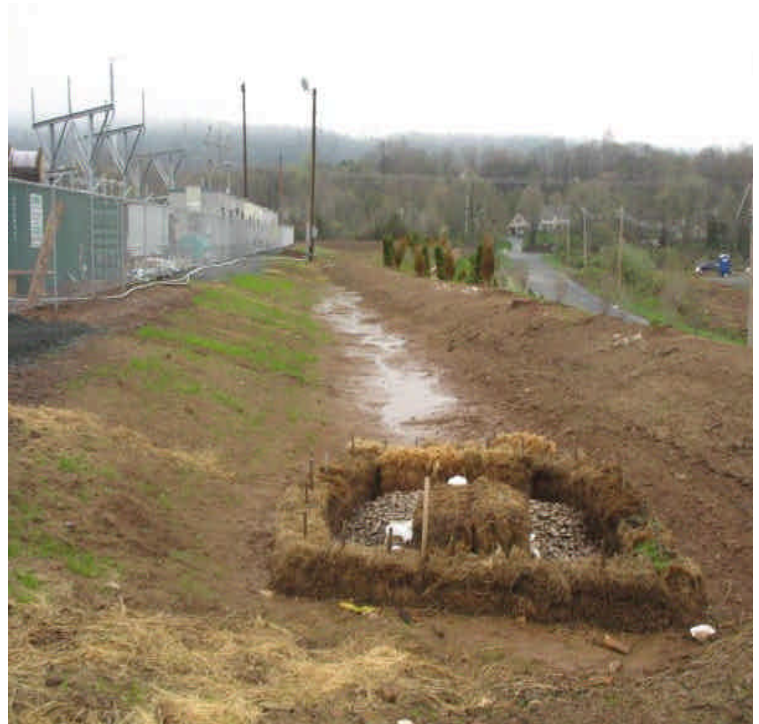
Haybales and controls remain in place at the inlet of the detention basin. Sediment from the stormwater run-off has settled in the basin.

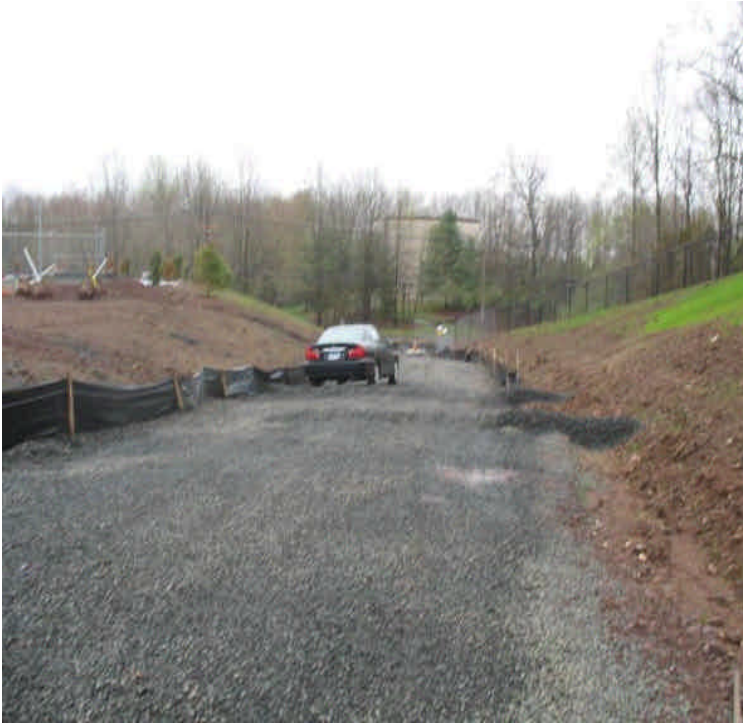
Stone base and stone check dams remain in place along the site entrance.

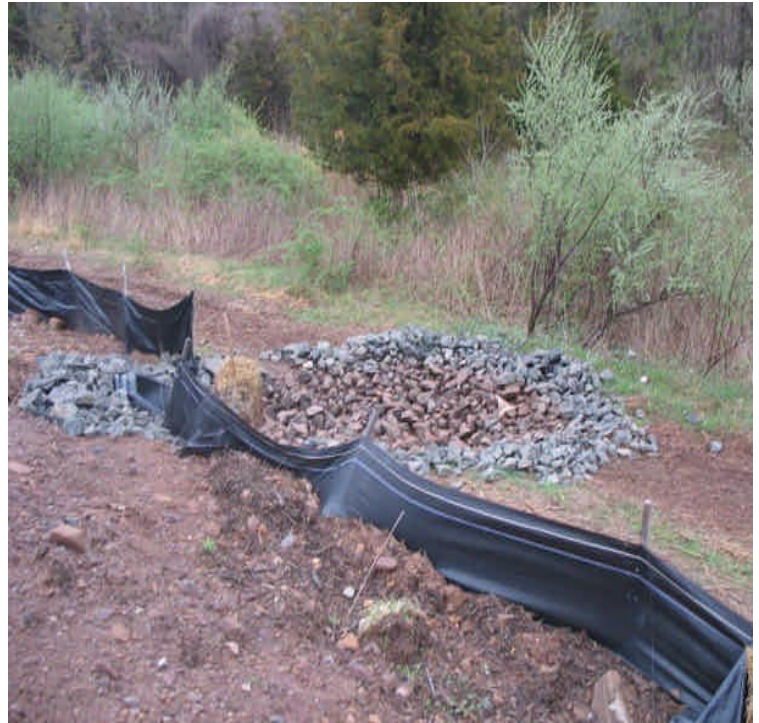
The sediment trap at the culvert under the ROW access road is dry and contains filtered sediment. Haybales are in place at the inlet and outlet. 5/2/07	This control works well for smaller storms but was overwhelmed by the heavy rain a few weeks ago. For future rain events, slow and filter water within the drainage ditch before it flows into the basin. 5/2/07	Sediment and turbid run-off remained contain during the recent storm.

View of the culvert and sediment trap under the access road to the ROW. This control works well for smaller storms but needs reinforcement during the larger rain events.

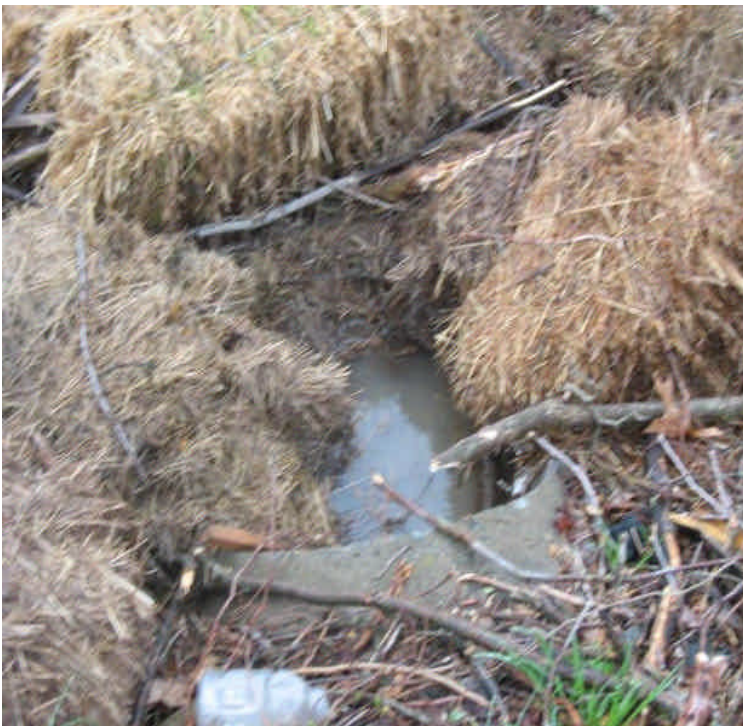
Areas of Inspection	Observation	Recommended Action	Corrected Action
	<p>the basins. 5/2/07</p> <p>The storm water outlet pipe at the wetland across Carpenter Lane has several layers of haybales in place to help filter turbid water. Water within the outlet and flowing into the wetlands were somewhat turbid. In general, sediment from the site is very fine and difficult to filter but efforts continue to be made onsite to reduce turbid run-off. 5/2/07</p>	<p>5/2/07</p> <p>Haybales should be monitored and replaced as needed at the storm drain outlet. Stormwater should continue to be contained and filtered before leaving the site to the extent possible. Continue addressing stormwater issues at the source. Good efforts were made on site to reduce run-off. Stone check dams along Carpenter Ln. should be considered to help reduce turbid run-off from entering the CBs. 5/2/07</p>	<p>The standing water at the drain outlet and within the wetland was somewhat turbid.</p>

Storm drain outlet across Carpenter Lane has turbid water flowing through the haybales.

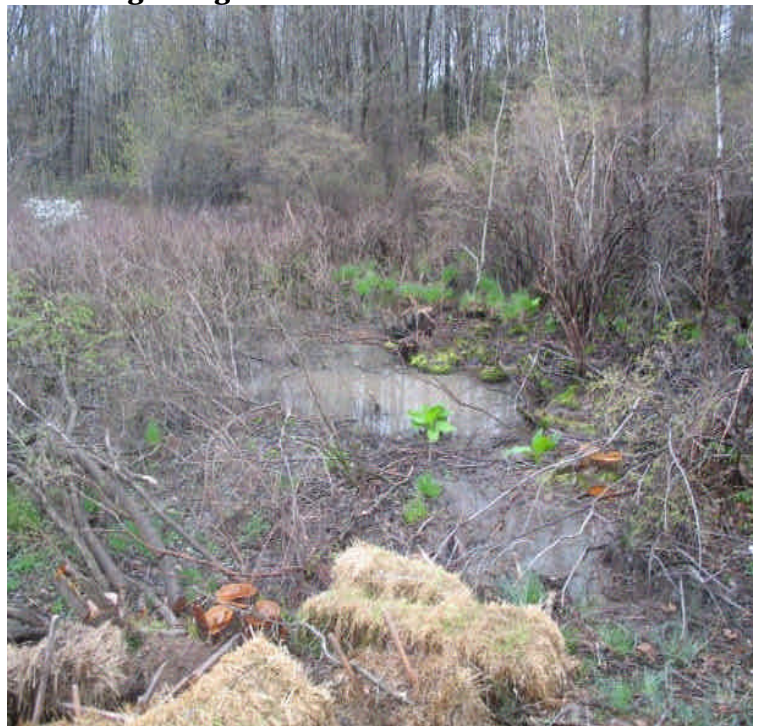
<p>Inland Wetland and Watercourse encroachment and mitigation</p>	<p>Turbid water was observed leaving the outlet across Carpenter Lane and ponding in the wetlands. 5/2/07</p> <p>The drainage ditch (north side of the site) and sediment trap under the ROW access remained dry. 5/2/07</p> <p>Additional work in the wetlands to the south and east of Beseck are covered in other project reports. 5/2/07</p>	<p>Several areas in the wetland have sediment accumulation. Sediment should be removed from the outlet and adjacent areas when water levels recede 12/26/06- 5/2/07. It will be evaluated whether the accumulation justifies the minor disturbance required to remove it. 1/23-5/2/07</p> <p>Add controls along the drainage ditch to slow and filter run-off before leaving the site. 5/2/07</p> <p>See Segment 1a or 2a inspection reports for more details. 5/2/07</p>	<p>Continue to evaluate and add controls as needed.</p> <p>NA.</p> <p>Not jurisdictional to this D&M plan.</p>

Turbid water was observed leaving the haybales and ponding in the wetlands. Evaluate whether the amount of sediment accumulation justifies the minor disturbance needed to remove it, once the water subsides.
