**Docket No. 272 – Development and Management Plan Inspection**

**Beseck Switching Station Inspection**

**Date:** May 8, 2007

**Location:** Beseck Switching Station

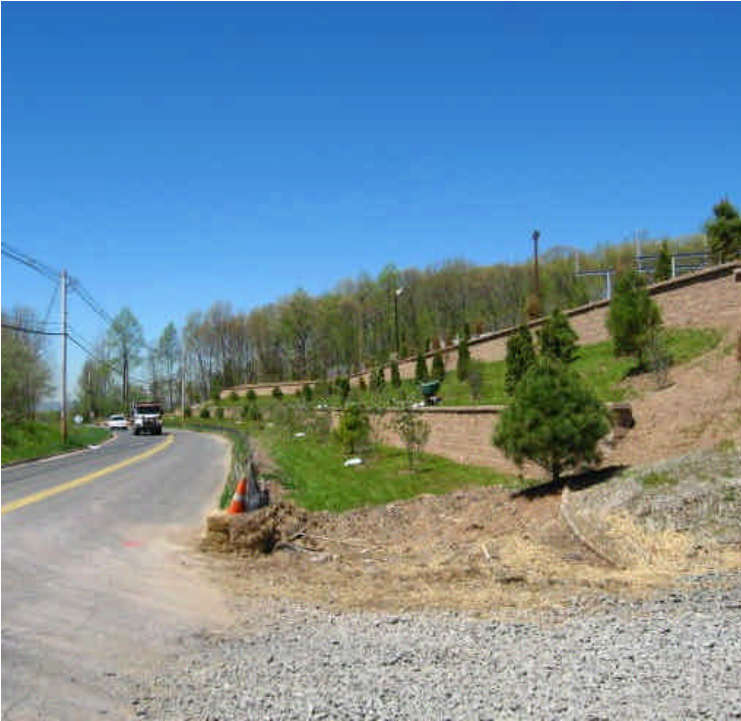
**Site egress off Carpenter Lane had minimal sediment tracking but; no turbid run-off. Haybales should be replaced for run-off containment.**

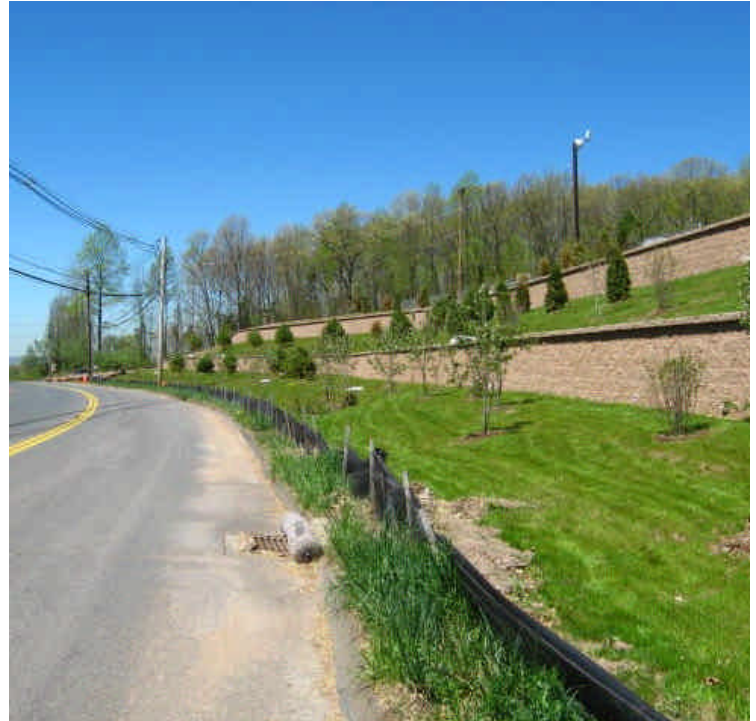
**Some sediment accumulation remains in the gutter of Carpenter Lane. Continue to sweep by hand if necessary.**

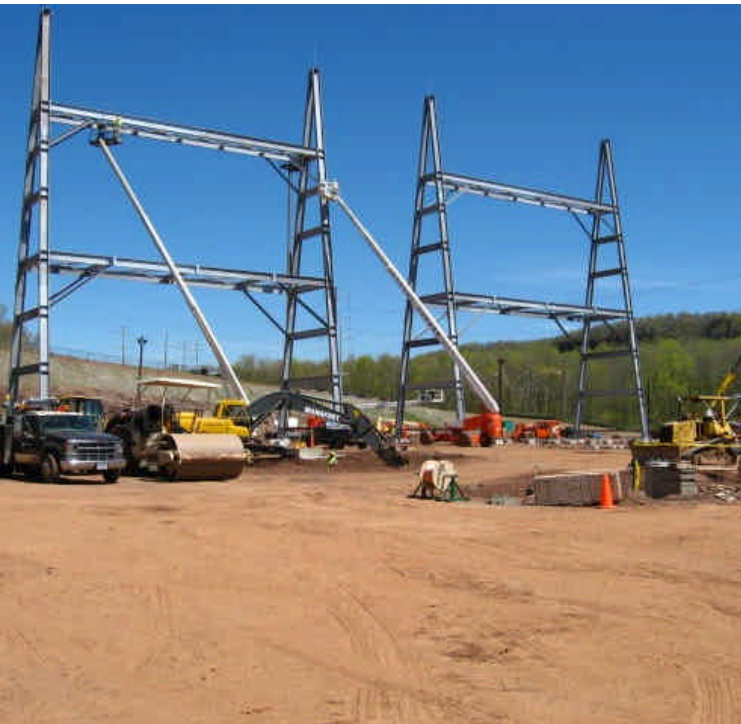
**View of the site and some of the structures being installed.**

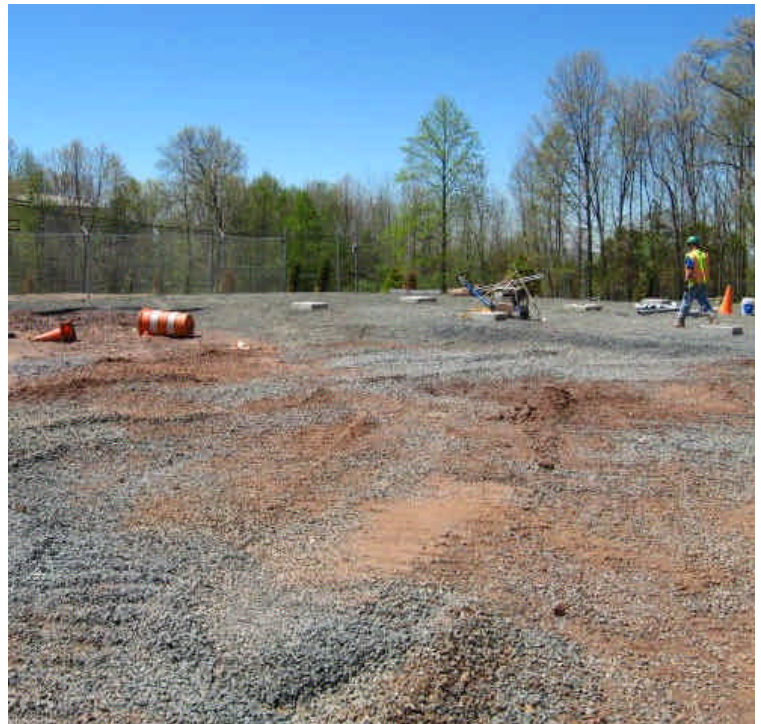
**Stone was being spread in some of the areas where structure foundations were complete for additional stabilization on site.**

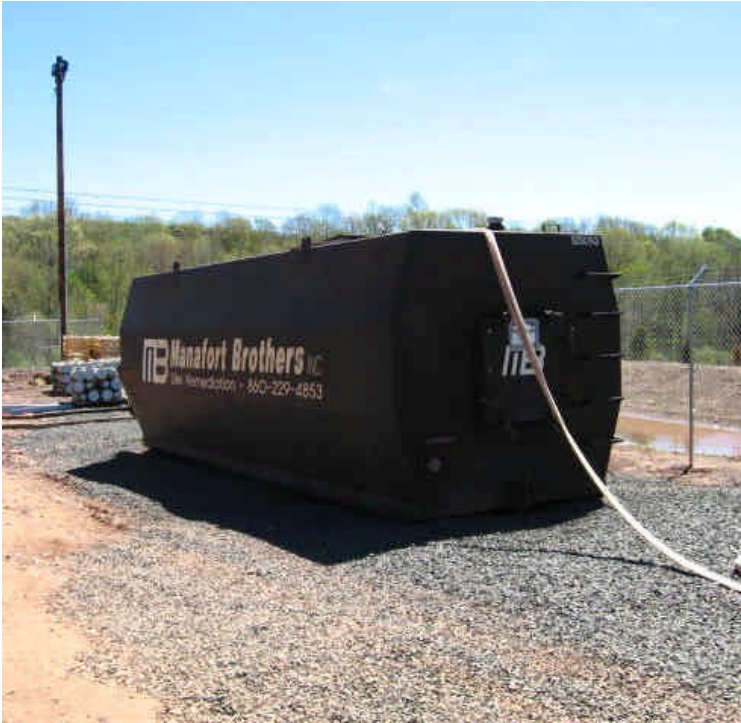
**A frac tank was being used on site to hold and settle-out water from foundation excavations.**

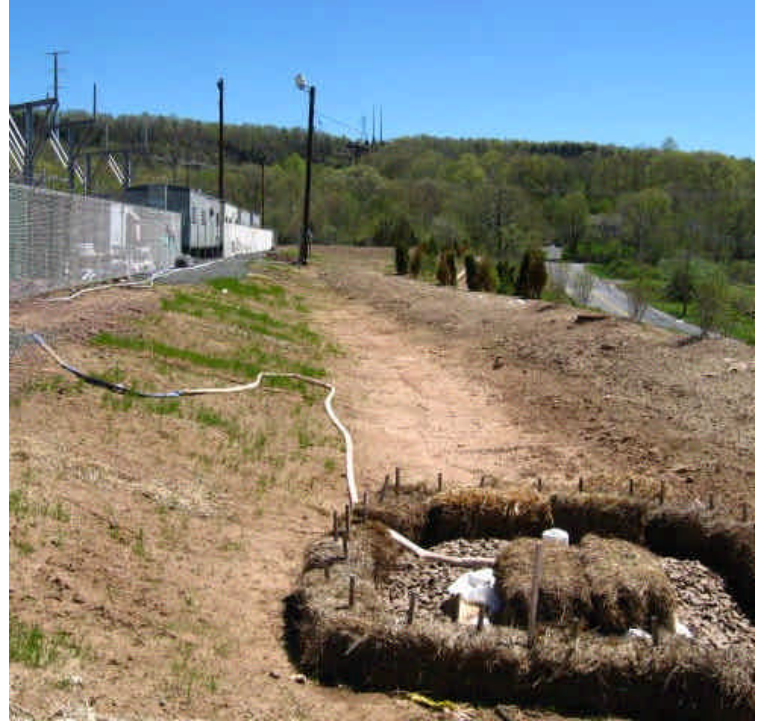
**Haybales and controls remain in place at the inlet of the detention basin. Clean water from the frac tank was being discharged directly to the inlet.**

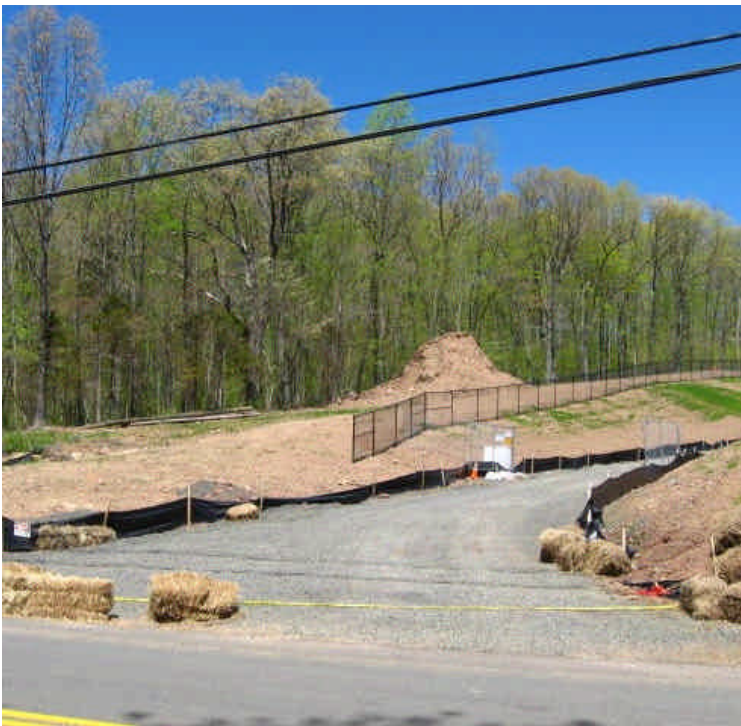
**Site entrance off Carpenter Lane is well controlled. Replace controls across the drive when feasible.**

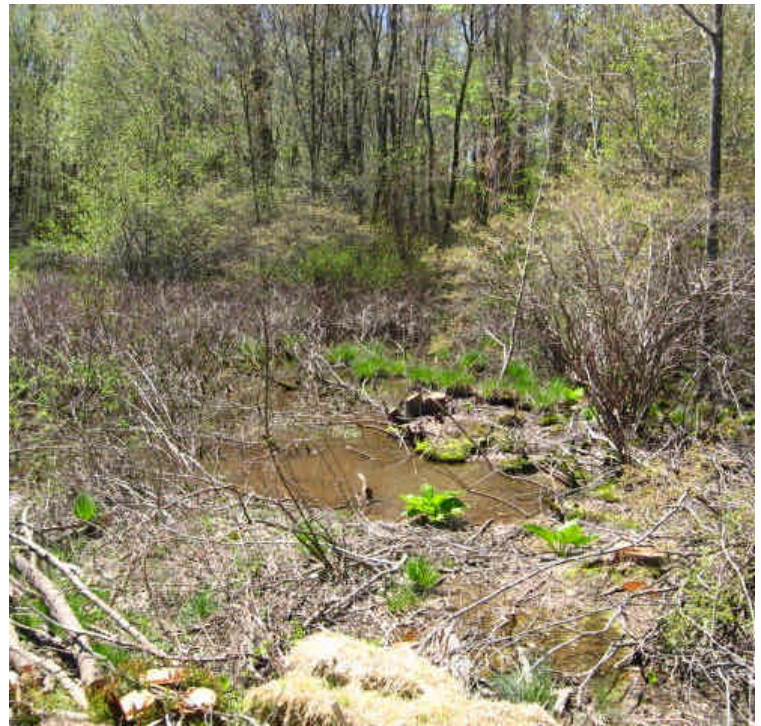
**Clear water was observed leaving the haybales and ponding in the wetlands. Evaluate whether the amount of sediment accumulation justifies the minor disturbance needed to remove it, once the water subsides.**
