Docket No. 272 – Development and Management Plan Inspection

Beseck Switching Station Inspection

Date: May 15, 2007

Location: Beseck Switching Station

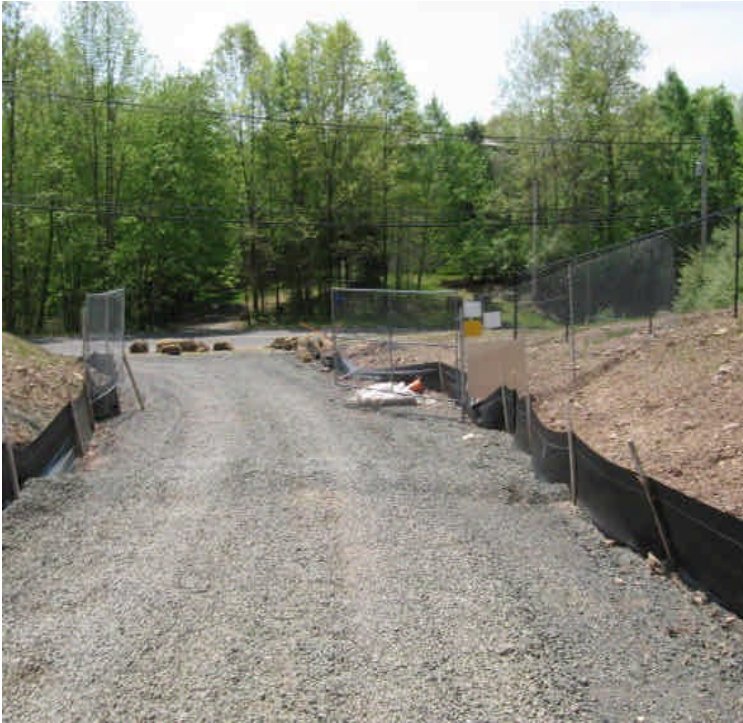
Site entrance off Carpenter Lane is at final grade. Stone base and stone check dams remain in place

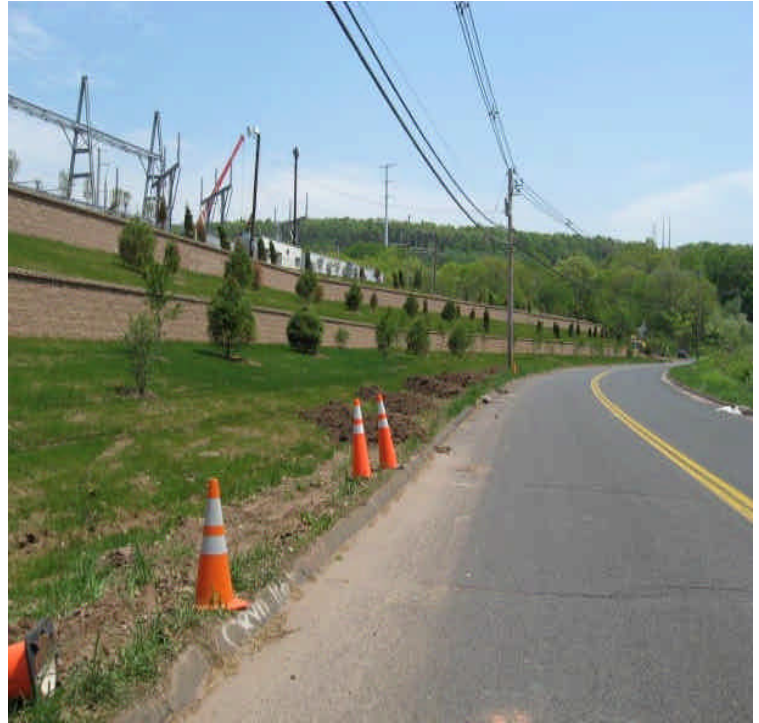
Silt fence was removed along Carpenter Lane. Apply seed to any exposed soil resulting from the removal.

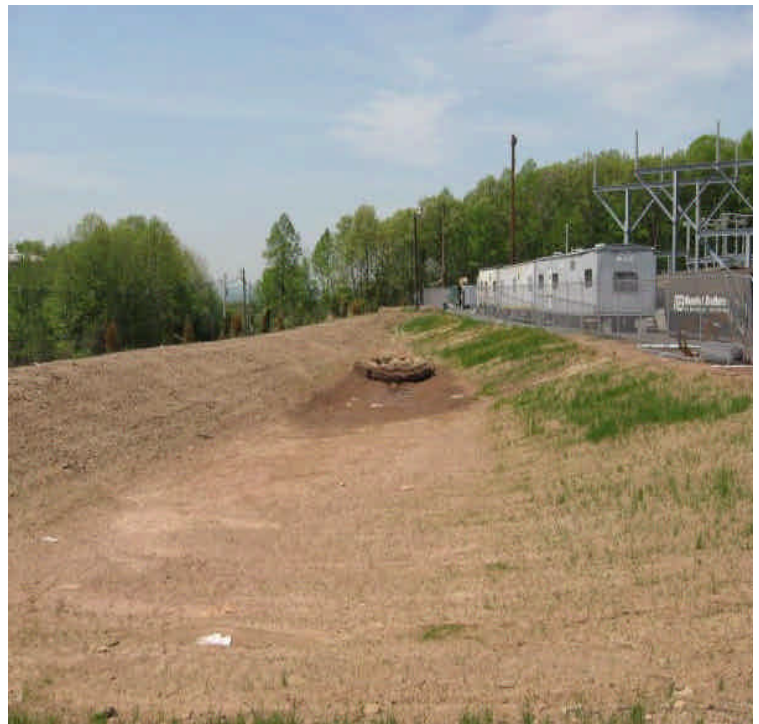
Haybales and controls remain in place at the inlet of the detention basin. Sediment from stormwater run-off has settled in the basin. Consider adding more seed here for further stabilization.

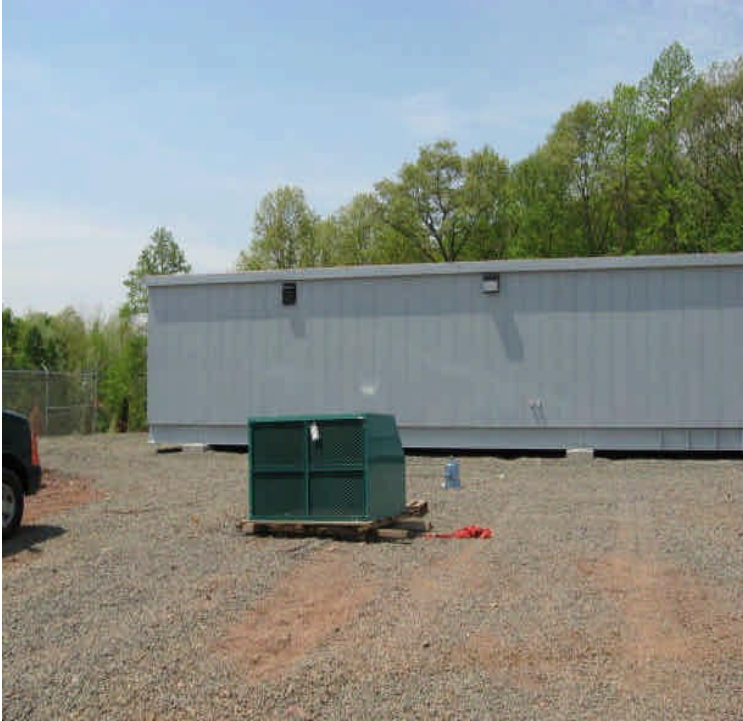
A new building was in place in the southwestern side of the site. Stone base was also applied to stabilize soil.

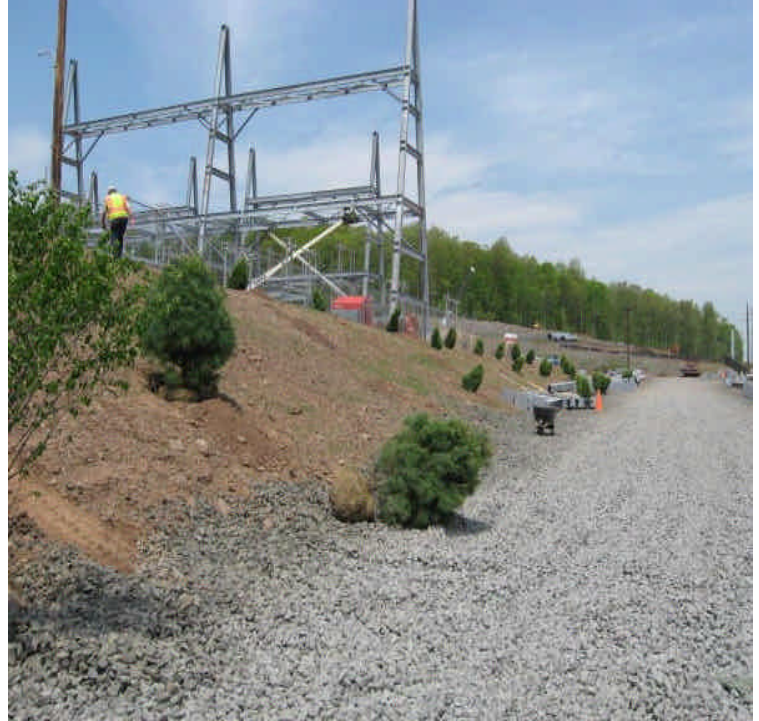
View of the eastern site exit and new shrubs being planted along the slope. Consider adding more seed along the slope as well.

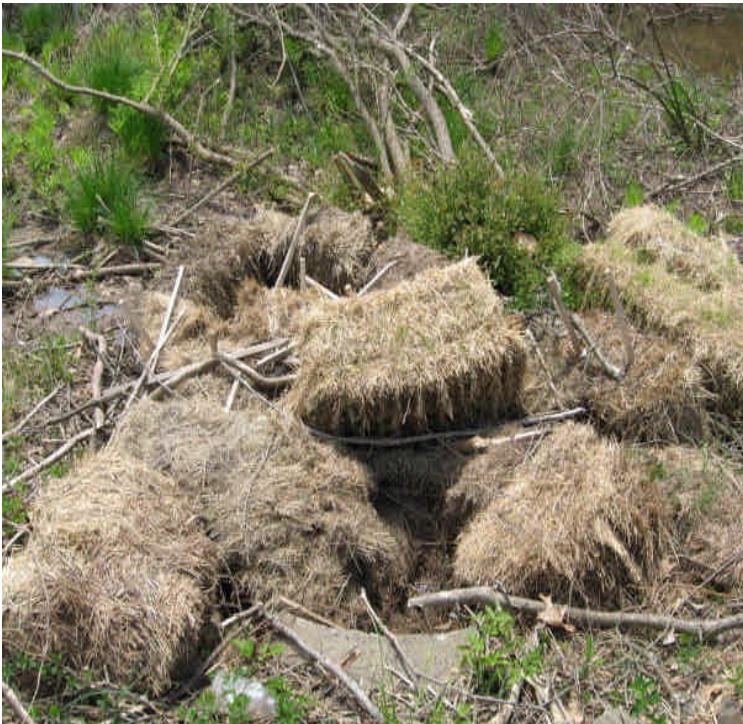
Storm drain outlet across Carpenter Lane has clear water flowing through the haybales.

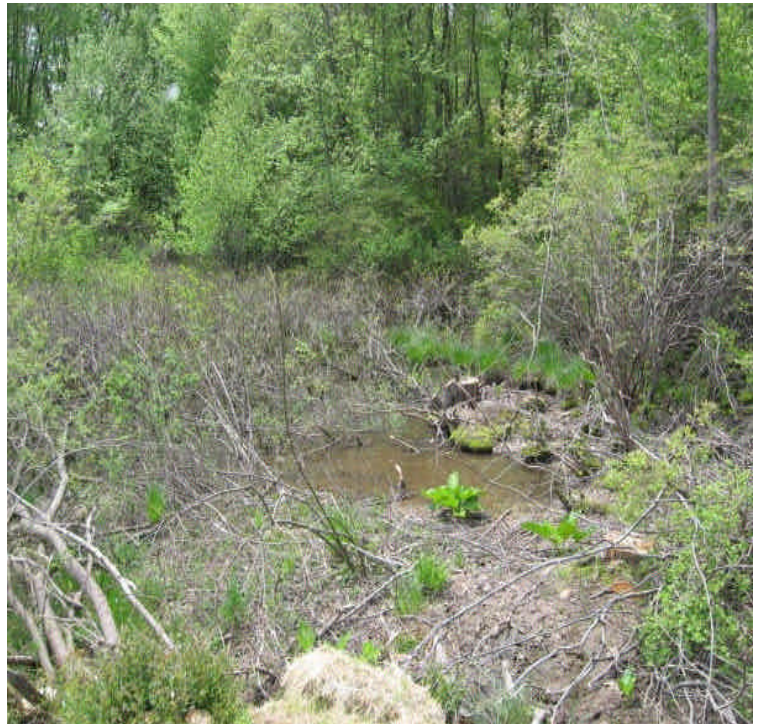
Clear water was observed leaving the haybales and ponding in the wetlands. Evaluate whether the amount of sediment accumulation justifies the minor disturbance needed to remove it, once the water subsides.
