Docket No. 272 – Development and Management Plan Inspection

Beseck Switching Station Inspection

Date: May 30, 2007

Location: Beseck Switching Station

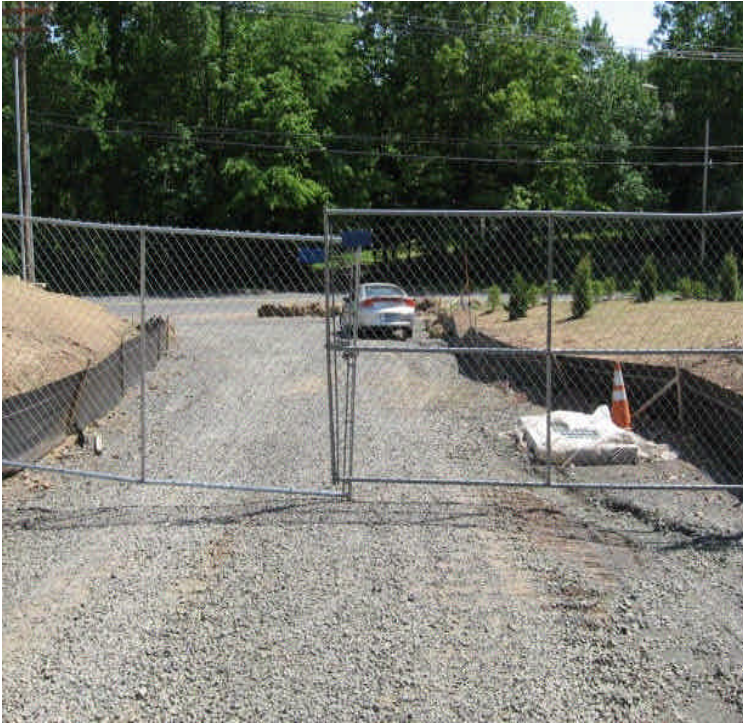
Site entrance off Carpenter Lane is at final grade. Stone base and stone check dams remain in place.

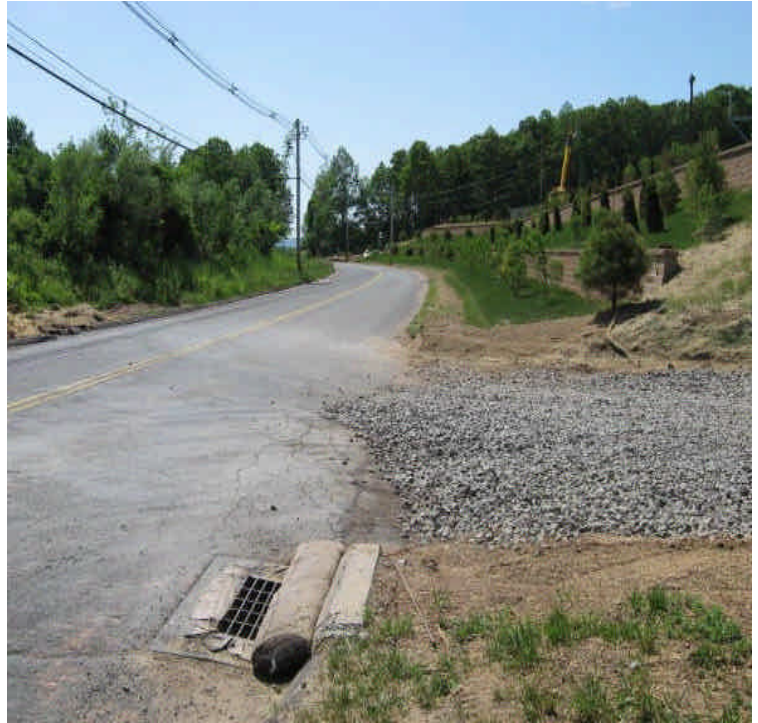
View of eastern site exit. The silt fence was removed along Carpenter Lane and haybales were removed from the exit. Apply seed to any exposed soil resulting from the removal.

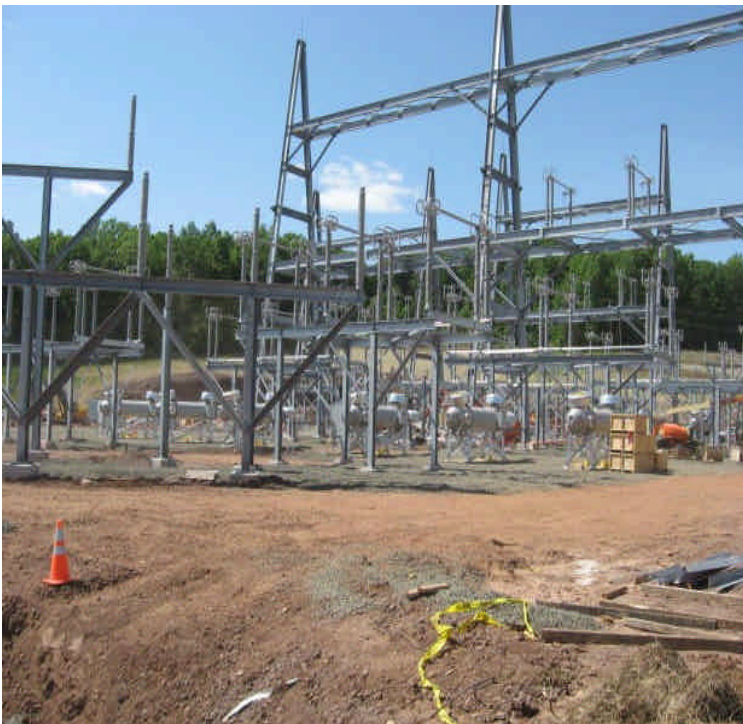
View of the entire site from the southeast corner looking north. Stone is being spread at completed areas for further stabilization.

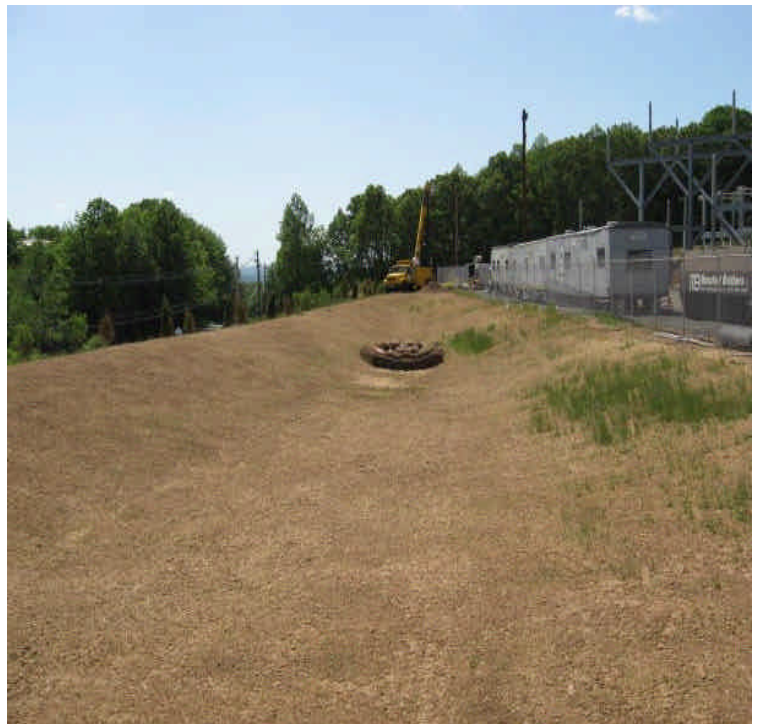
Haybales and controls remain in place at the inlet of the detention basin. Basin slopes and floors have been graded and hydroseeded.

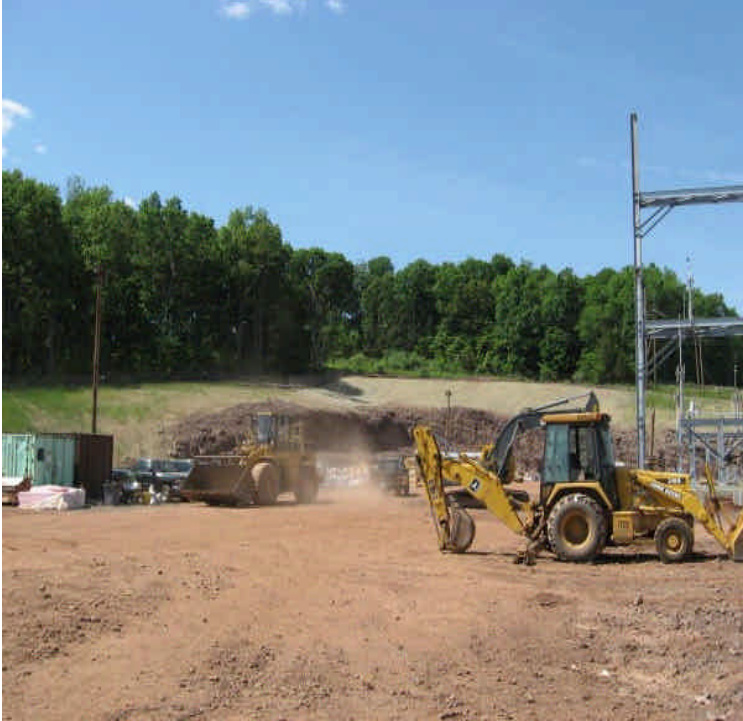
Some airborne dust generation was noted; Continue to monitor and add controls as needed

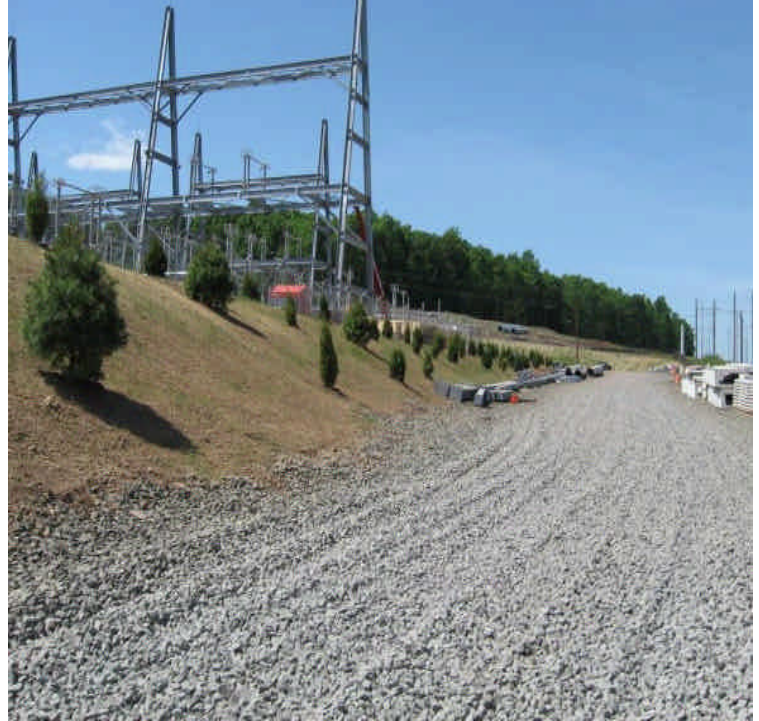
View of the eastern site exit and the new shrubs planted along the slope.

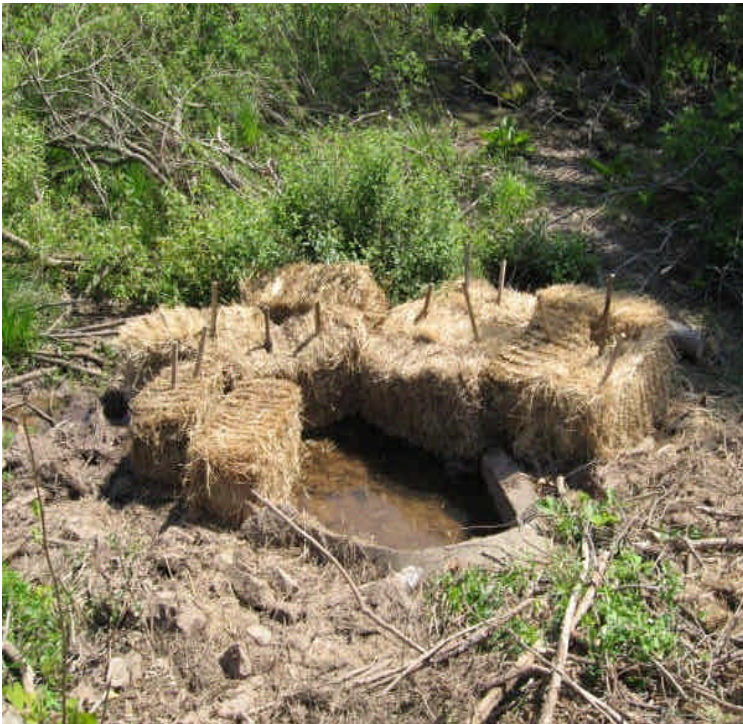
Storm drain outlet across Carpenter Lane has clear water flowing through the haybales. Deteriorated haybales were removed and replaced.

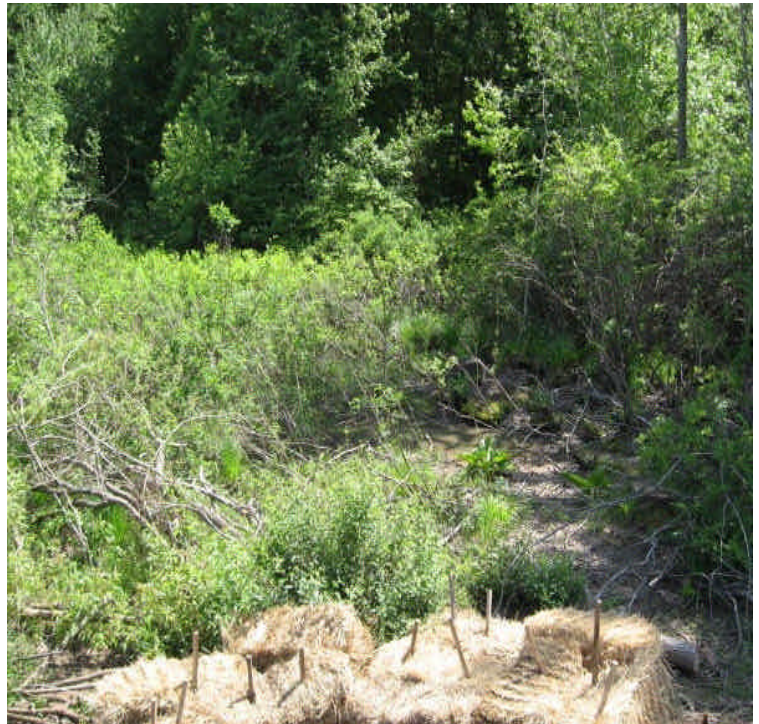
Clear water was observed leaving the haybales and ponding within the wetlands. Evaluate whether the amount sediment accumulation justifies the minor disturbance needed to remove it, once the water subsides.
