Docket No. 272 – Development and Management Plan Inspection

Beseck Switching Station Inspection

Date: June 5, 2007

Location: Beseck Switching Station

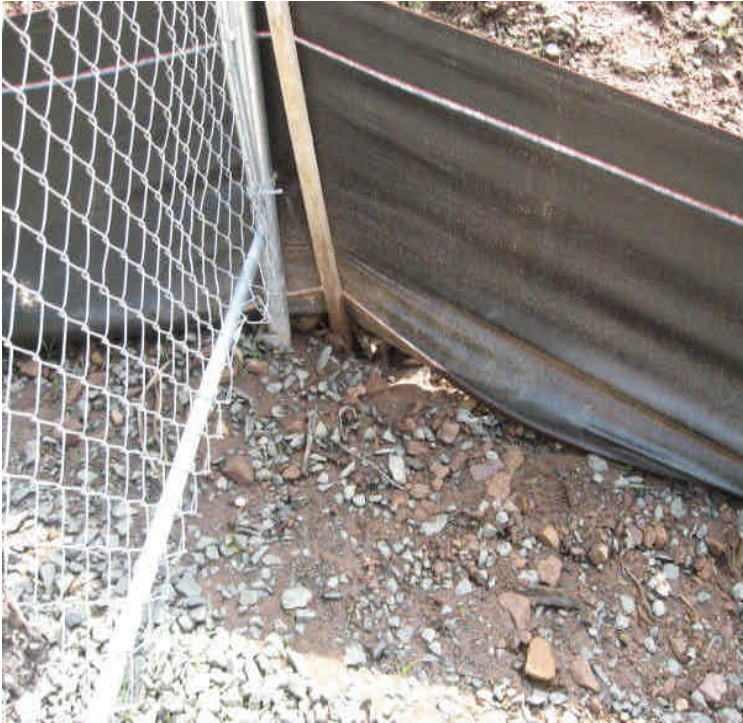
Silt fence at entrance off Carpenter Lane appears to have been undermined by stormwater run-off and should be toed back in.

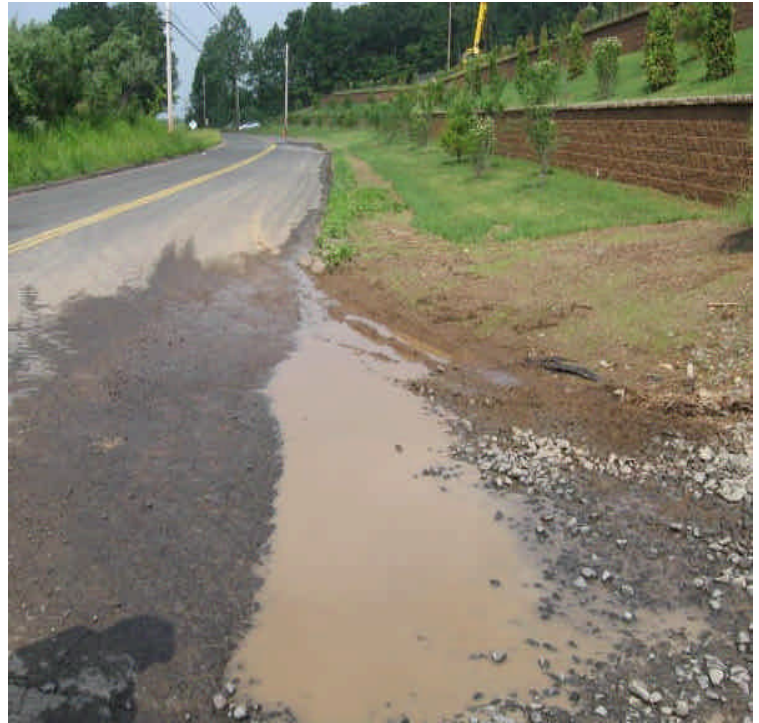
View of eastern site exit along Carpenter Lane. Haybales were removed and not replaced at the corner of this area and turbid run-off from the storm was flowing off site.

Areas of Inspection	Observation	Recommended Action	Corrected Action
Access roads and adjacent roadways	As a result of the recent heavy rain, turbid run-off was observed leaving the site egress to the east during this week's inspection. The haybales that were removed from the edge of the drive (noted 5/22) have not been replaced. 6/5/07	Continue to monitor and evaluate during larger storm events. Haybales should be replaced here to contain and filter the run-off until the site is fully stabilized. Stone should be cleaned. 6/5/07	Needs attention-haybales should be replaced.
	A few haybales, clean stone and check dams remain along the western site entrance. 5/30/07	See erosion control section for more details and recommendations. 6/5/07	Not Applicable (NA)
	The stone access east of Beseck remains in place to reduce tracking to the main pad. 6/5/07	Continue to maintain and work out schedule with 1A contractors to share responsibility. 6/5/07	NA

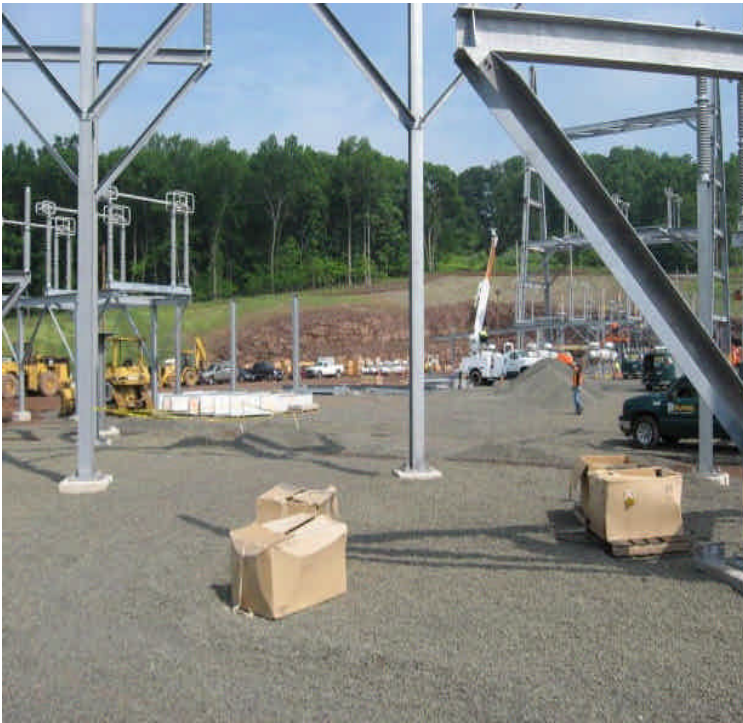
View of the entire site from the southeast corner looking north Stone is being spread at completed areas for further stabilization

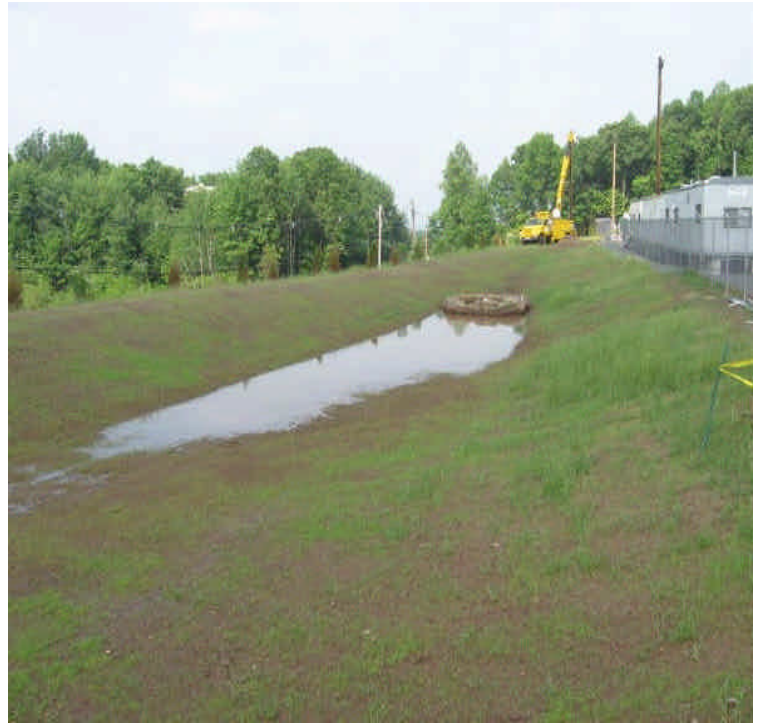
Haybales and controls remain in place at the inlet of the detention basin. Some run-off has ponded here. Additional grass growth was noted in recently hydroseeded areas.

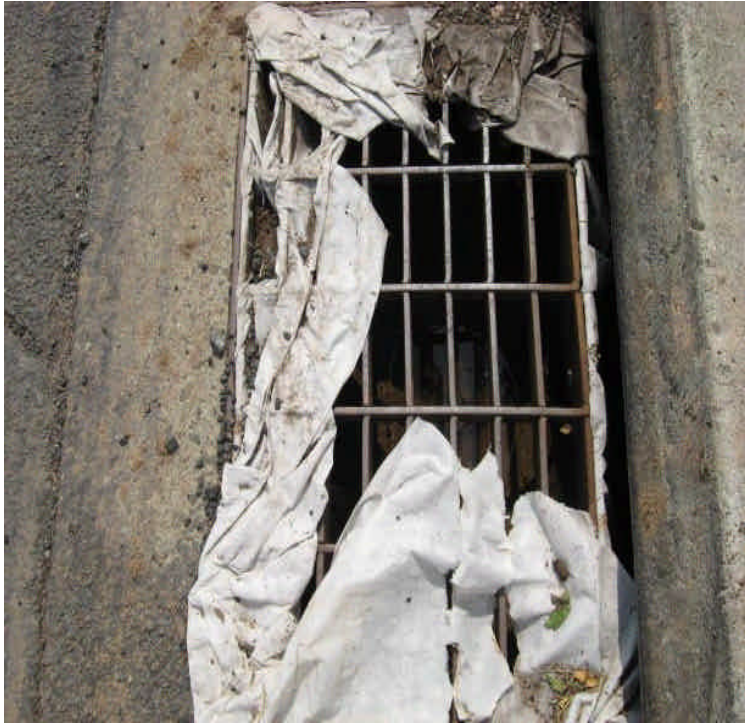
Clean and replace CB controls along Carpenter Lane. They had deteriorated as a result of the rain event.

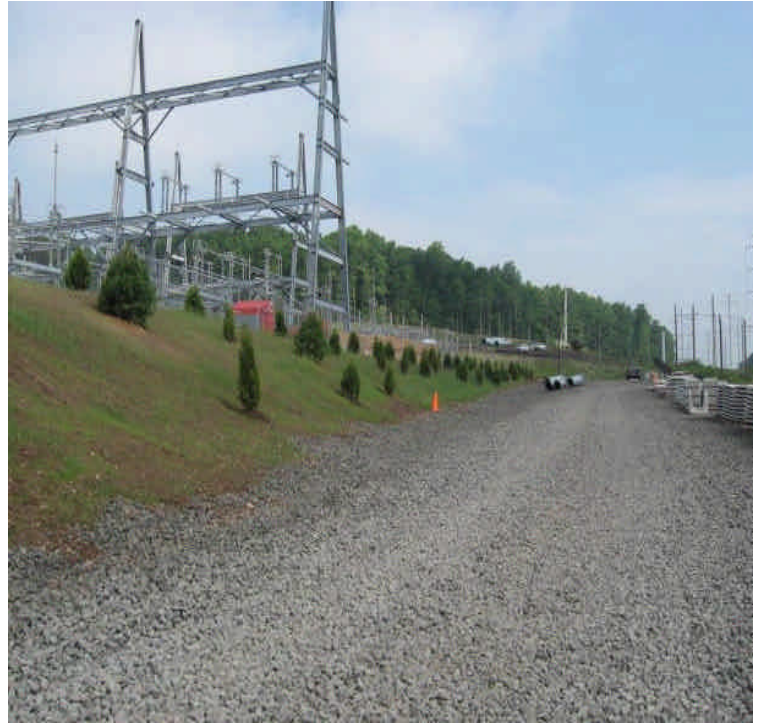
View of the eastern site exit and shrubs in place along the slope. Grass cover also appears to be increasing here.

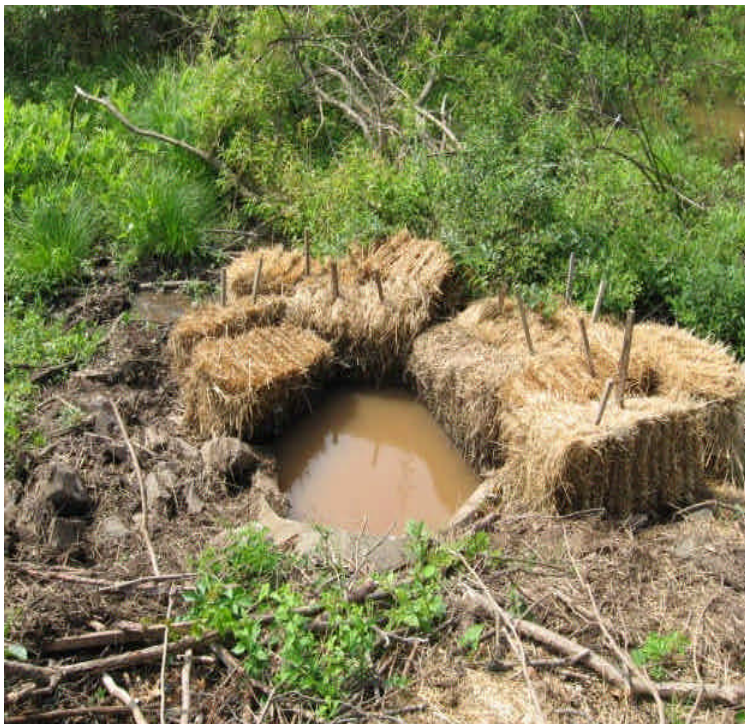
Areas of Inspection	Observation	Recommended Action	Corrected Action
	<p>basins and along the slopes at the eastern site egress. 6/5/07</p> <p>New haybales remain at the storm water outlet pipe at the wetland across Carpenter Lane. Standing water within the outlet is turbid as a result of the recent heavy rains, but water flowing into the wetlands is mostly clear. Sediment buildup noted within the wetlands from previous storms. In general, sediment from the site is very fine and difficult to filter but efforts continue to be made onsite to reduce turbid run-off. 6/5/07</p>	<p>6/5/07</p> <p>Continue to monitor and replace haybales as needed at the storm drain outlet. Stormwater should continue to be contained and filtered before leaving the site to the extent possible. Continue addressing stormwater issues at the source. Good efforts were made on site to reduce run-off. Stone check dams along Carpenter Ln. should be considered to help reduce turbid run-off from entering the CBs. 6/5/07</p>	<p>Water at the storm drain outlet is turbid but is filtered well by the new haybales in place.</p>

Storm drain outlet across Carpenter Lane has standing turbid water as a result of the storm and some site run-off

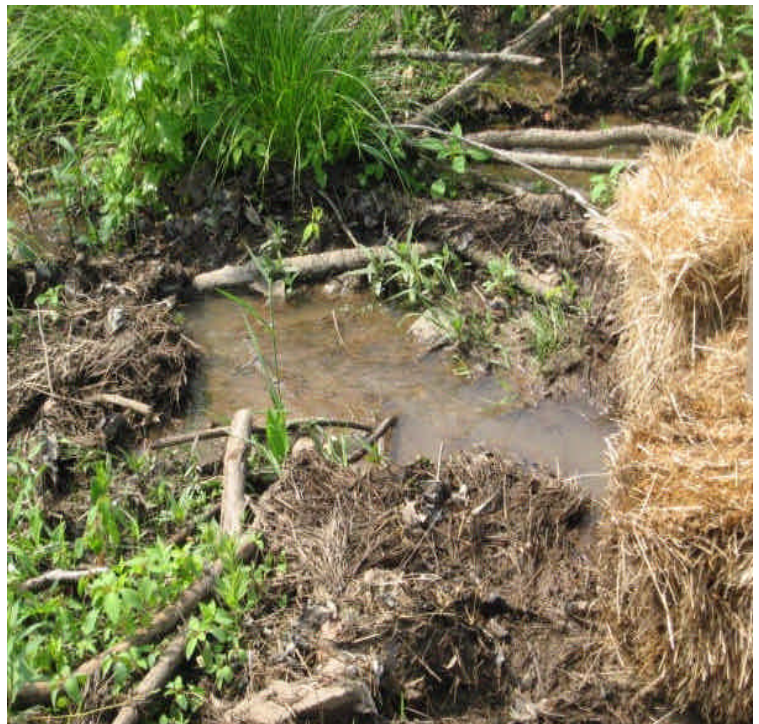
<p>Inland Wetland and Watercourse encroachment and mitigation</p>	<p>Turbid water was noted within the outlet across Carpenter Lane but was mostly clear by the time it reached wetlands due to the recently replaced haybales. Haybales still don't appear capable of containing all sediment during peak flows. 6/5/07</p> <p>The drainage ditch (north side of the site) and culvert under the ROW access was flowing during the storm and overflowing the sediment trap with turbid water. 6/5/07</p> <p>Additional work in the wetlands to the south and east of Beseck are covered in other project reports 6/5/07</p>	<p>Several areas in the wetland have sediment accumulation. Sediment should be removed from the outlet and adjacent areas when water levels recede 12/26/06- 6/5/07. It will be evaluated whether the accumulation justifies the minor disturbance required to remove it. 1/23-6/5/07</p> <p>Add controls along the drainage ditch to slow and filter run-off before leaving the site (noted since 4/25/07). 6/5/07</p> <p>See Segment 1a or 2a inspection reports for more details. 6/5/07</p>	<p>Continue to evaluate and add controls as needed.</p> <p>Needs attention.</p> <p>Not jurisdictional to this D&M plan.</p>

Mostly clear water was observed leaving the haybales and entering the wetlands. The new haybales helped to filter out the sediment. Evaluate whether the amount of sediment accumulation justifies the minor disturbance needed to remove it, once the water subsides.
