Docket No. 272 – Development and Management Plan Inspection

East Devon Substation Inspection

Date: May 24, 2007

Location: East Devon Substation

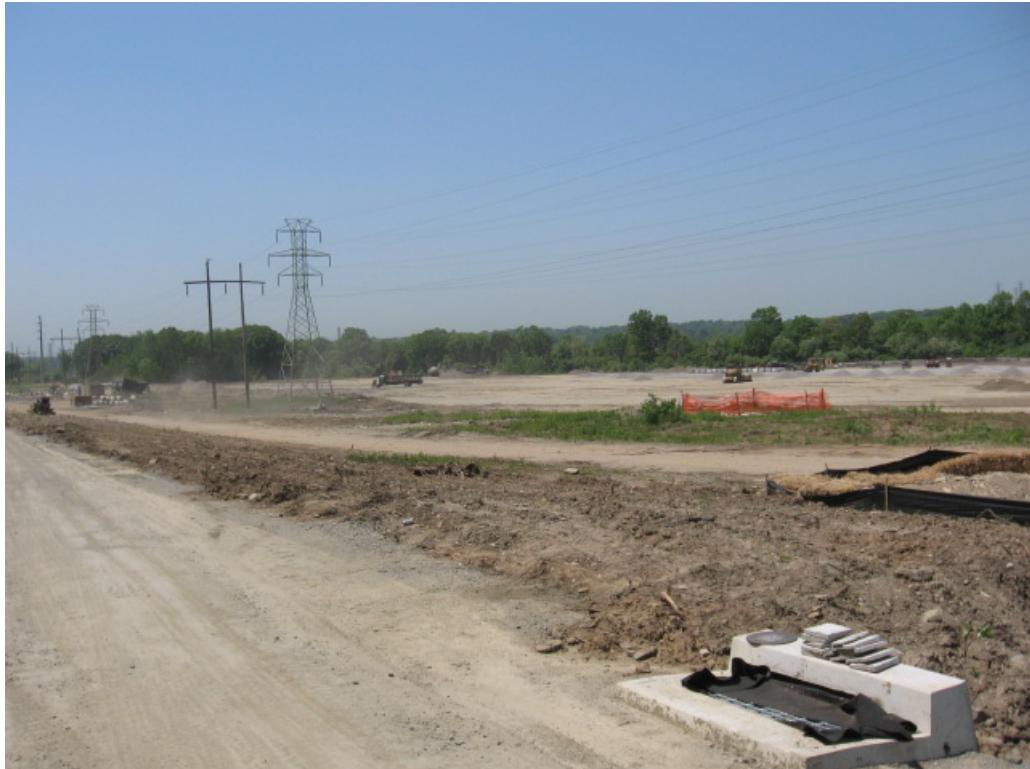
Overall view of substation work from Shelland Street. Site grading and stone spreading continues.

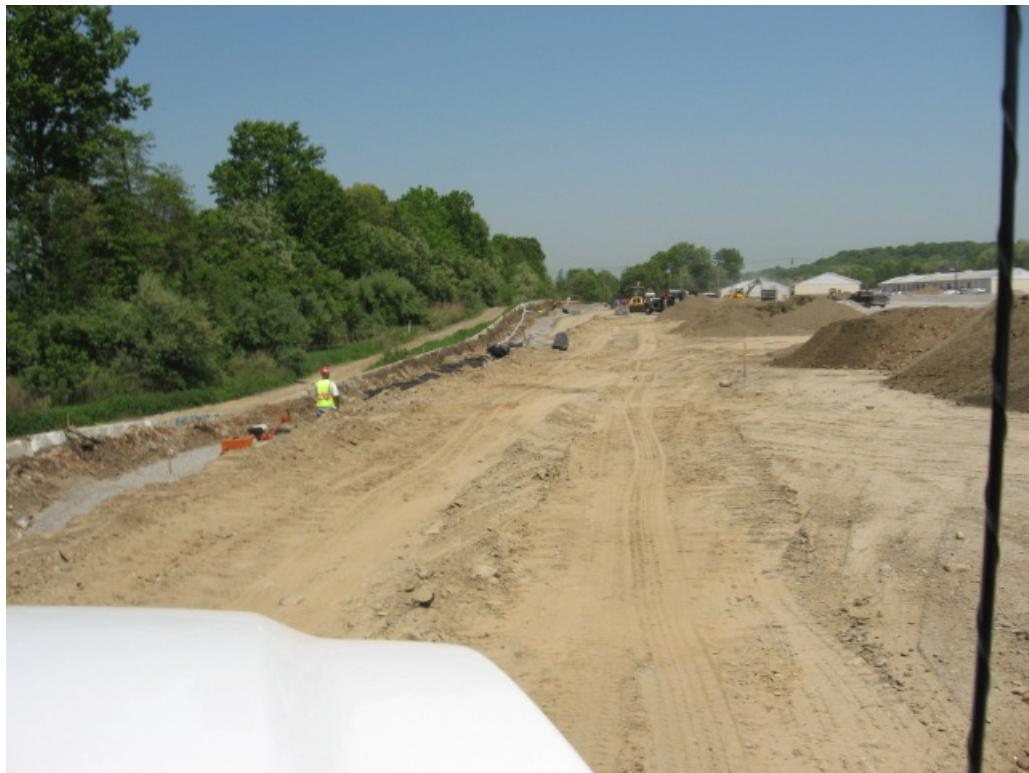
View of perimeter/retaining wall construction along the western site boundary. Stockpiles were noted here this week.
