Docket No. 272 – Development and Management Plan Inspection

East Devon Substation Inspection

Date: June 1, 2007

Location: East Devon Substation

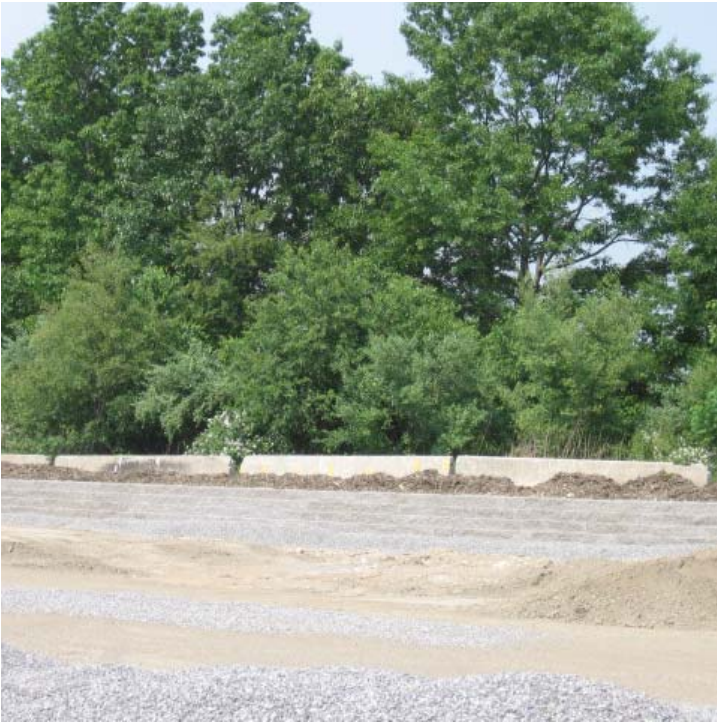
Retaining wall construction continues this week. Stone is still being spread throughout the site for dust control.

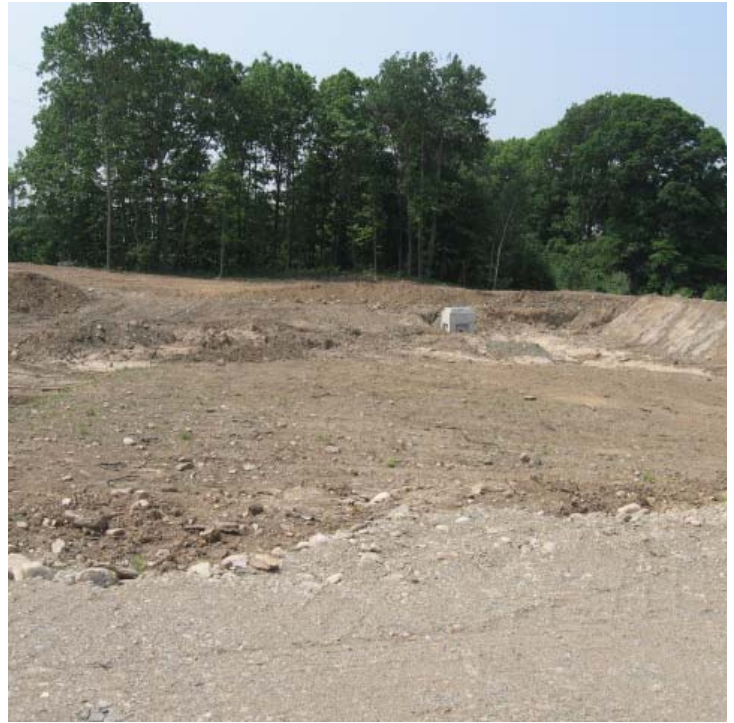
Detention basin construction continues at the southeastern portion of the site.

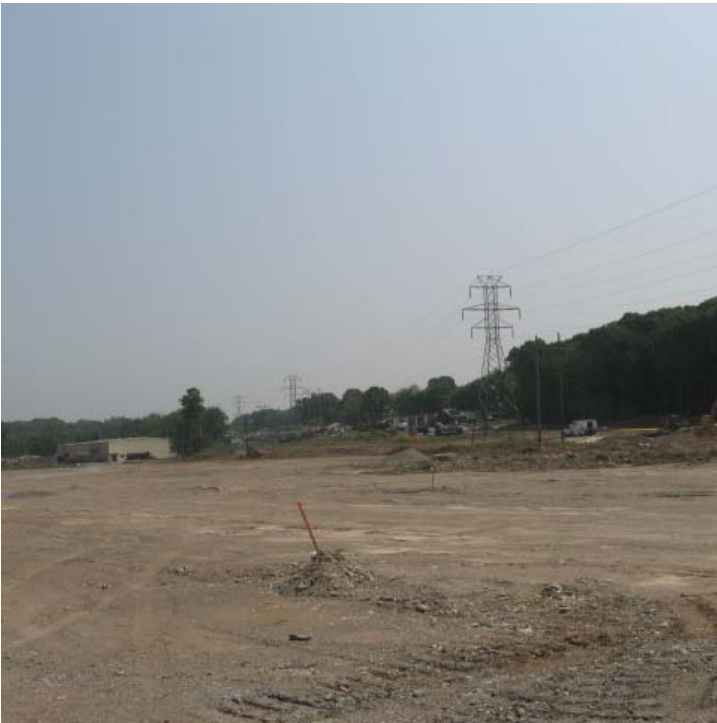
Grading continues throughout the site.

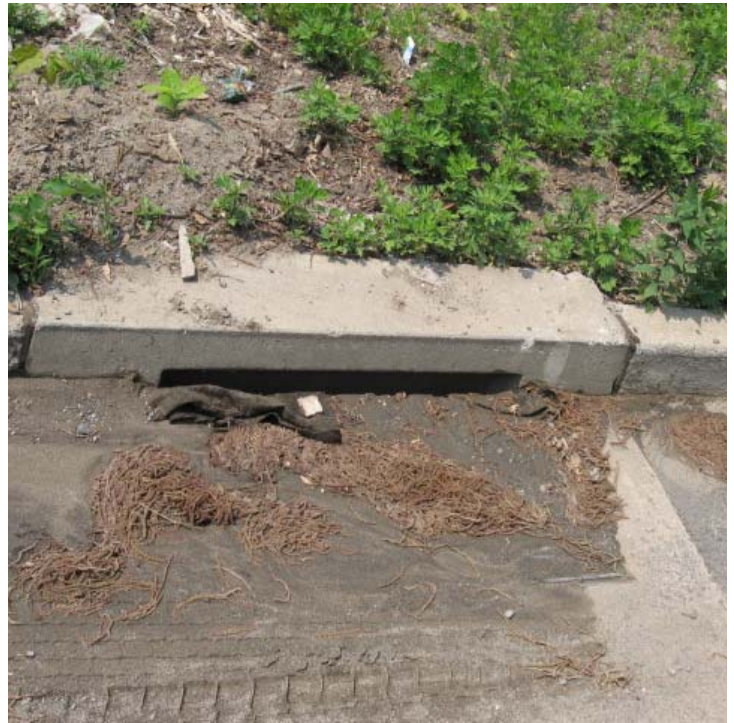
Plains Road appeared to have been recently swept. 6/1/07 Sediment build up was noted at some of the CBs on Plains Road this week. "Silt saks" (or similar) remain intact, but curb drop inlet protection was not provided in some locations. Filter fabric was pulled over the inlets of the CBs located immediately adjacent to the western most access points. 6/1/07	Sweep the roadway on a regular basis and clean the catch basins as necessary. 5/3-6/1/07 Continue to monitor and maintain as necessary. Evaluate methods to protect the curb drop inlets and prevent sedimentation as needed. 6/1/07	Plains Road had been recently swept CB controls are in place but need regular attention

Sediment build up remains at some of the catch basins along Plains Road. Silt sacks remain intact but curb inlet protection was not provided in some locations.
